OBSERVATION REPORT

Tecumseh Historic Square Preservation – Structural Evaluation

Submitted by Olsson Inc.

February 18, 2022

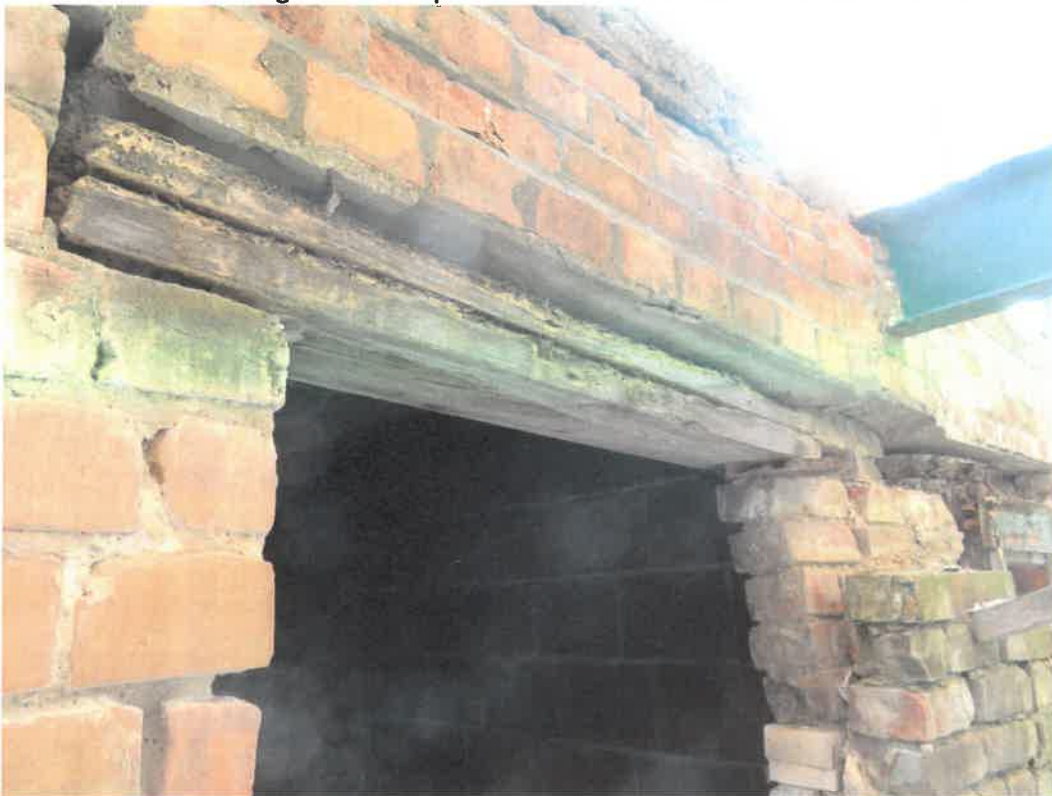
Vault 1 extends from the eastern edge of the open hallway to the backside of the street curb for approximately 59 feet. This vault is not in use. Vault 1 could not be completely inspected because of rubble on the floor and unsafe conditions. This vault has four separate compartments with doorways from the hallway. The vault is in very poor condition with partially collapsed walls, missing walls, displaced or missing doorway headers, and severely corroded steel beams in the vault lid, etc. These present potential safety hazards to the public should the vault lid be subjected to heavy traffic. Olsson recommends the concrete lid and associated steel beams be removed, many of the vault walls removed, a new retaining wall be replaced for the hallway constructed from reinforced cast-in-place concrete with a brick veneer of like kind, and the vault void spaces filled in with an aggregate/gravel material. The floor of the hallway is currently concrete and will be replaced with reinforced concrete. The new stairwell will be designed and constructed so they span from the upper ground level to the lower-level floor without attachment to or support from the existing building. The existing steel railing appears to be in good shape. The steel railing will need to be removed and stored-off site before being reinstalled after sidewalk improvements.

Photo 30 **Building No. 17 – Nester & Mercure Attorneys (398 Broadway St)**
Typical Deterioration of Walk Door in Vault 1

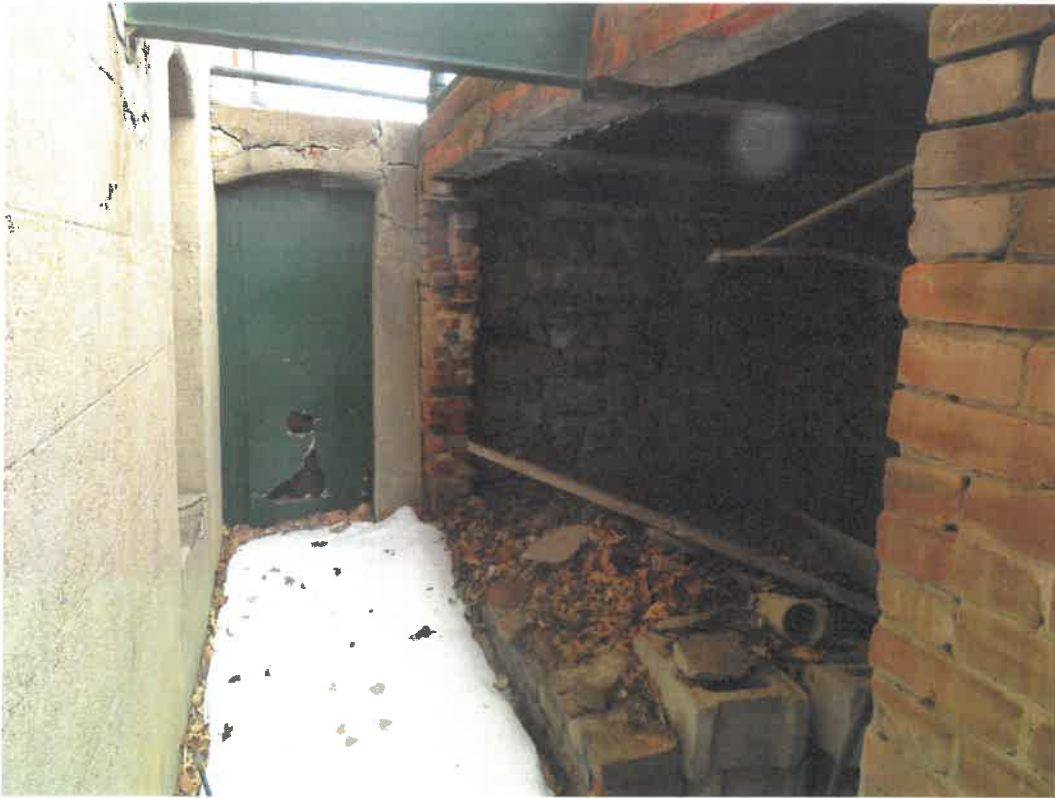
**Photo 31 Building No. 17 – Nester & Mercure Attorneys (398 Broadway St)
Fallen Wall at North End of Vault 1 w/ Vault 2 South Walk Door**

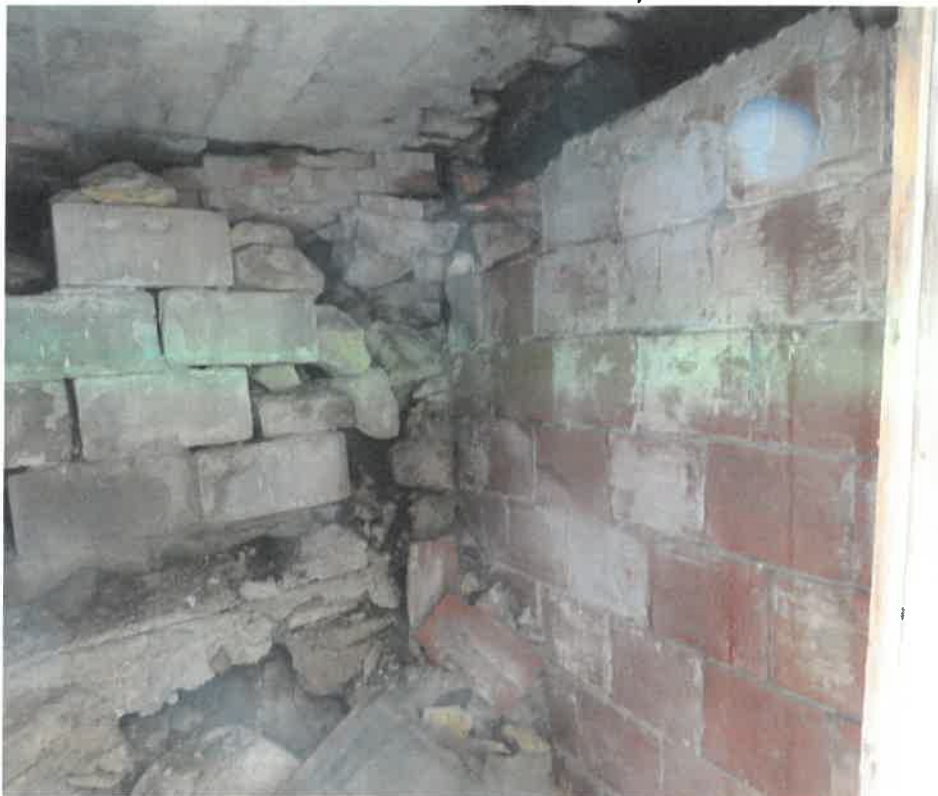
**Photo 32 Building No. 17 – Nester & Mercure Attorneys (398 Broadway St)
Typical Deterioration of Limestone & Hollow Clay Tile Foundation in Vault 1**

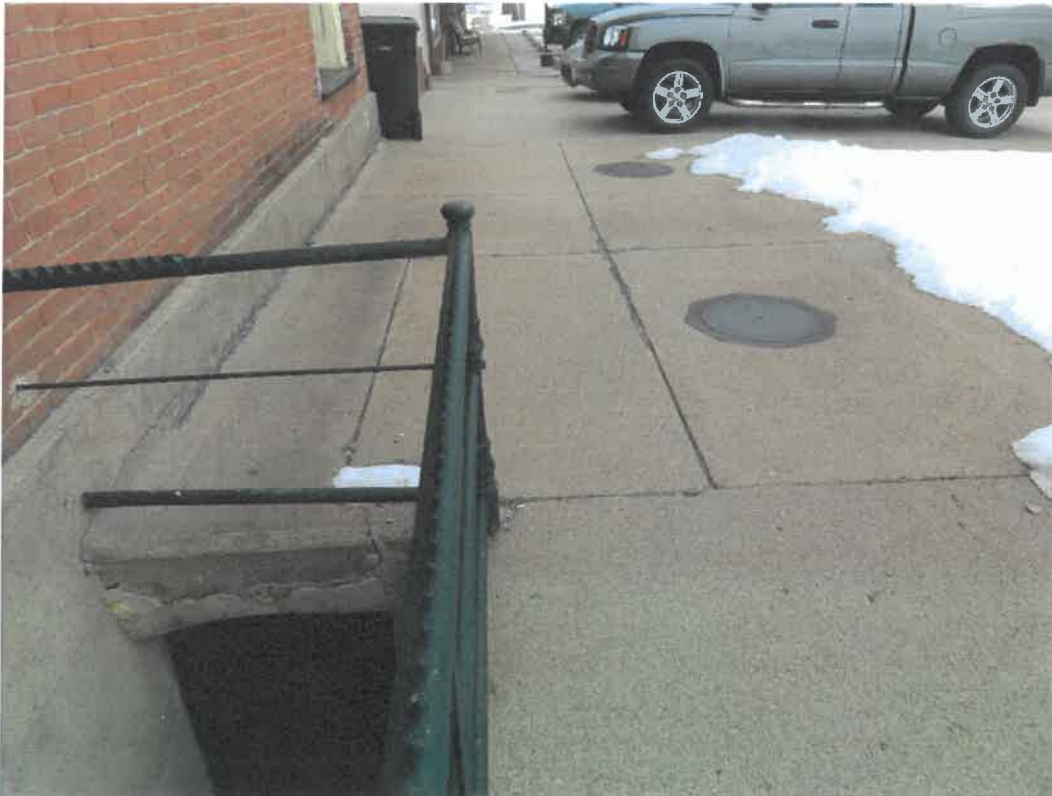
Vault 2 extends from the western edge of the building to the backside of the street curb for approximately 19 feet. This vault is not in use. The walls of the vault beneath the sidewalk are in satisfactory condition; however, the concrete lid of the vault is in very poor condition. All the steel beams supporting the concrete lid of the vault are severely rusted, with some portions of the beams completely rusted through. This presents a potential safety hazard to the public should heavy traffic be subjected to the vault lid. Olsson recommends the concrete lid be removed and the vault filled in with an aggregate/gravel material.

Photo 33 Building No. 17 – Nester & Mercure Attorneys (398 Broadway St)
Looking North at Top of Vault 2 Under Sidewalk that Extends to Street Curb

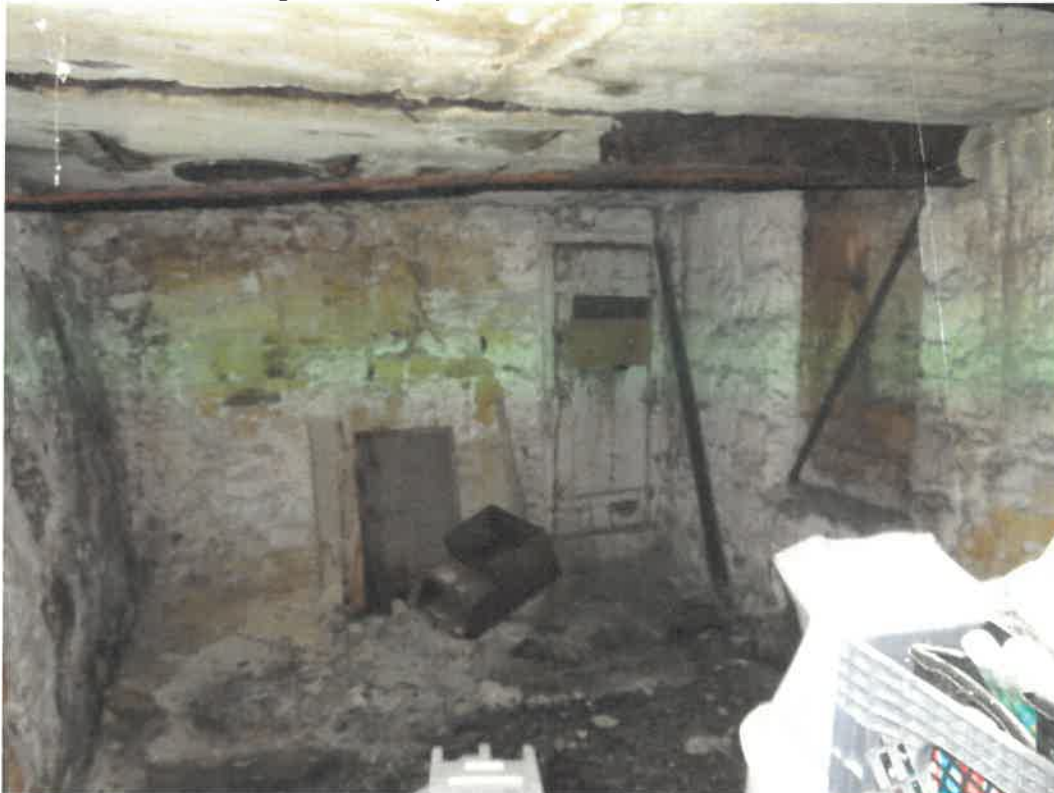
Photo 34 Building No. 17 – Nester & Mercure Attorneys (398 Broadway St)
Looking South at Typical Deterioration in Vault 2 with Window on Right

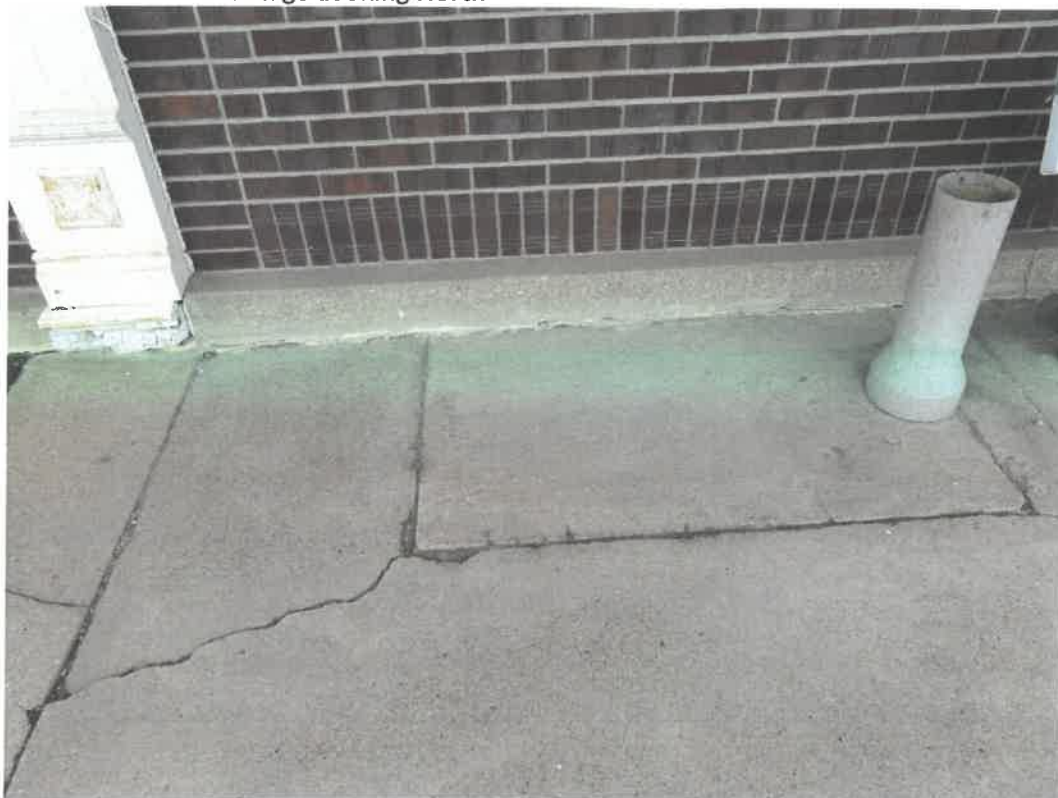
Photo 38 Building No. 20 – TNT Smoke House (366 Broadway St)
Concrete Filled-In Coal Chute on East Half of Building

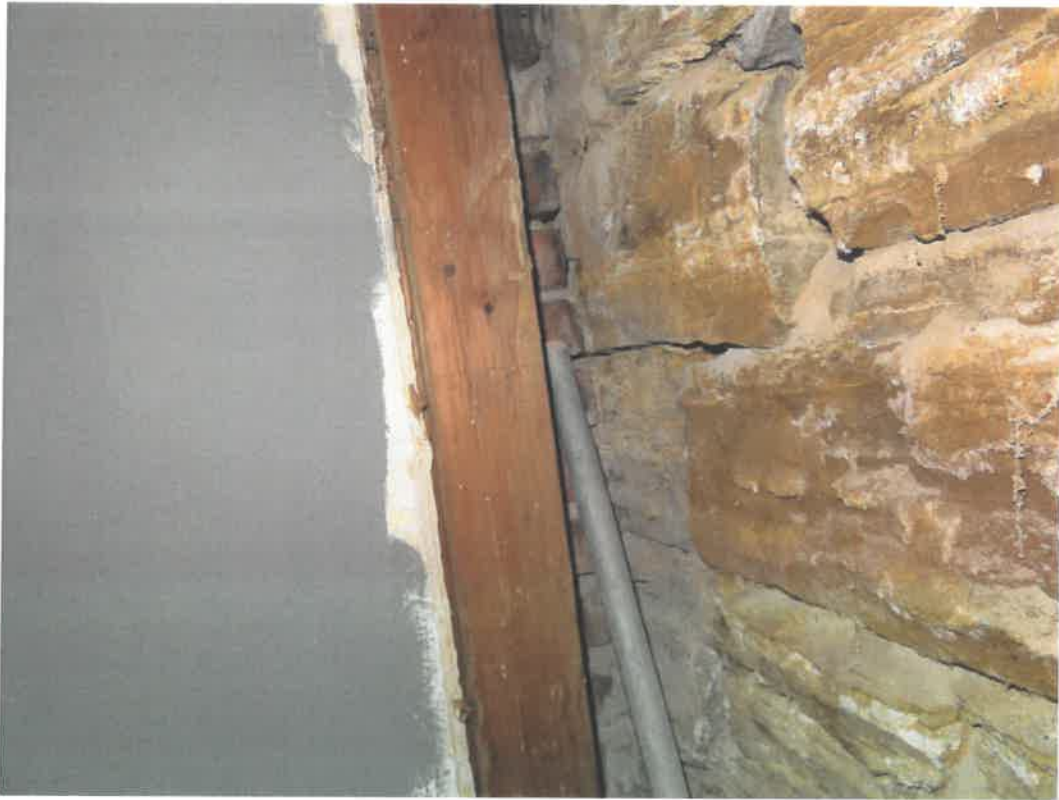
Photo 41 **Building No. 20 – TNT Smoke House (366 Broadway St)**
Partial View of Filled-In Coal Chute w/ Brick on West Half of Building

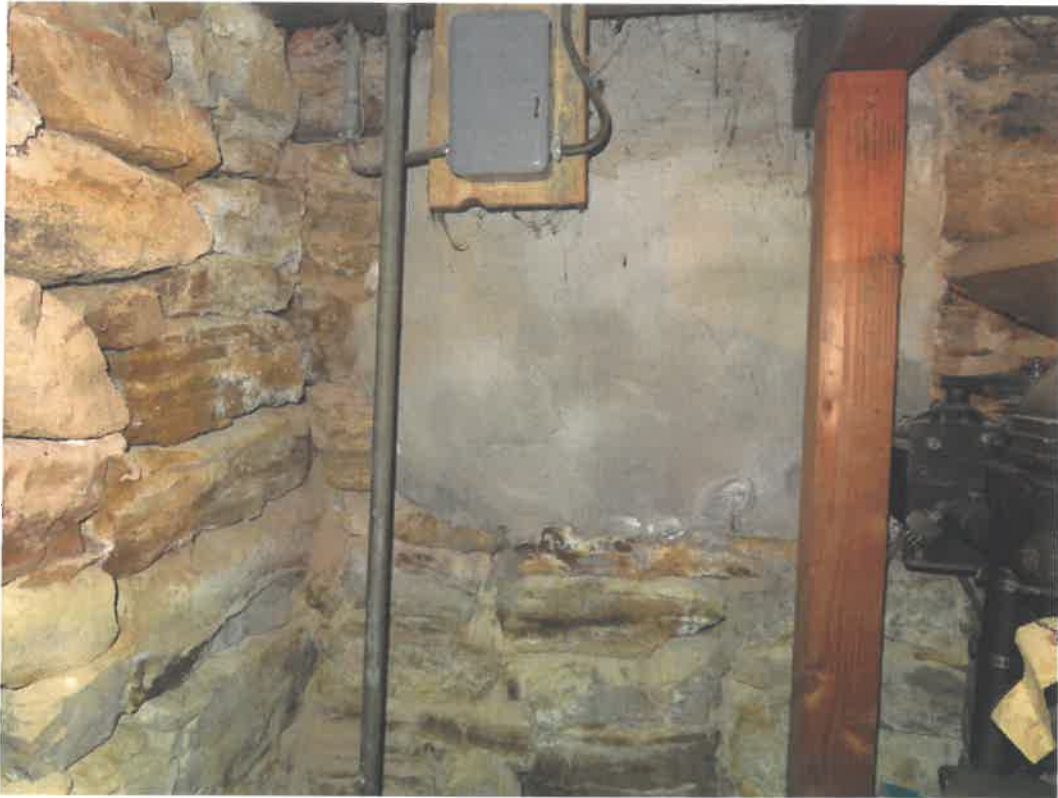
Photo 43 **Building No. 21 – D.A. Wolken & Sons (362 Broadway St)**
Concrete Filled-In Coal Chute on East End of Building

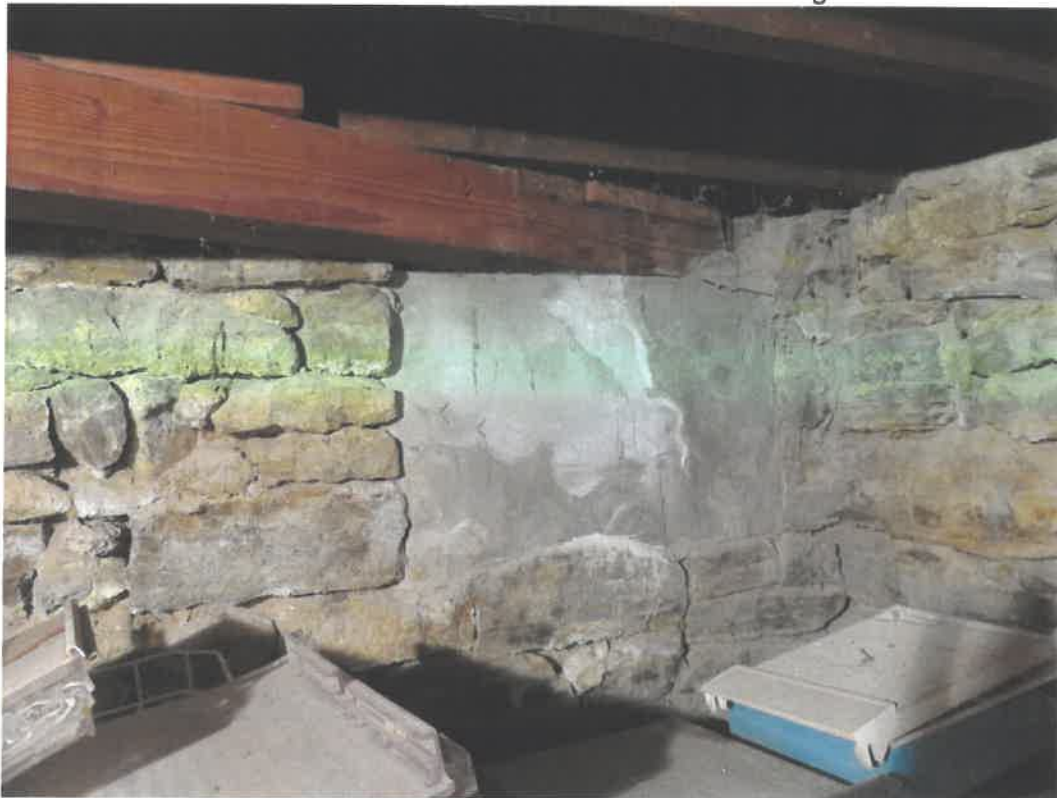
Photo 44 **Building No. 21 – D.A. Wolken & Sons (362 Broadway St)**
Concrete Filled-In Coal Chute on West End of Building

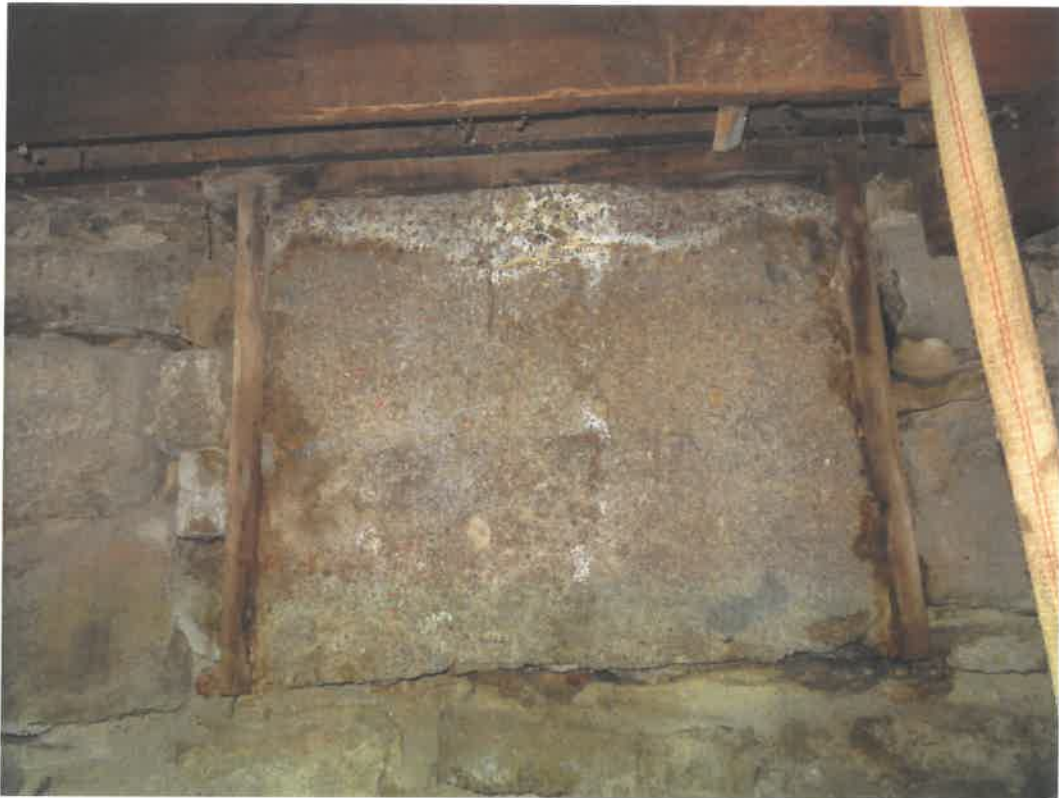
Four identical lightwells along the frontage of the building were identified in the basement foundation wall. The two lightwell openings in the limestone foundation wall on the eastern half of the building are filled in with poured concrete and appear to be in stable condition. Sidewalk improvements can be made with no effects to the building. For sidewalk improvements at these two lightwells, Olsson recommends the concrete covers with glass blocks be removed, the walls of the openings beneath the sidewalk be removed down to the bottom of the basement openings, and any voids beneath the new sidewalk be filled in with an aggregate/gravel material prior to the placement of a new sidewalk. Access into the basement by the contractor during construction will not be necessary for these two lightwells.

Photo 47 **Building No. 22 – Hopkins Block (340 Broadway St)**
Concrete Filled-In Lightwell on East Half of Building

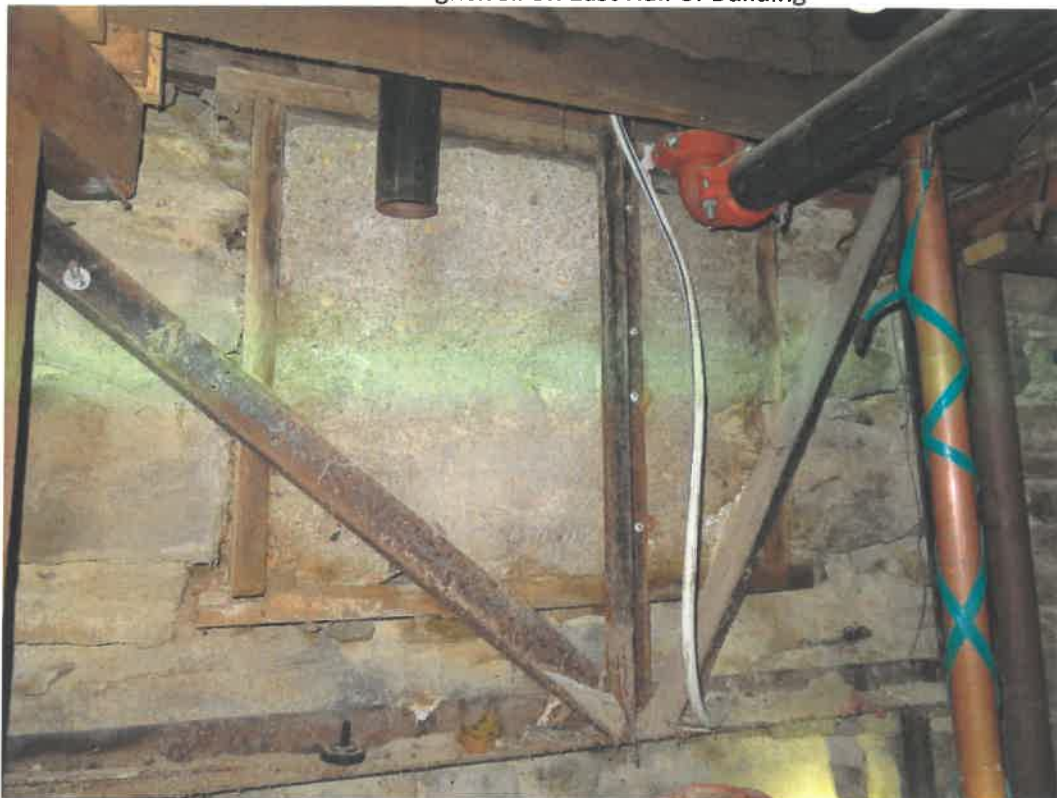
Photo 48 **Building No. 22 – Hopkins Block (340 Broadway St)**
Concrete Filled-In Lightwell on East Half of Building

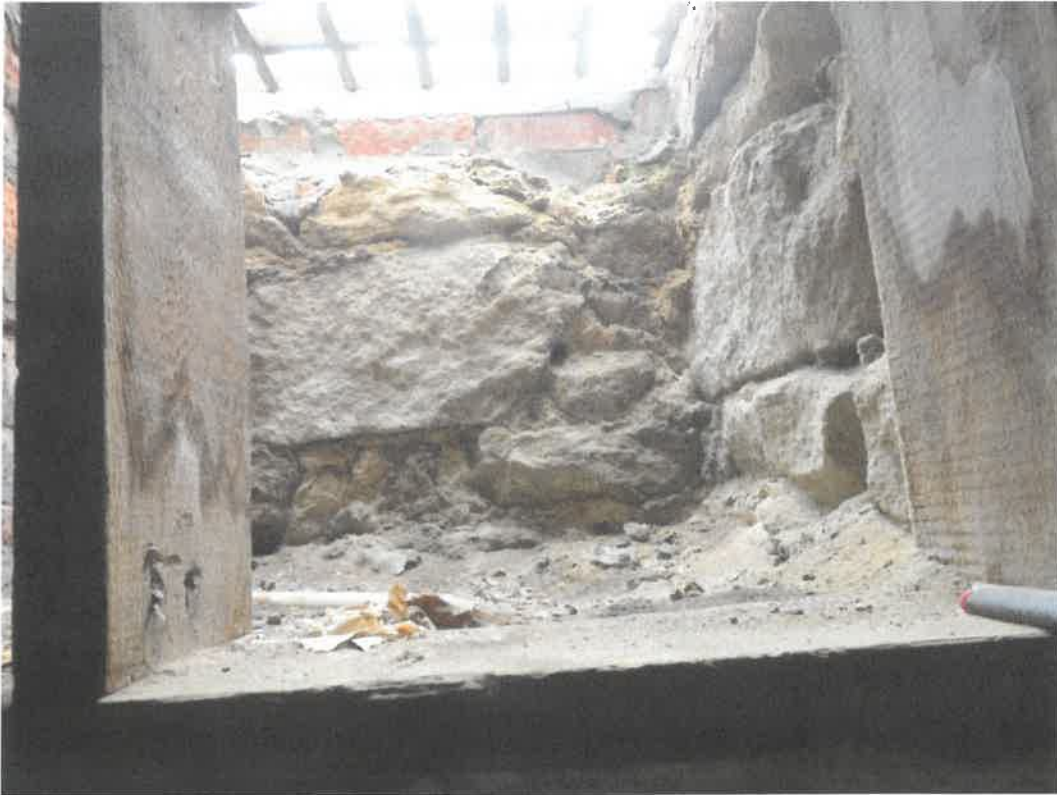
The two lightwell openings in the limestone foundation wall on the western half of the building are open. The wood framing for these two openings is not in good condition, but they are structurally stable. For sidewalk improvements at these two lightwells, Olsson recommends the concrete covers with glass blocks be removed, the wood framing of the wall openings be removed, the walls of the openings beneath the sidewalk be removed down to the bottom of the basement openings, the wall openings be filled in with limestone and appropriate mortar, and the voids beneath the sidewalk be filled in with an aggregate/gravel material prior to the placement of a new sidewalk. Implementing these recommendations will require the contractor to access the basement during construction for these two lightwells.

Photo 49 **Building No. 22 – Hopkins Block (340 Broadway St)**
Open Lightwell on West Half of Building

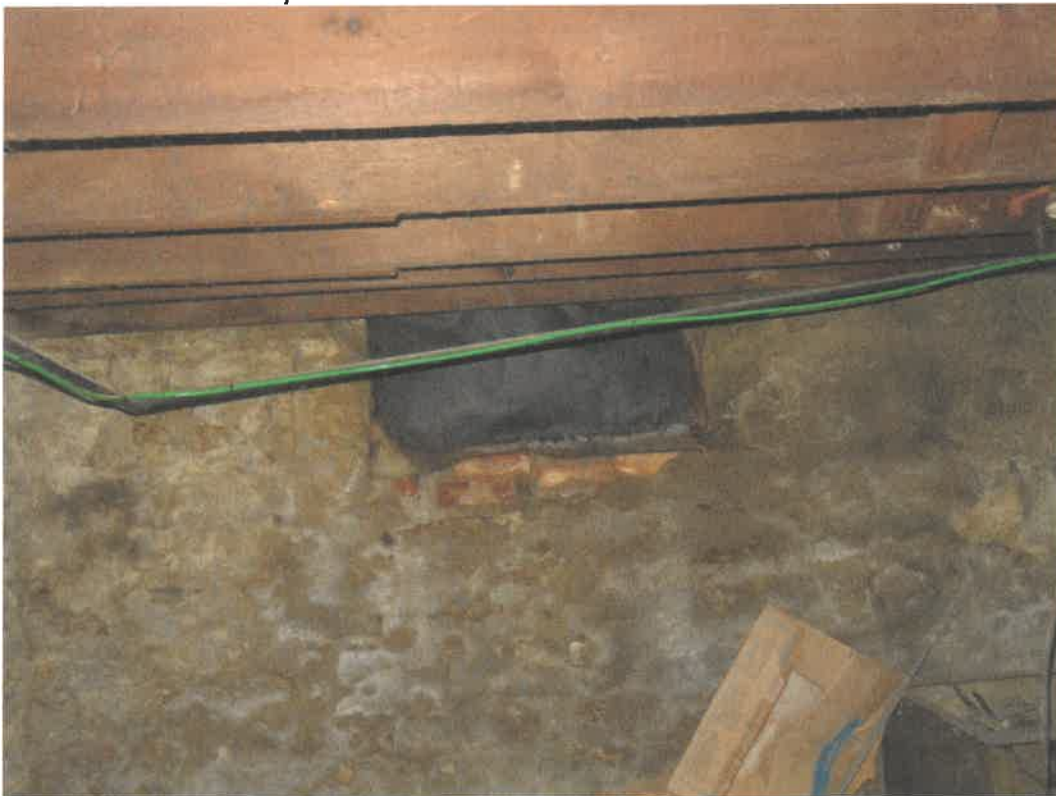
Photo 56 **Building No. 24 – Broadway Beauty & Bargains (318 Broadway St)**
Partially Filled-In Coal Chute Using Fabric in Basement

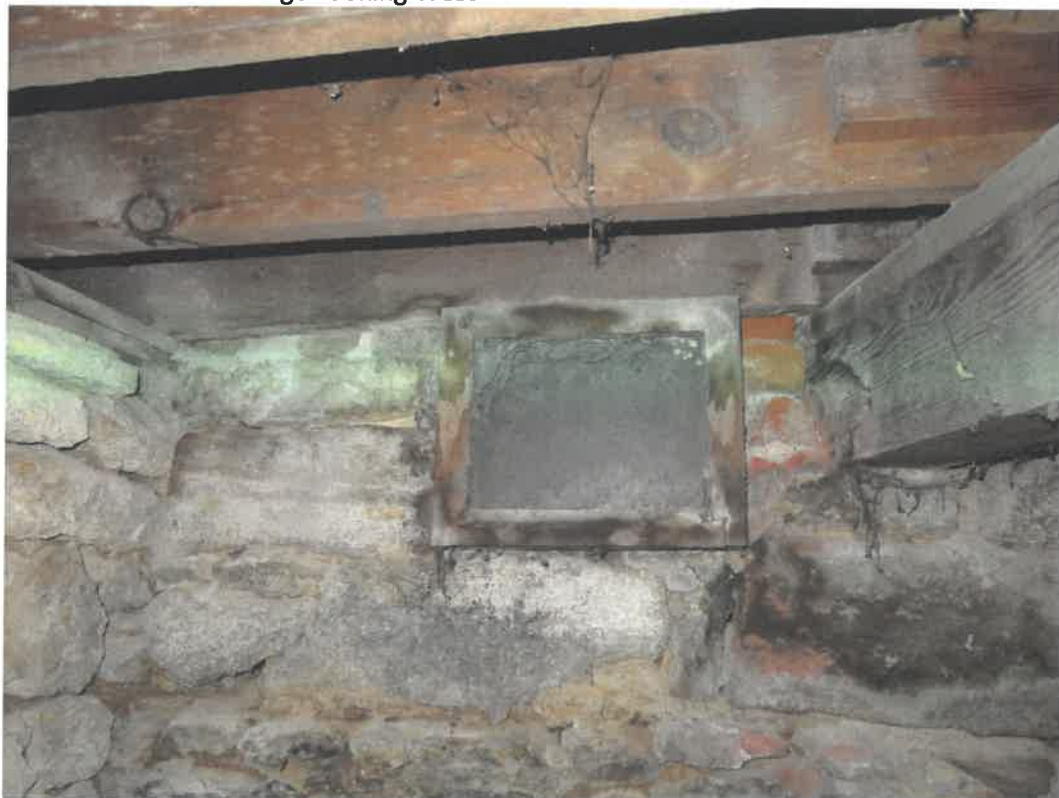
**Photo 80 Building No. 35 – Chuck Ebeler Insurance & Investments (137 S 3rd St)
Partially Filled-In Coal Chute Using Fabric in Basement**

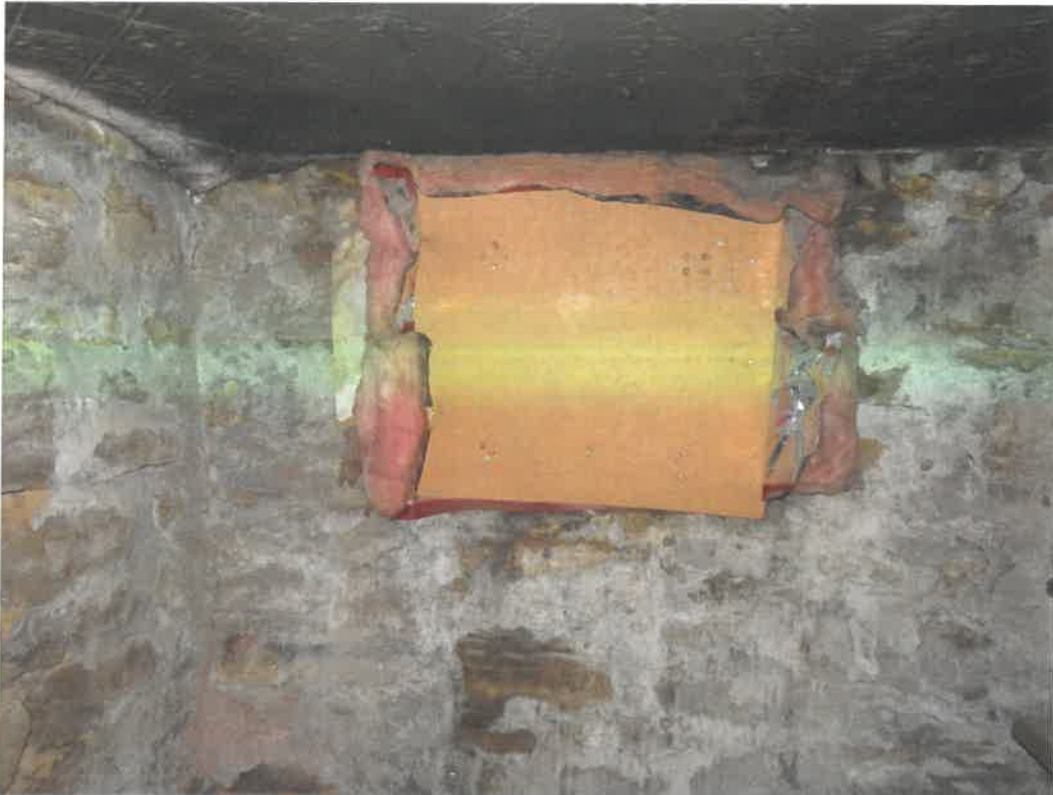
**Photo 102 Building No. 42 – Morrissey, Morrissey & Dalluge (177 S 3rd St)
Plywood/Insulation Filled-In Coal Chute in Basement**

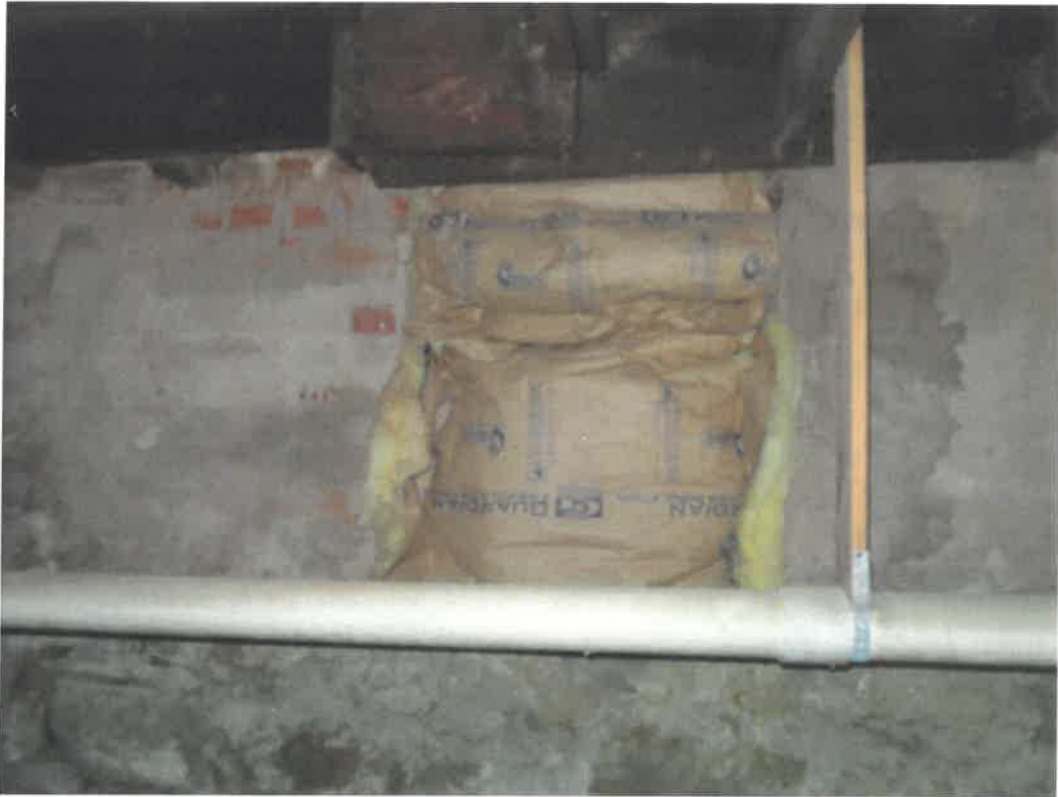
Photo 159 Building No. 59 – Tecumseh Central Market (381 Clay St)
Partially Filled in Vent Opening in Basement on East Side of East Annex
