SITE DEVELOPMENT PLAN

ASHLAND WETLAND MITIGATION BANK SAUNDERS COUNTY, NEBRASKA

**Prepared for
Nebraska Department of Transportation**

**Benesch Project No. 00120472.00
NDOT Project No. STWD (1044)
NDOT Control No. 10584B
USACE Project No. 2018-01099-WEH**

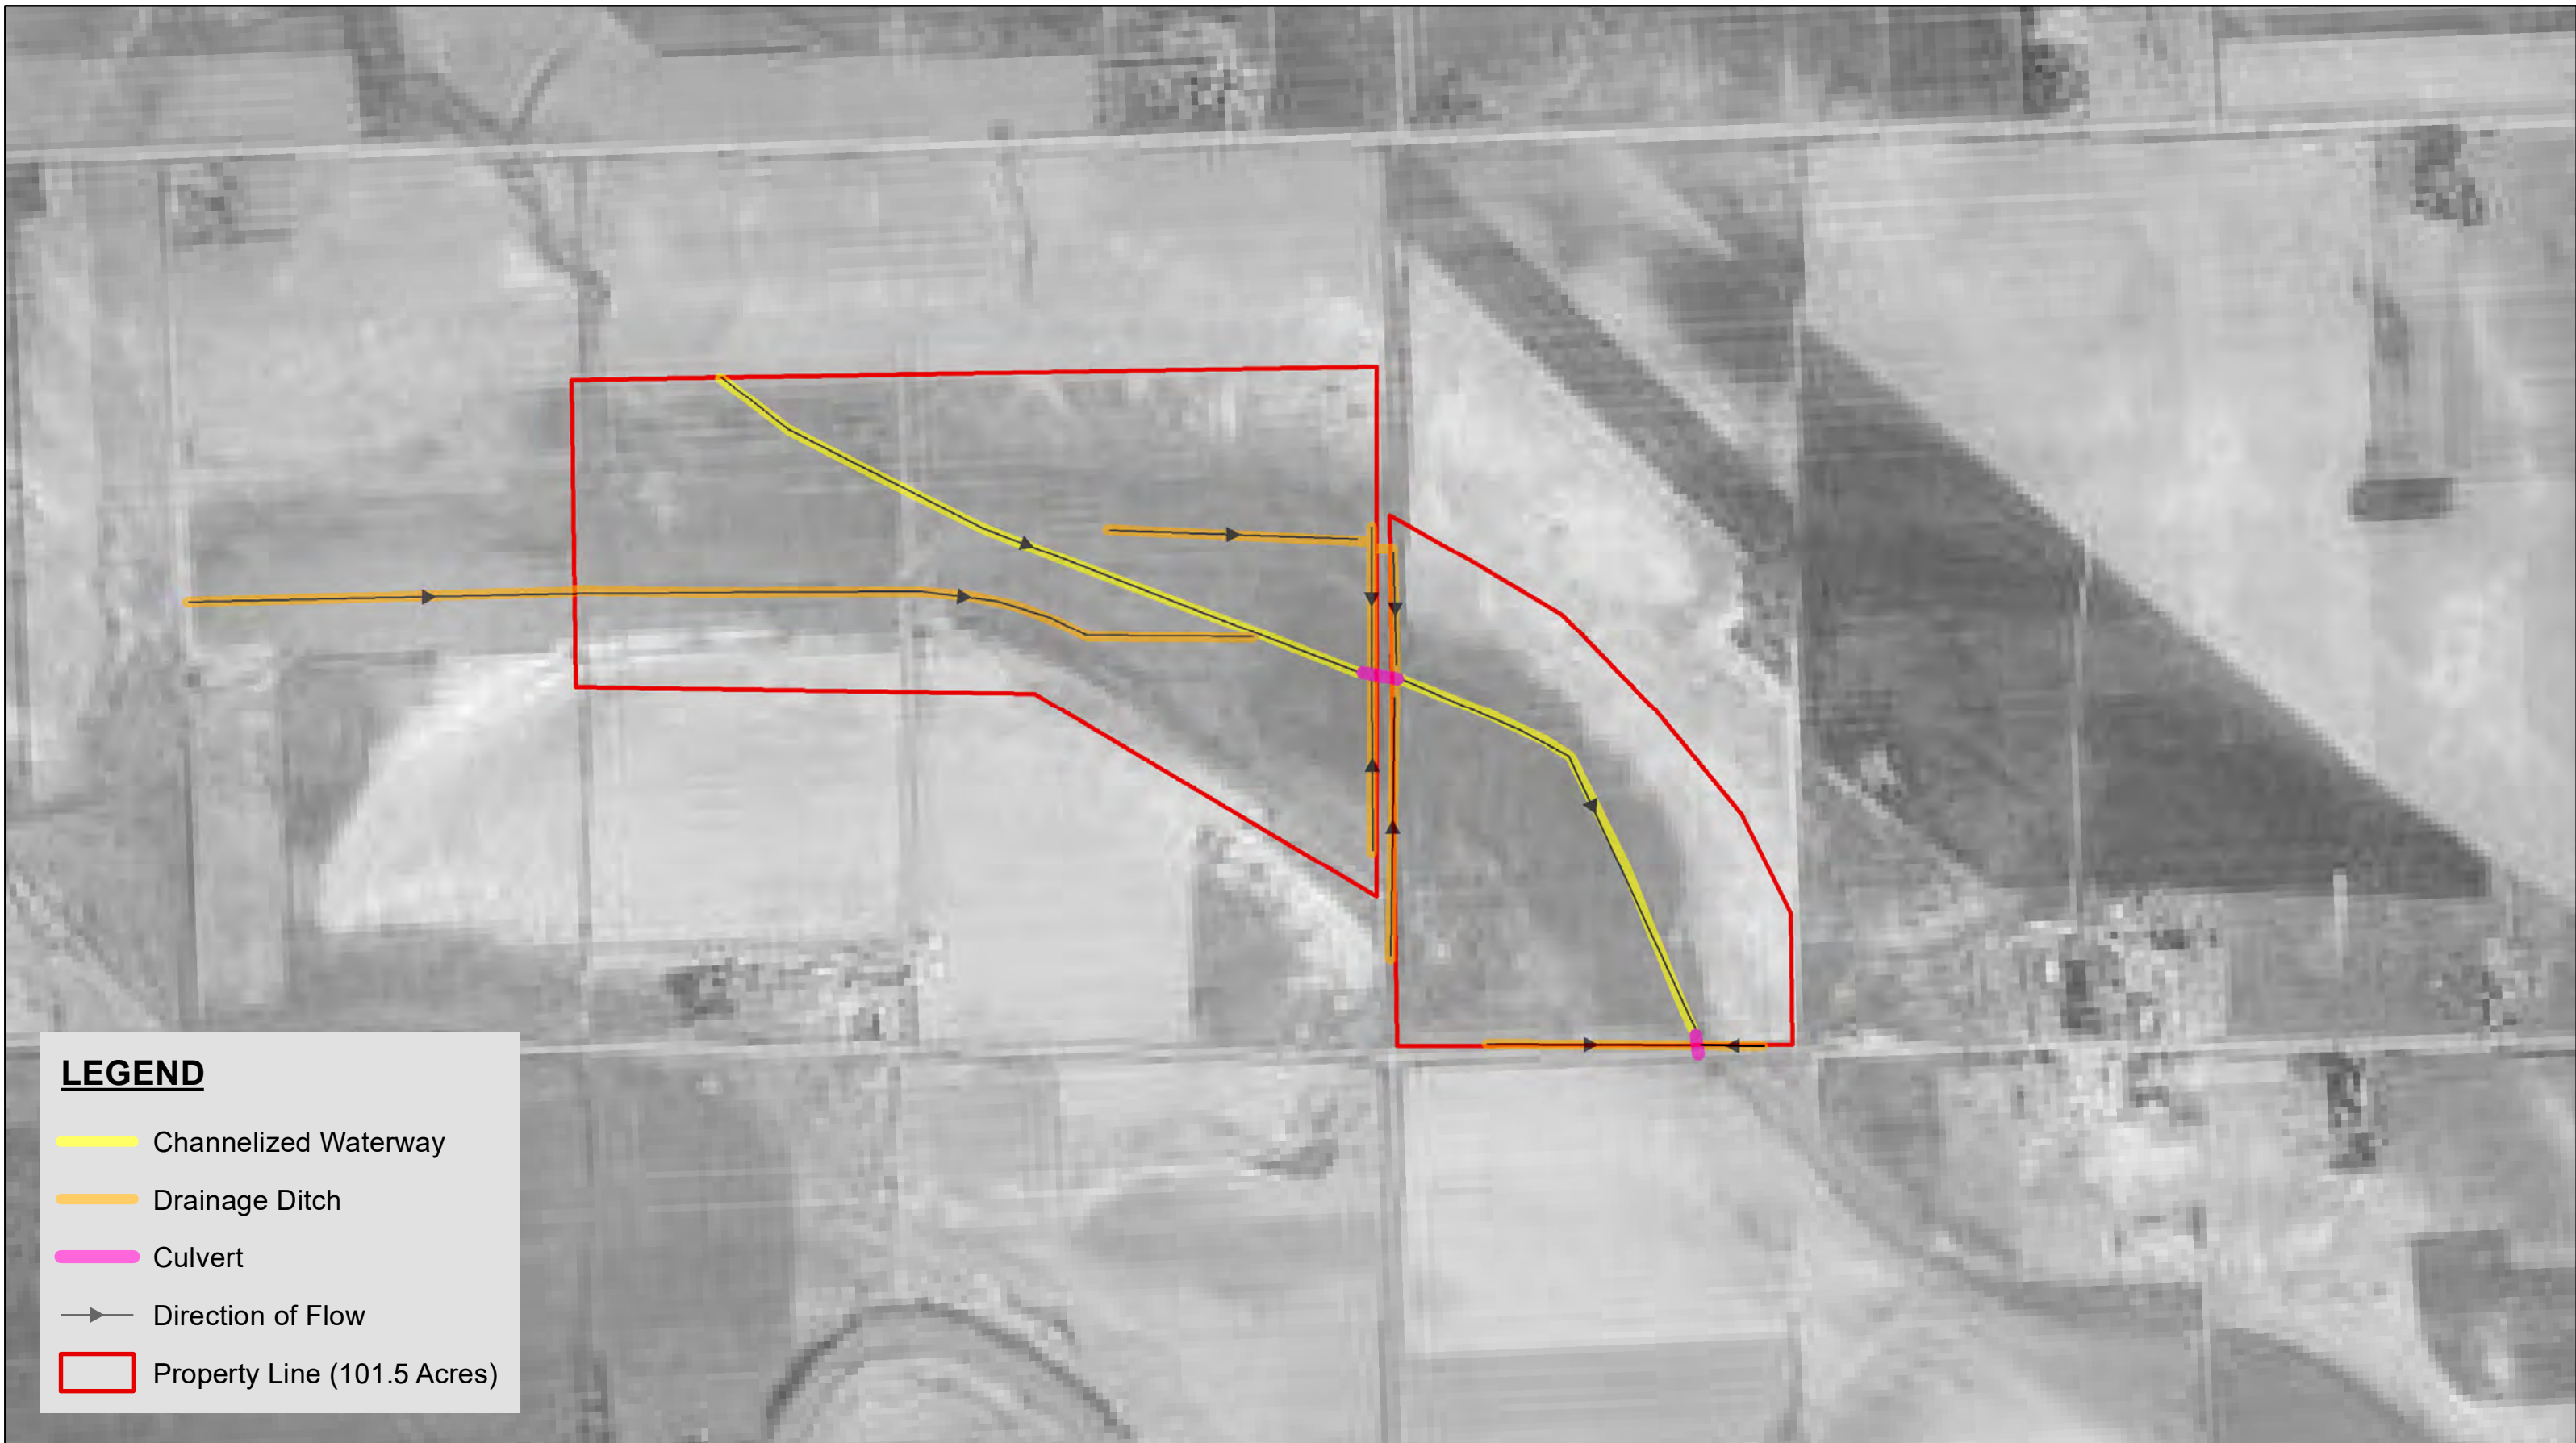
1949 AERIAL & DRAINAGE MANIPULATIONS

- Channelized Waterway
- Drainage Ditch
- Culvert
- Direction of Flow
- Property Line (101.5 Acres)

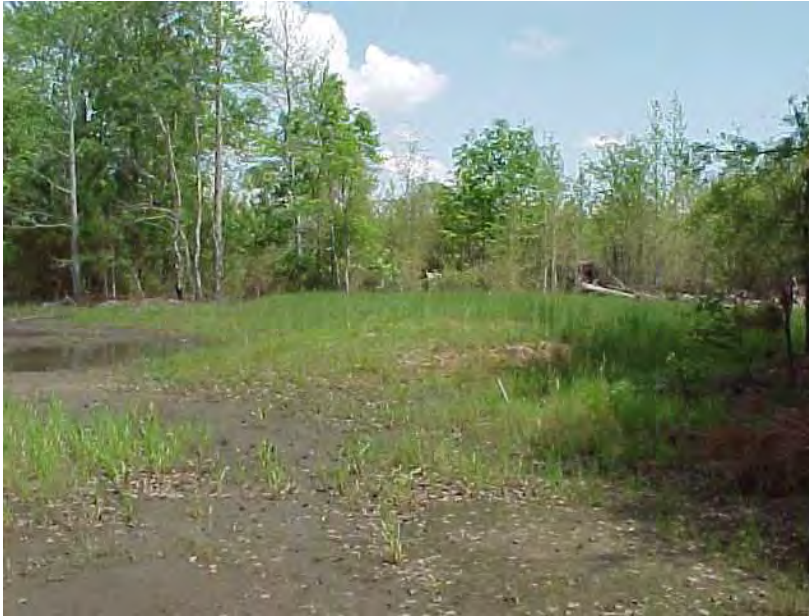
Engineering Job Sheet – Ditch Plug

Where open channels were previously constructed to drain wetlands, the channel will be filled with earth to restore the wetland hydrology as close as possible to the pre-drained or natural condition.

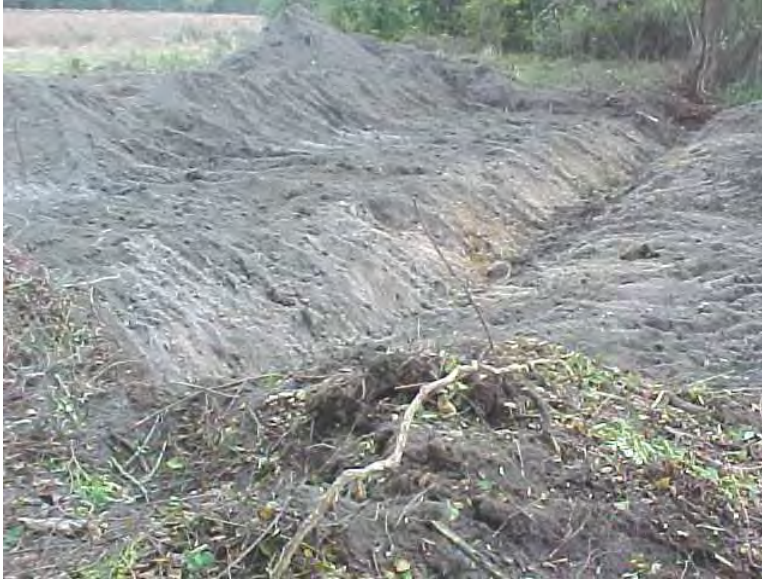
- The ditch side slopes shall be pulled back on a 3:1 (H:V) to create the proper bonding surface between the existing soil and the new backfill material.
- A keyway trench shall be excavated to a depth 2.0 feet below the existing ditch bottom and shall extend a minimum of 10 feet into each bank. The trench shall be backfilled and compacted with non-sandy material to the elevation of the existing ditch bottom.
- The backfill for the plug and crown shall be placed in 9 inch loose lifts and compacted to a 6 inch layer.
- The equipment and specific compaction methods to be utilized shall be discussed and agreed upon by the landowner, contractor, and NRCS.
- The ditch plug location shall be marked in the field by NRCS and shall not be moved or altered under any circumstance, unless authorized by NRCS.
- Vegetation of the finished plug shall be in accordance with NRCS specifications.

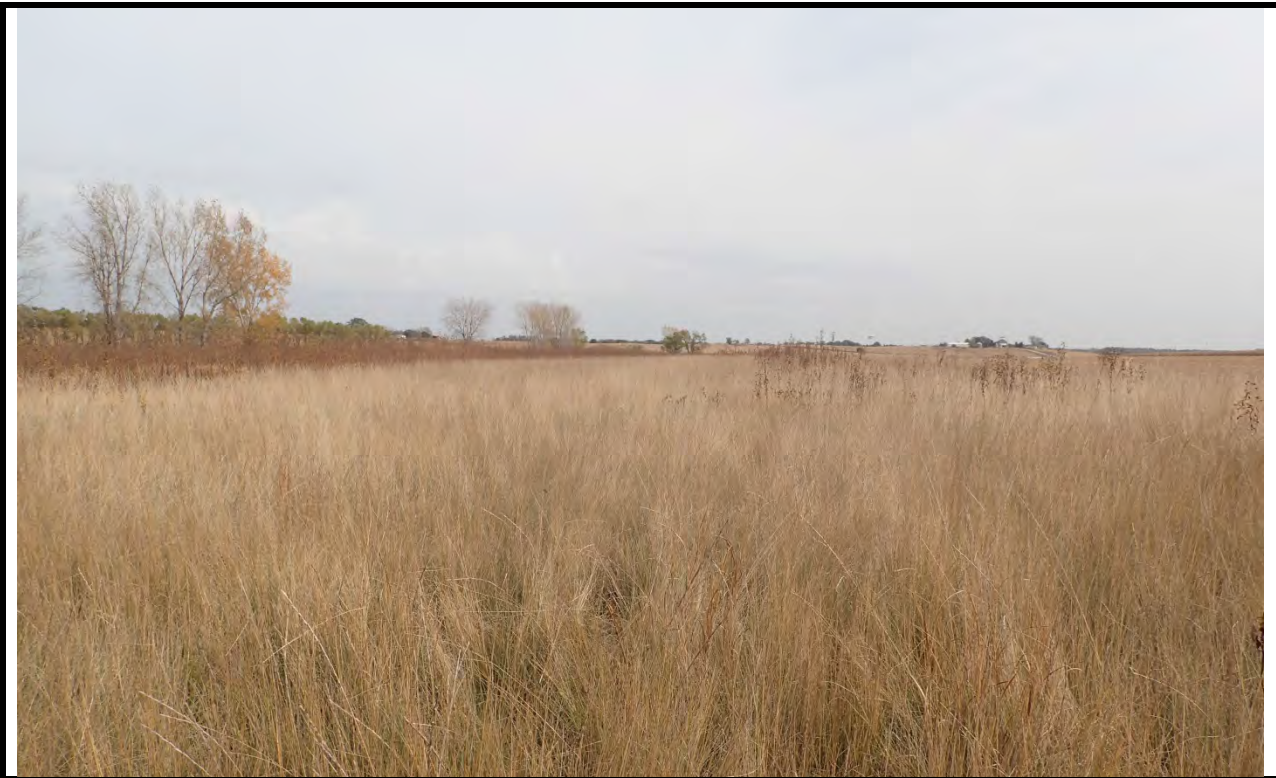
Photo 1: View of the farmed wetland area associated with S1 and S7, at the west side of the project area. Facing east.

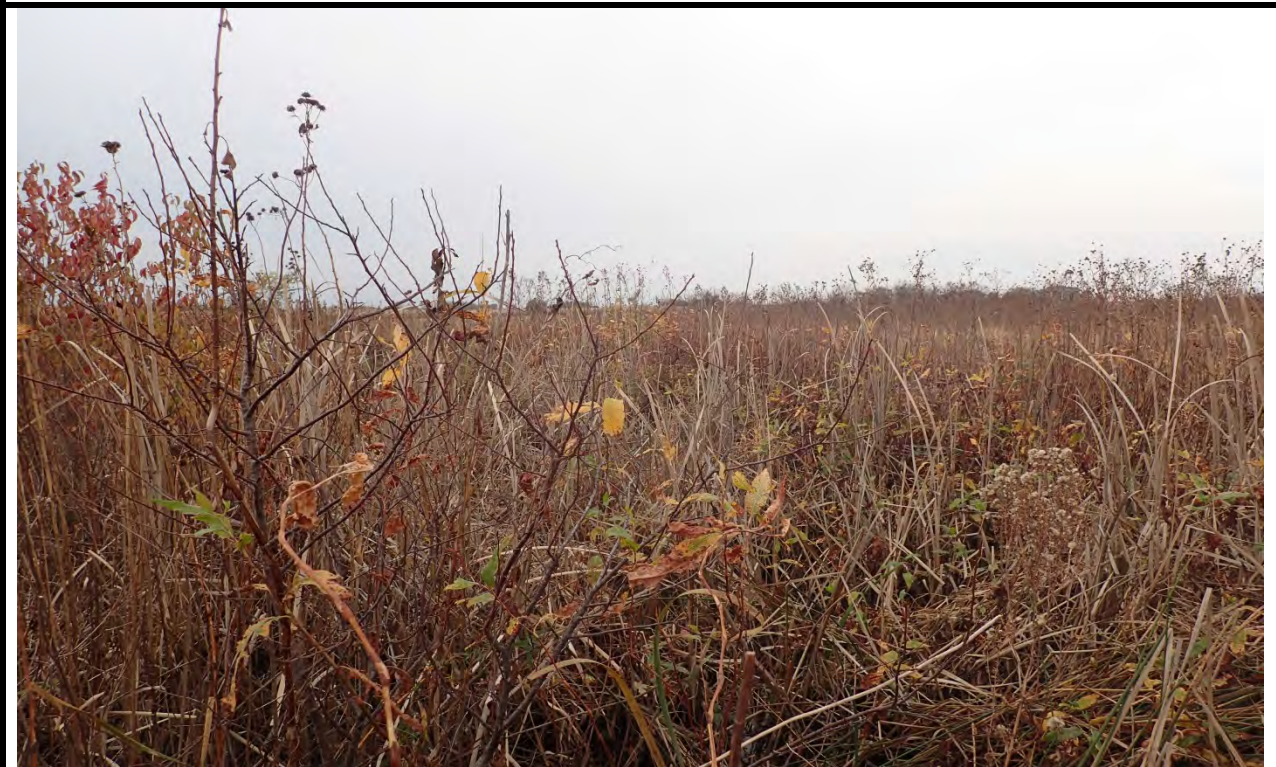
Photo 2A: View of the wetland ditch/swale area associated with S2. Facing northwest.

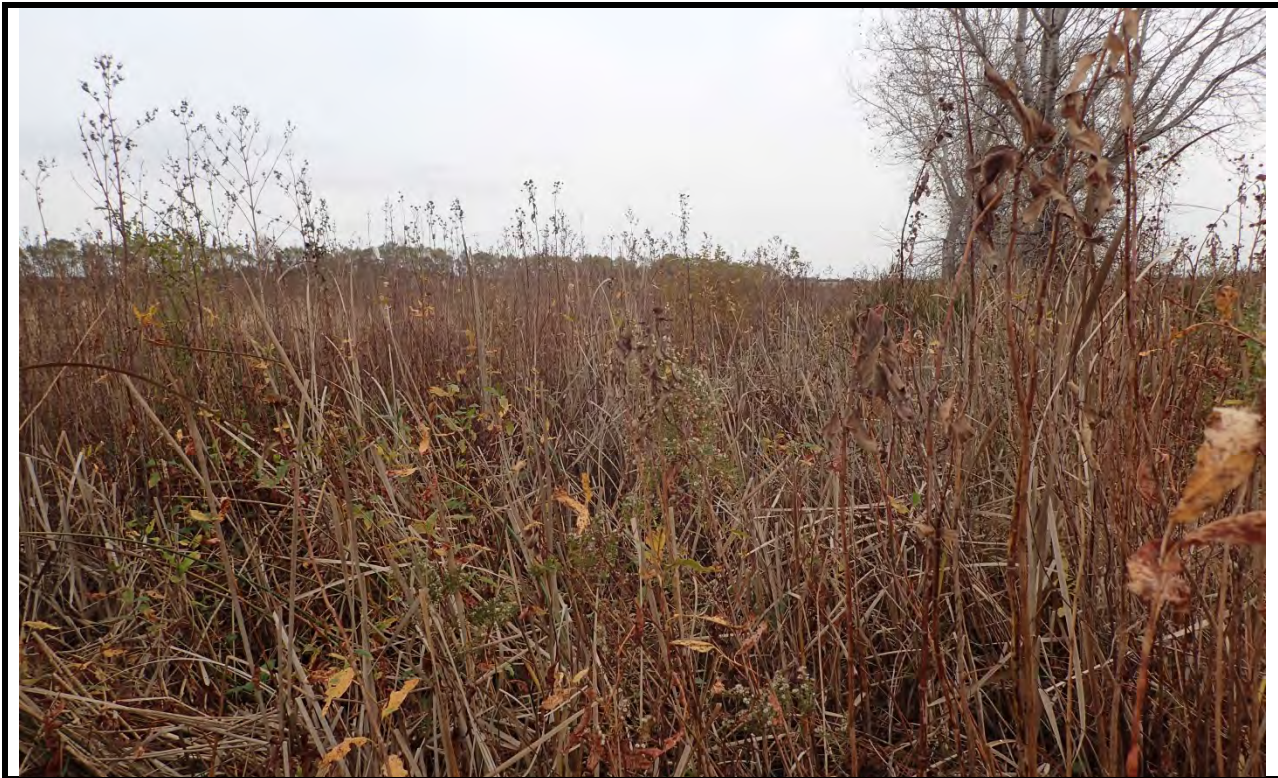
Photo 2B: View of the wetland ditch/swale area associated with S2. Facing northeast.

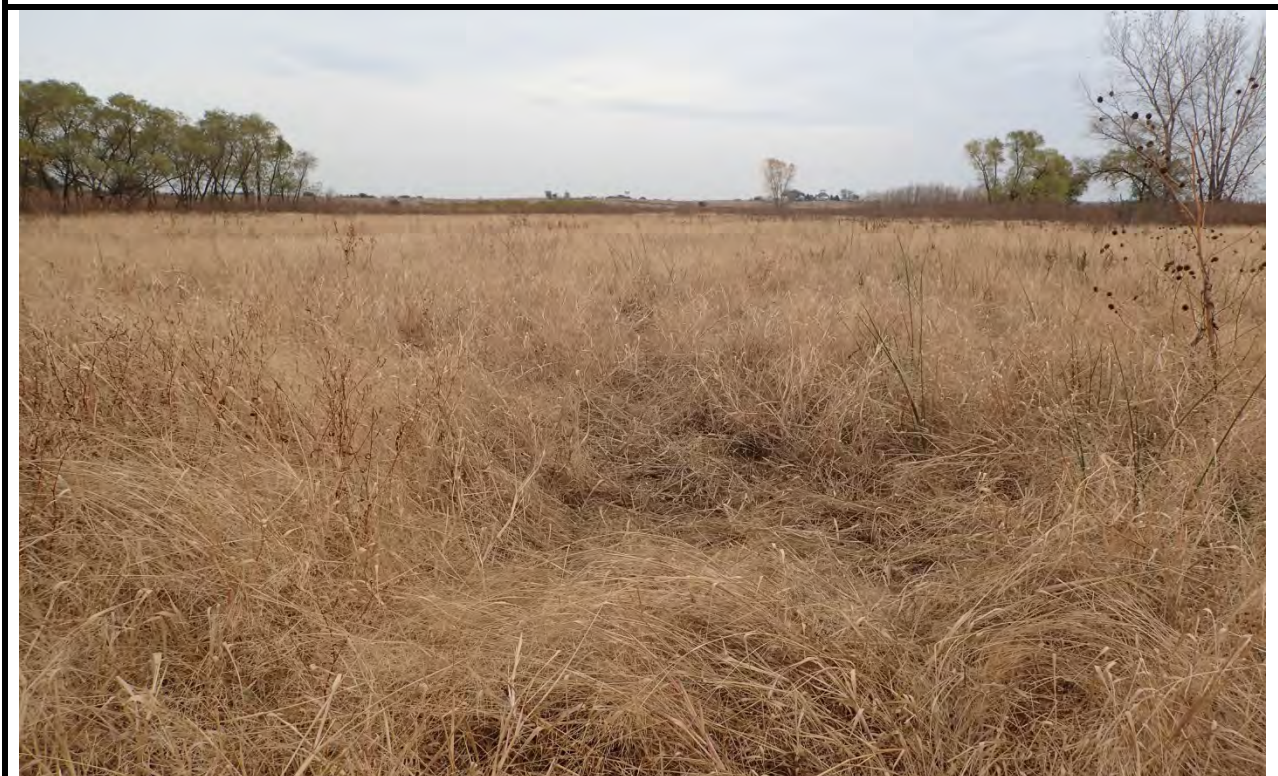
Photo 3A: View of the area associated S3 removed from consideration as a wetland based on a lack of hydric soil criteria. Facing east.

Field has been converted to row crop agriculture, and so the vegetation present may not be representative of normal circumstances. Photo 3A, 3B.

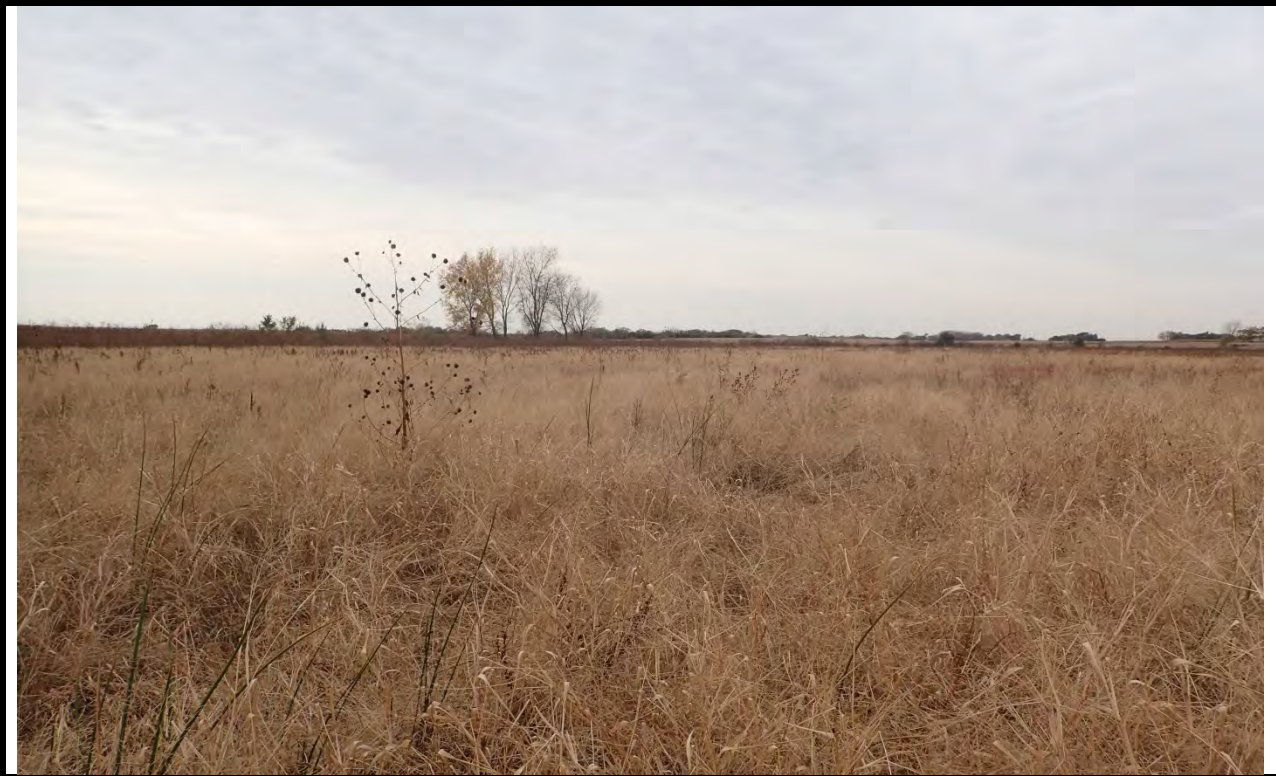
Photo 3B: View of the area associated S3 removed from consideration as a wetland based on a lack of hydric soil criteria. Facing west.

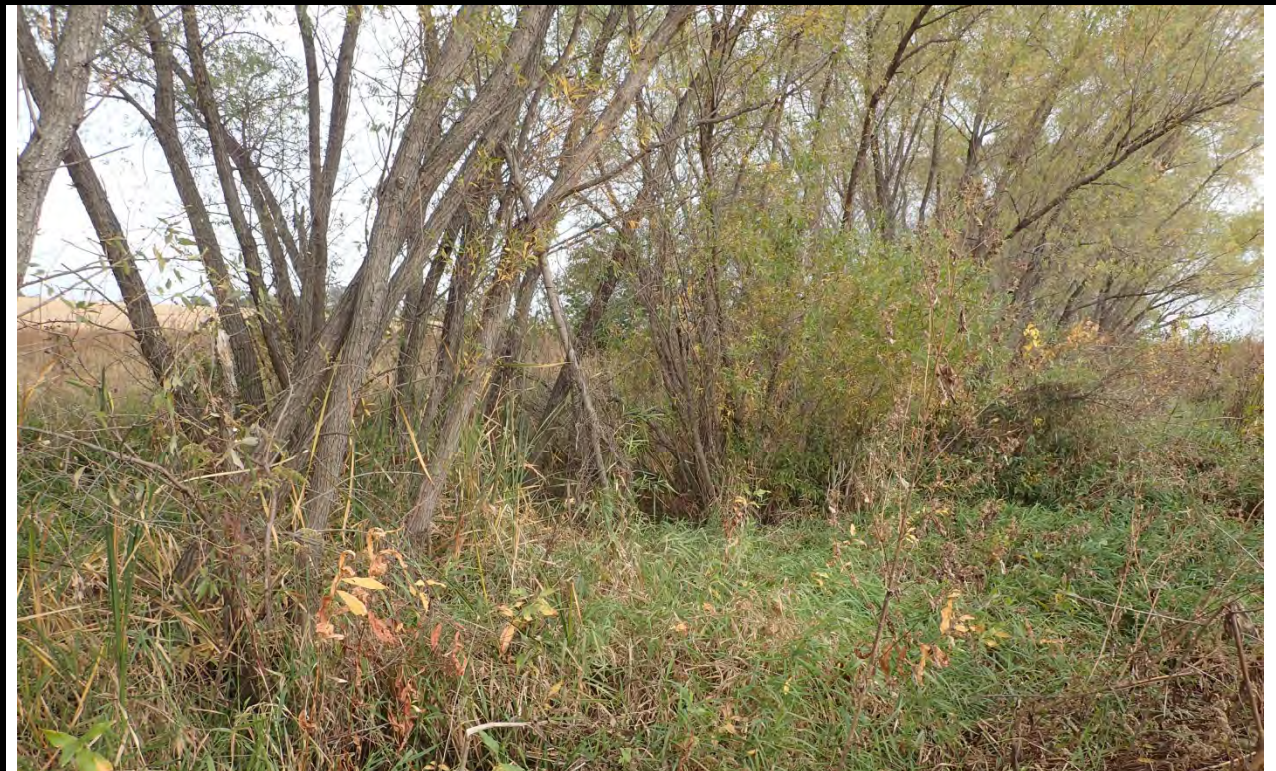
Photo 4A: View of the wetland area associated with S4, along the swale corresponding to the unnamed tributary to Salt Creek. Facing east.

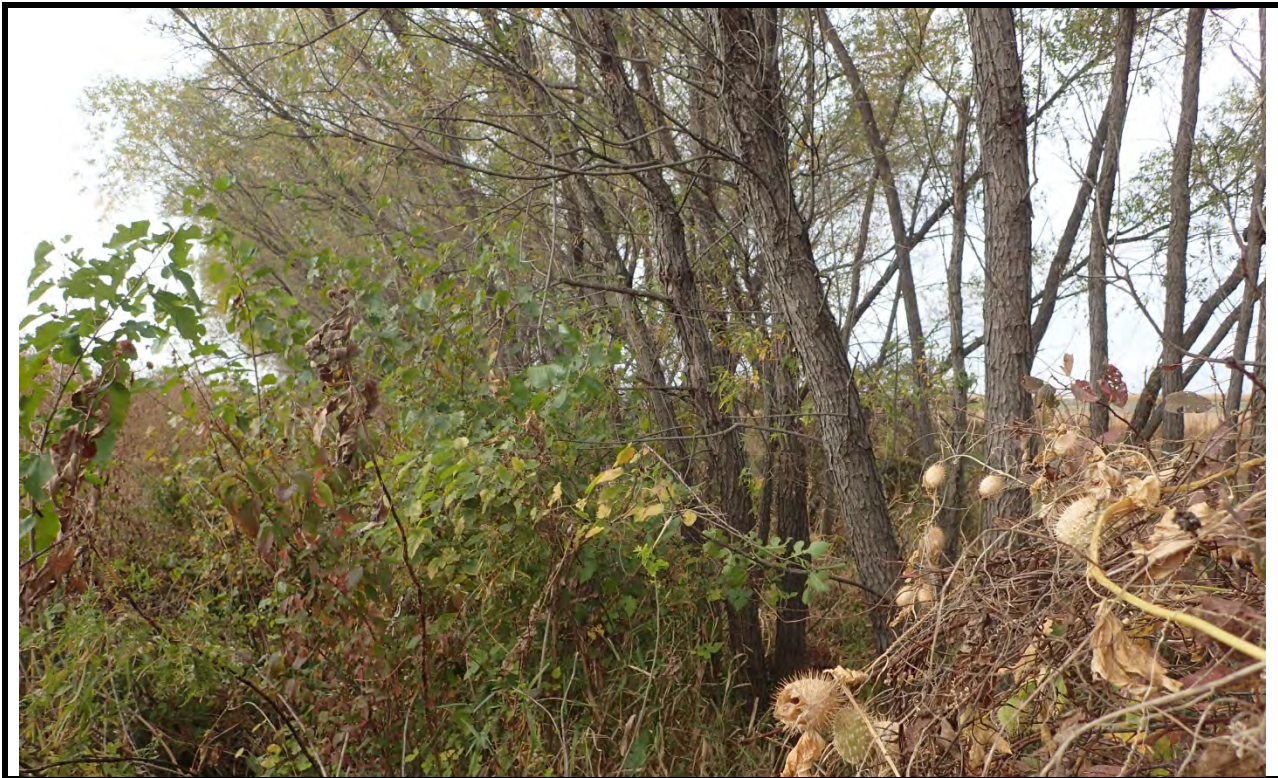
Photo 4B: View of the wetland area associated with S4, along the swale corresponding to the unnamed tributary to Salt Creek. Facing north.

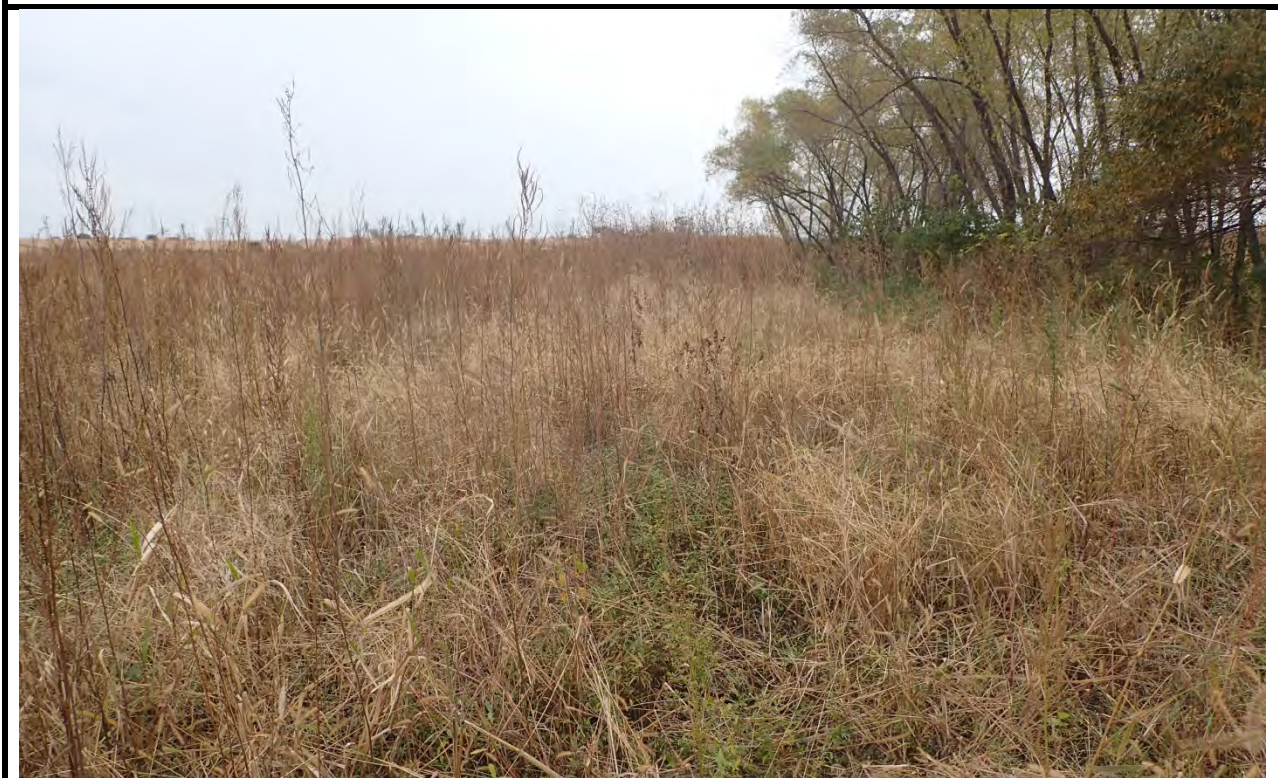
Photo 5: View of the upland area associated with S5. Facing southeast.

Remarks: (Include photo numbers here or on a separate sheet.)
 Field has been converted to row crop agriculture, and so the vegetation present may not be representative of normal circumstances. Photo 5.

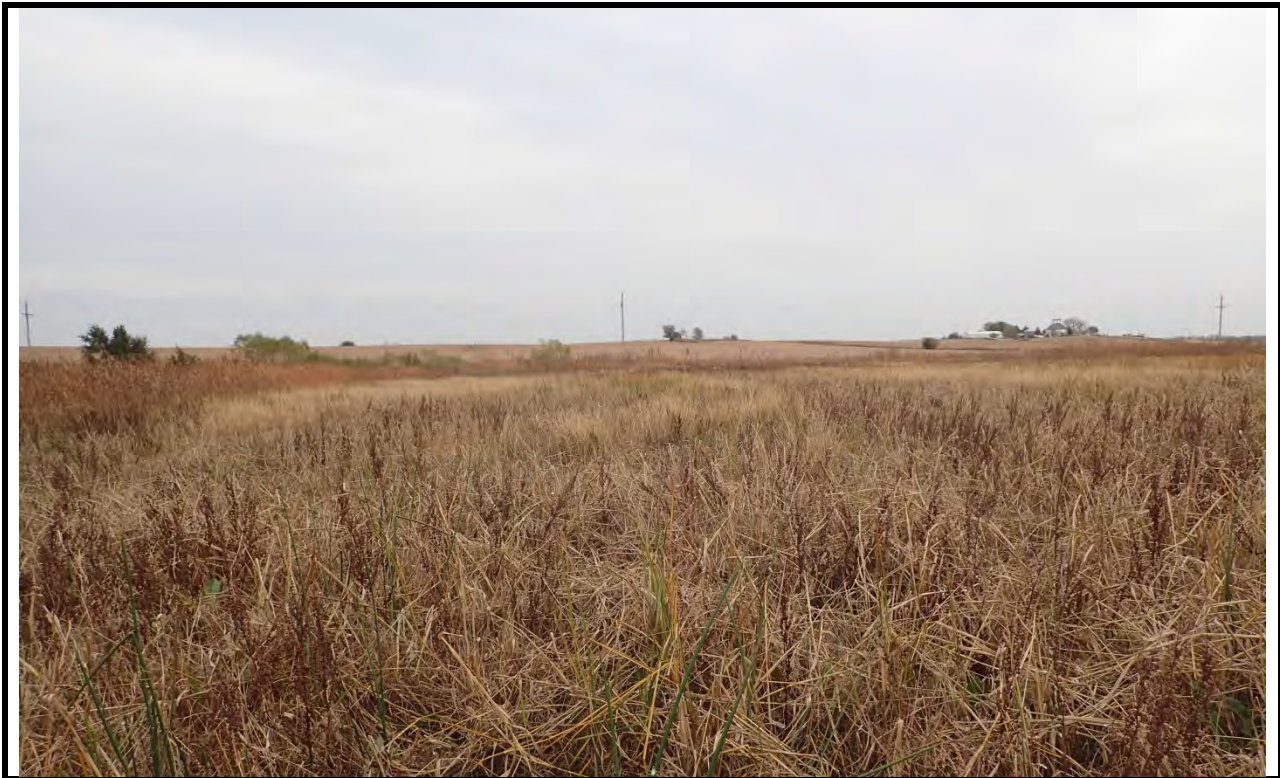
Photo 6A: View of the farmed wetland area associated with S6. Facing east.

Field has been converted to row crop agriculture, and so the vegetation present may not be representative of normal circumstances. Pphoto 6A, 6B, 6C, 6D.

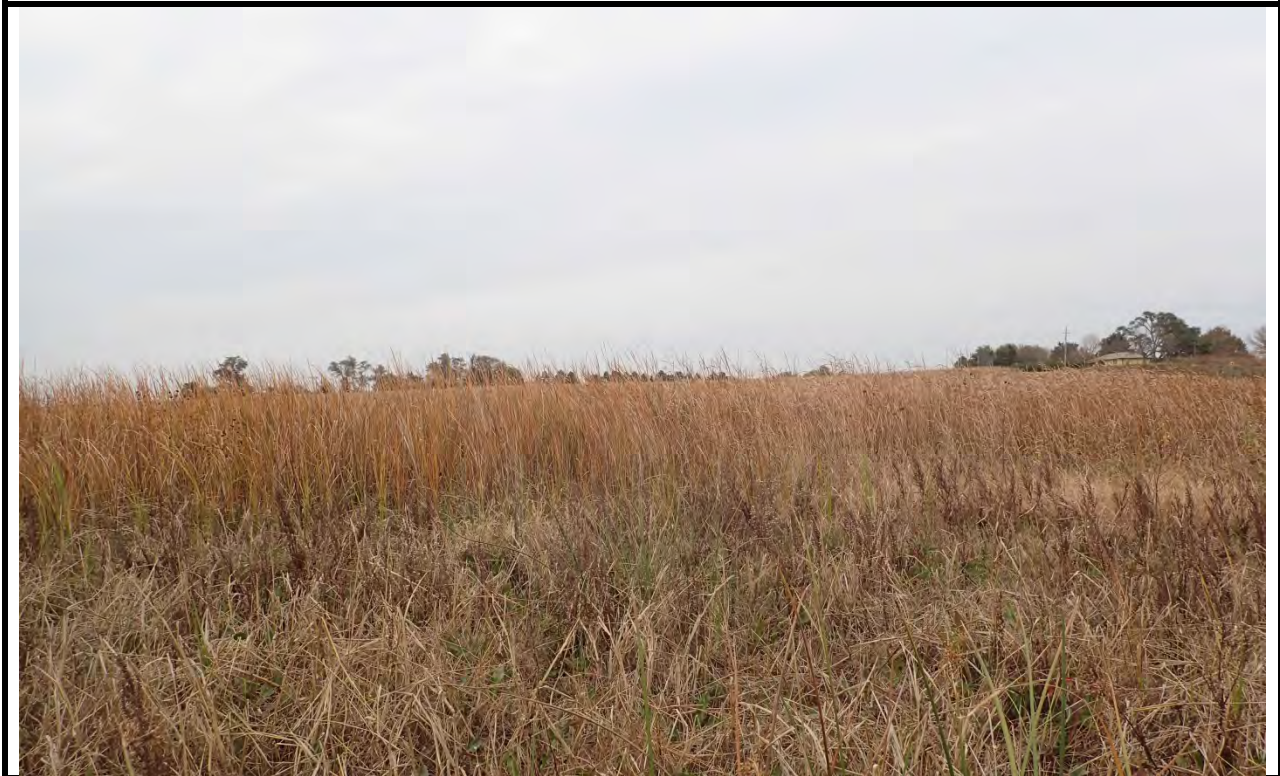
Photo 6B: View of the farmed wetland area associated with S6. Facing north.

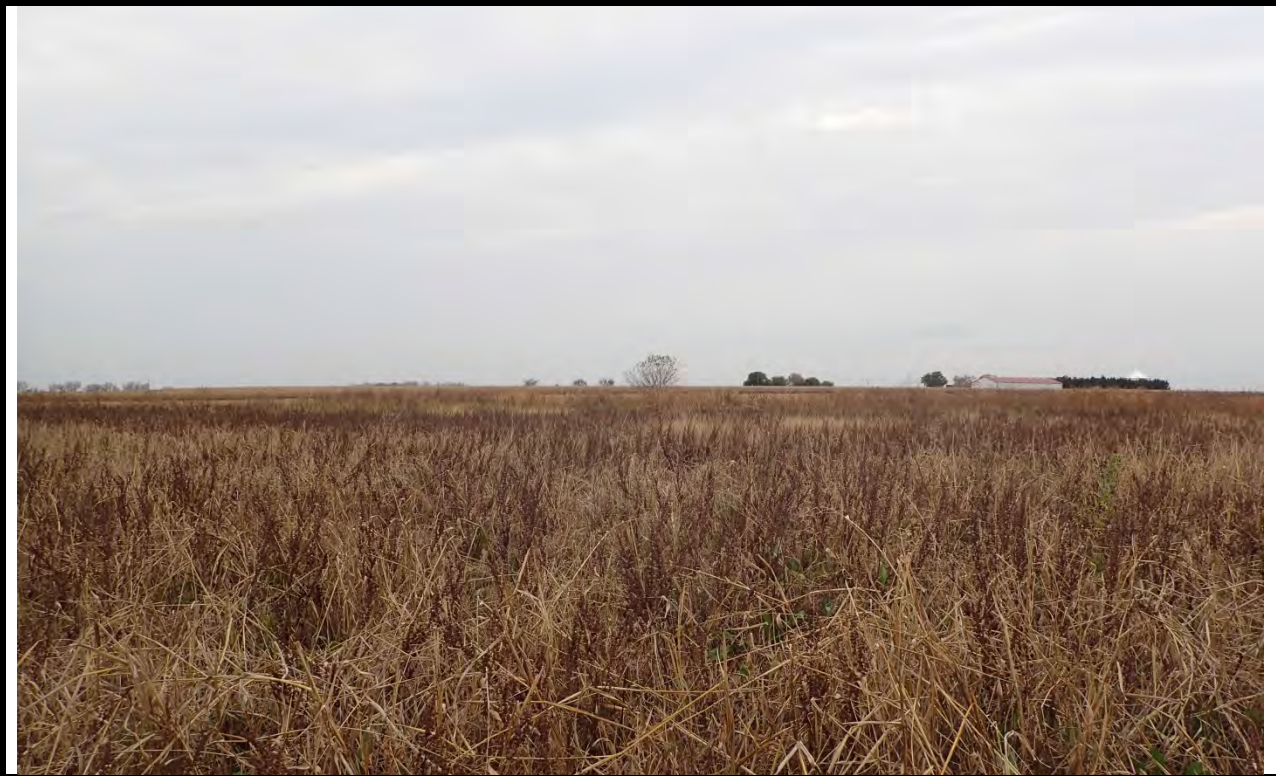
Photo 6C: View of the farmed wetland area associated with S6. Facing south.

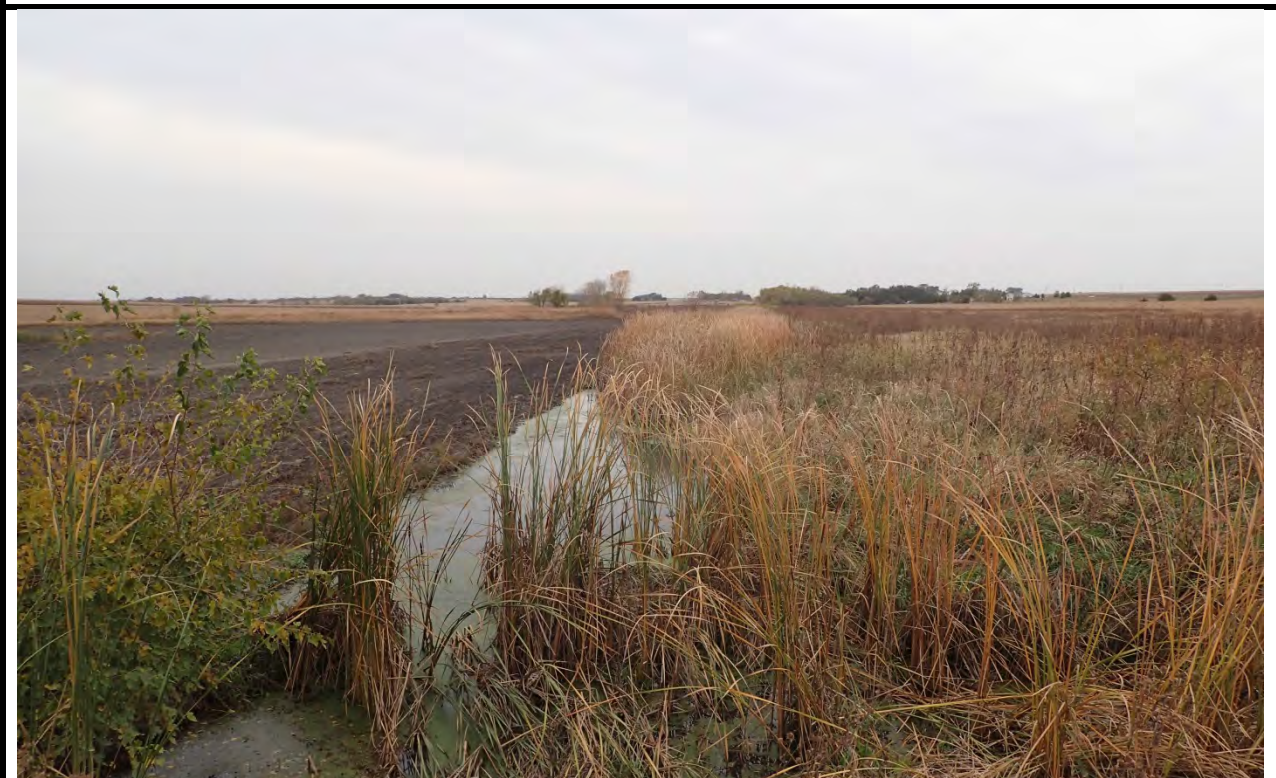
Photo 6D: View of the farmed wetland area associated with S6. Some standing water is visible next to a culvert in this area. Facing northwest.

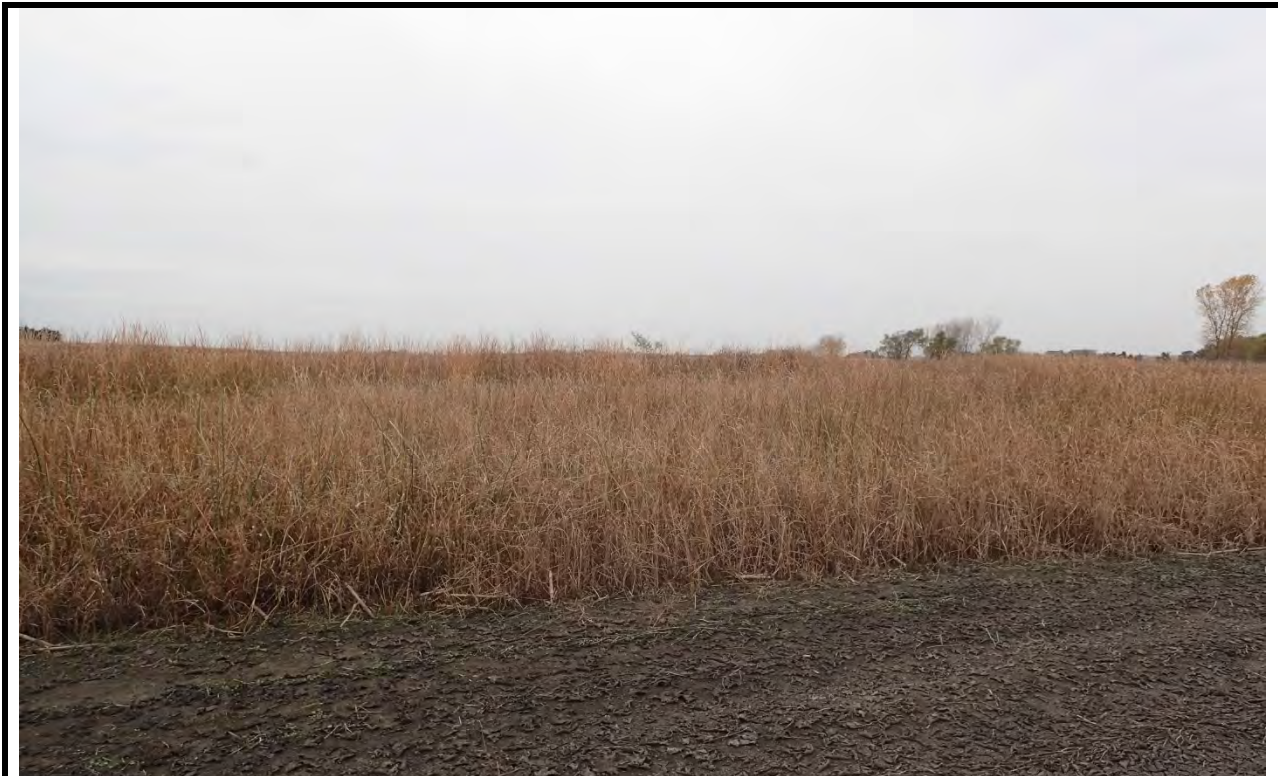
Photo 7A: View of the farmed wetland area associated with S1 and S7, from the eastern side of the wetland. Facing northeast.

Remarks: (Include photo numbers here or on a separate sheet.)
 Field has been converted to row crop agriculture, and so the vegetation present may not be representative of normal circumstances. The earth was bare at this location, and appeared to have been cleared recently. Photo 7A, 7B.

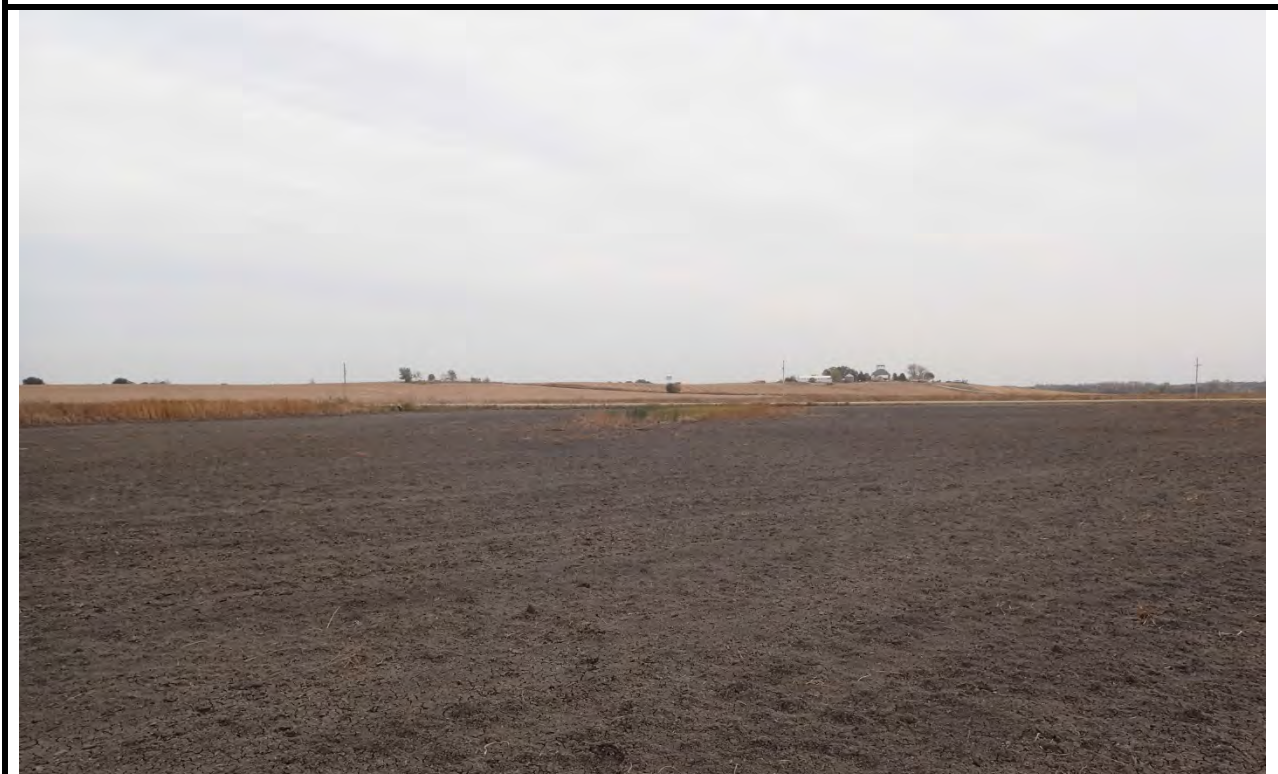
Photo 7B: View of the farmed wetland area associated with S1 and S7, from the eastern side of the wetland. Facing east.

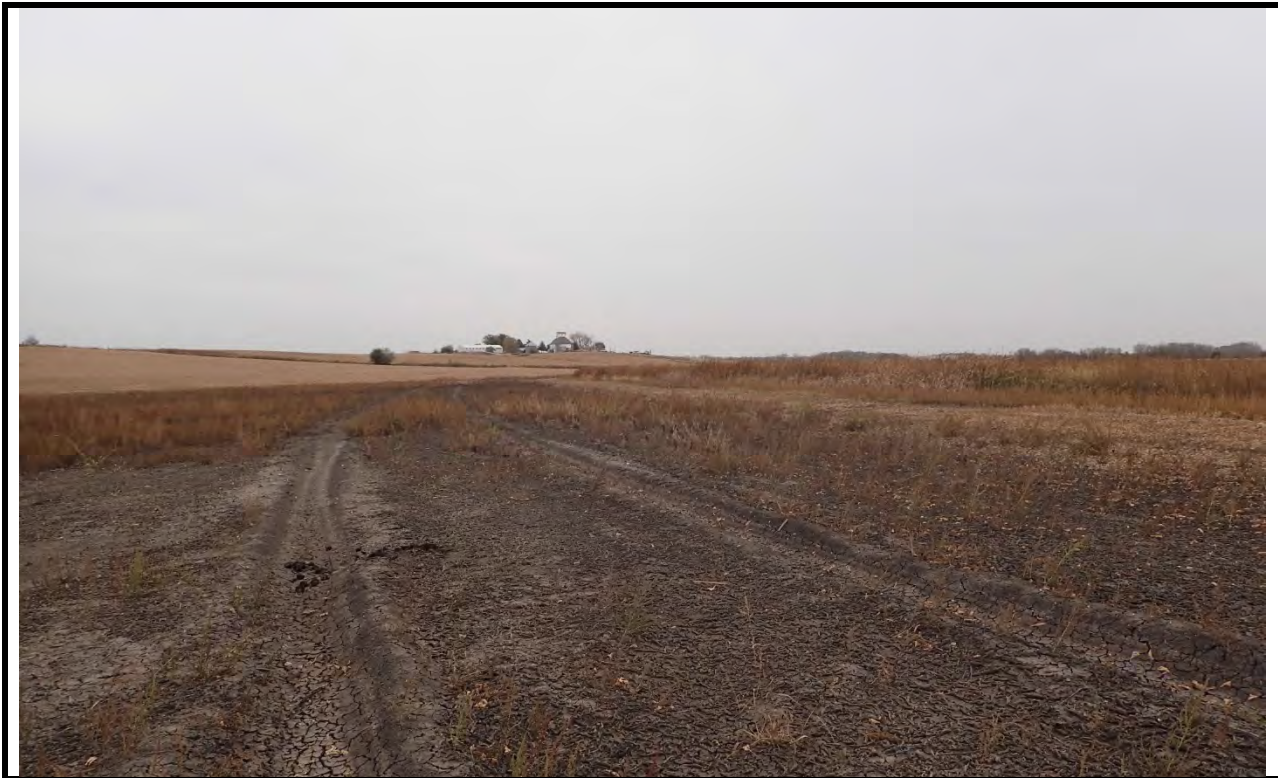
Photo 8A: View of the farmed wetland associated with S8. Facing southeast.

Field has been converted to row crop agriculture, and so the vegetation present may not be representative of normal circumstances. Photo 8A, 8B.

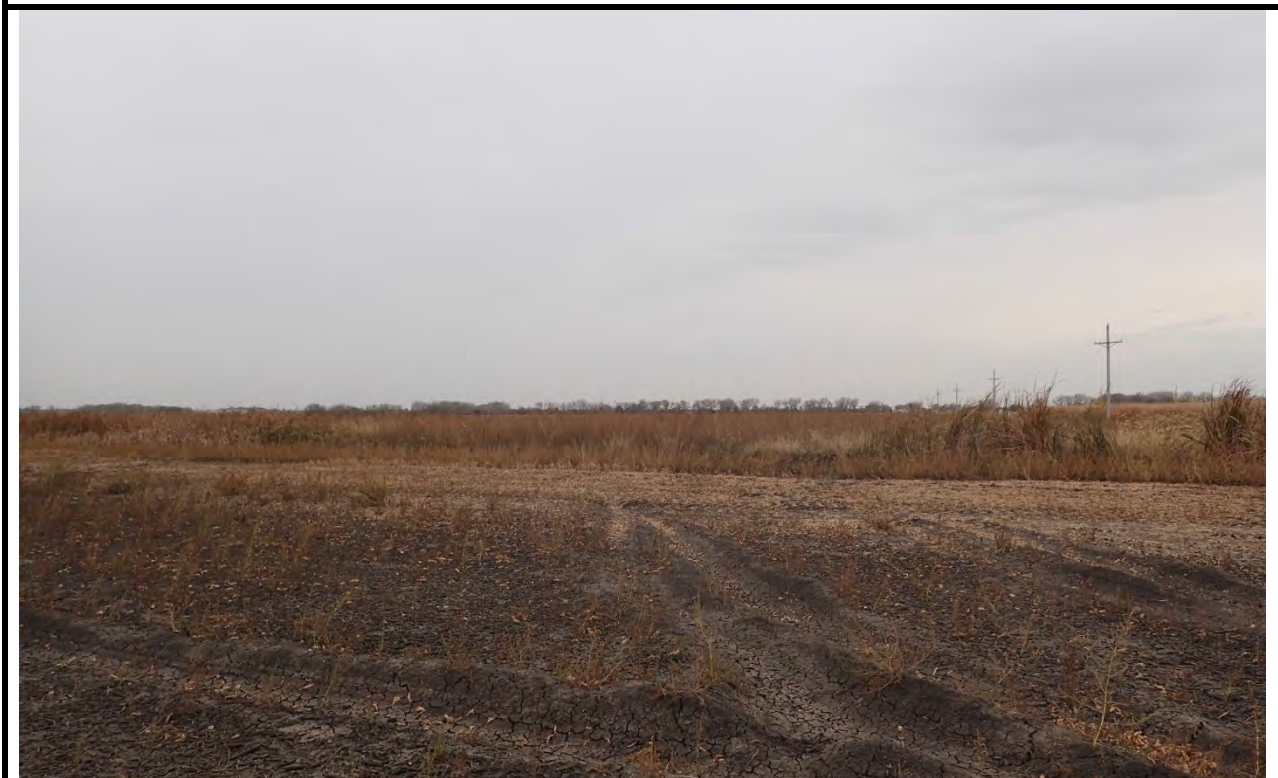
Photo 8B: View of the farmed wetland associated with S8. Facing south.

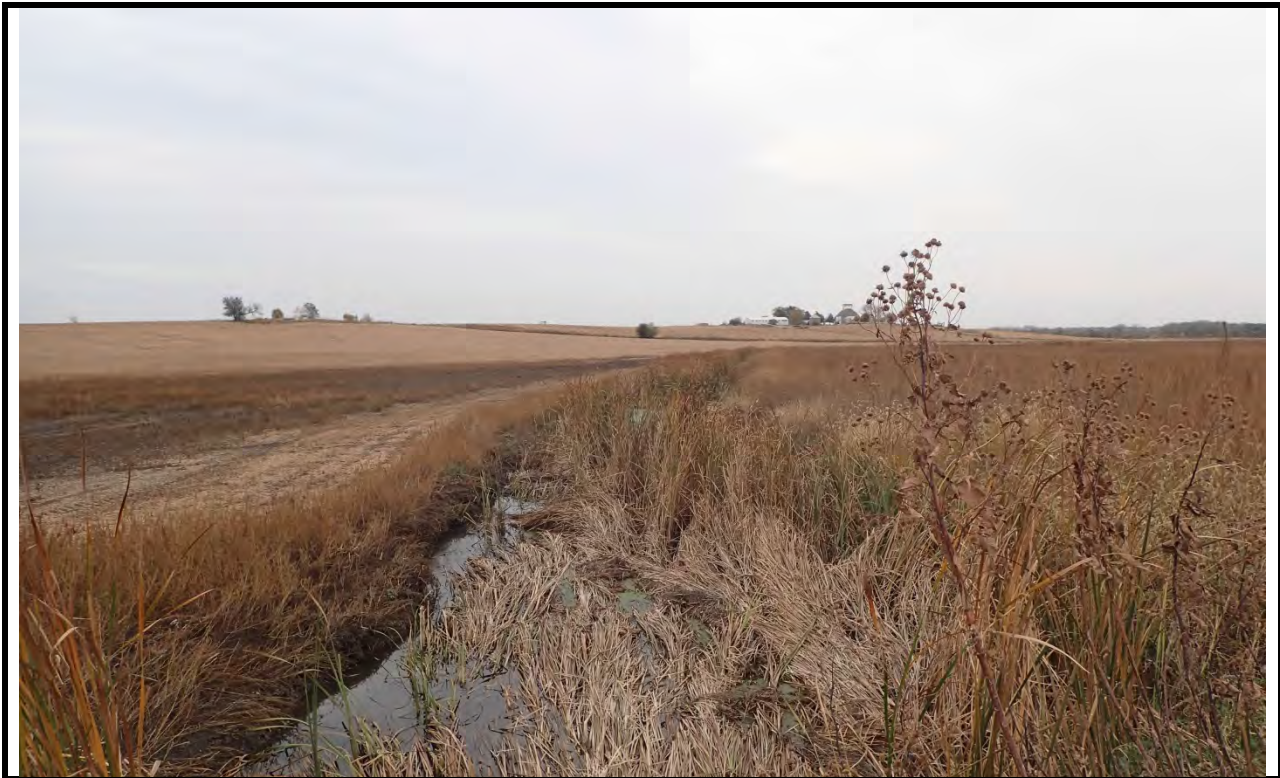
Photo 9A: View of the wetland area associated with S9, along the swale corresponding to the unnamed tributary to Salt Creek. Facing east.

Remarks: (Include photo numbers here or on a separate sheet.)
 The vicinity has been disturbed by row crop agriculture, and so the vegetation present may not be representative of normal circumstances. Photo 9A, 9B, 9C.
