SITE DEVELOPMENT PLAN

ASHLAND WETLAND MITIGATION BANK SAUNDERS COUNTY, NEBRASKA

**Prepared for
Nebraska Department of Transportation**

**Benesch Project No. 00120472.00
NDOT Project No. STWD (1044)
NDOT Control No. 10584B
USACE Project No. 2018-01099-WEH**

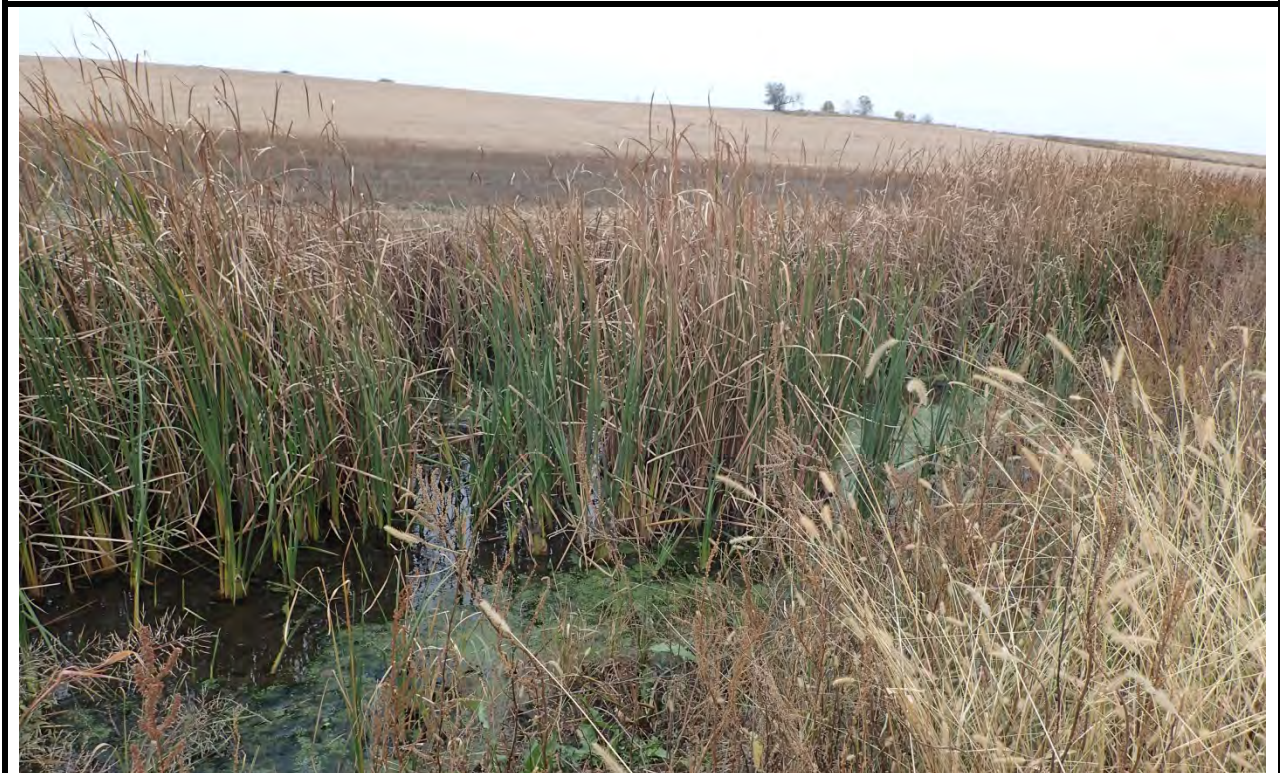
Photo 9B: View of the wetland area associated with S9, along the swale corresponding to the unnamed tributary to Salt Creek. Facing northeast.

Remarks: (Include photo numbers here or on a separate sheet.)
 The vicinity has been disturbed by row crop agriculture, and so the vegetation present may not be representative of normal circumstances. Photo 9A, 9B, 9C.

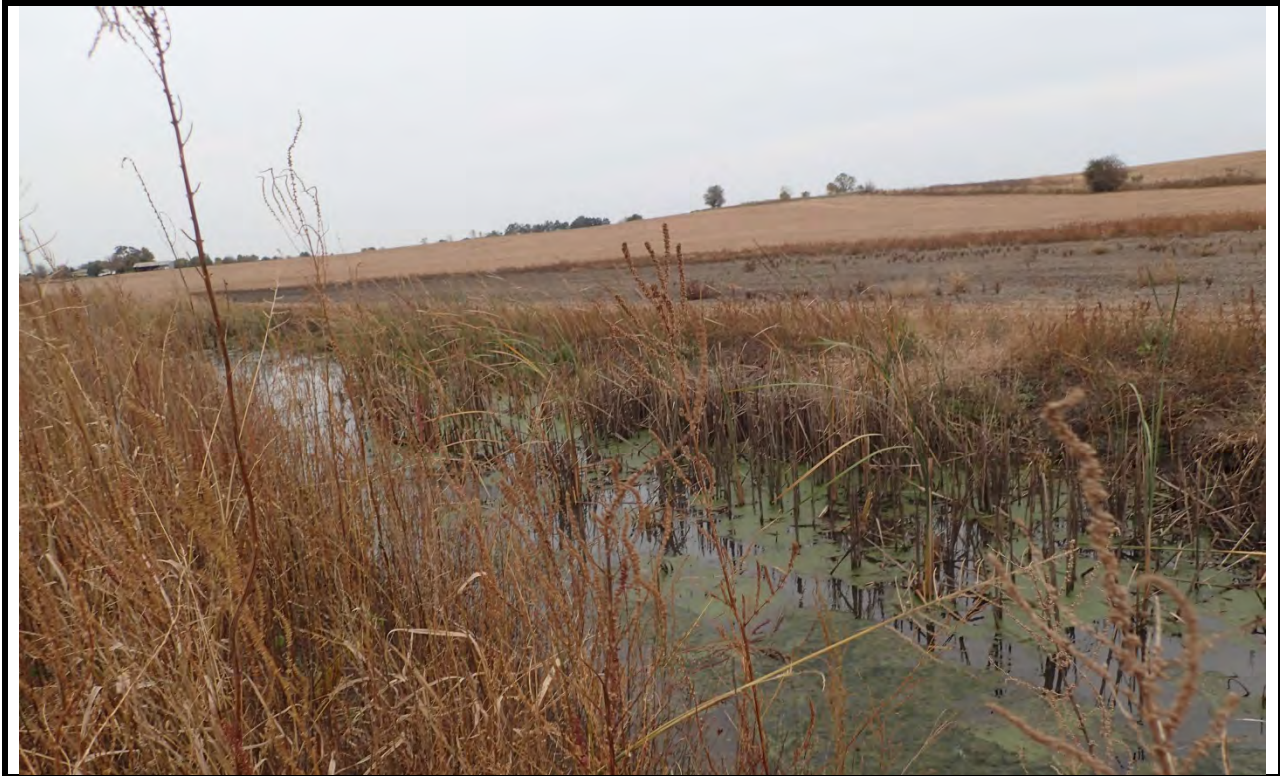
Photo 9C: View of the wetland area associated with S9, along the swale corresponding to the unnamed tributary to Salt Creek. Facing north.

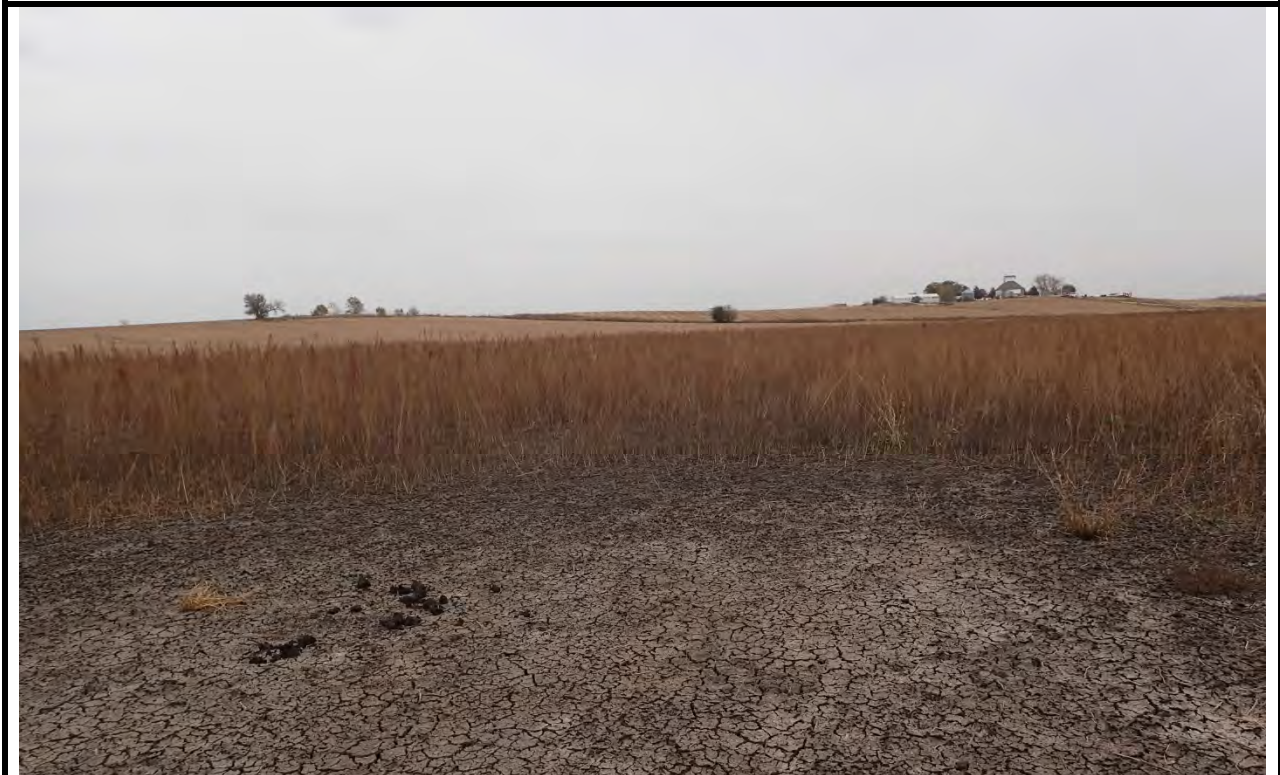
Photo 10A: View of the farmed wetland area associated with S10. Facing east.

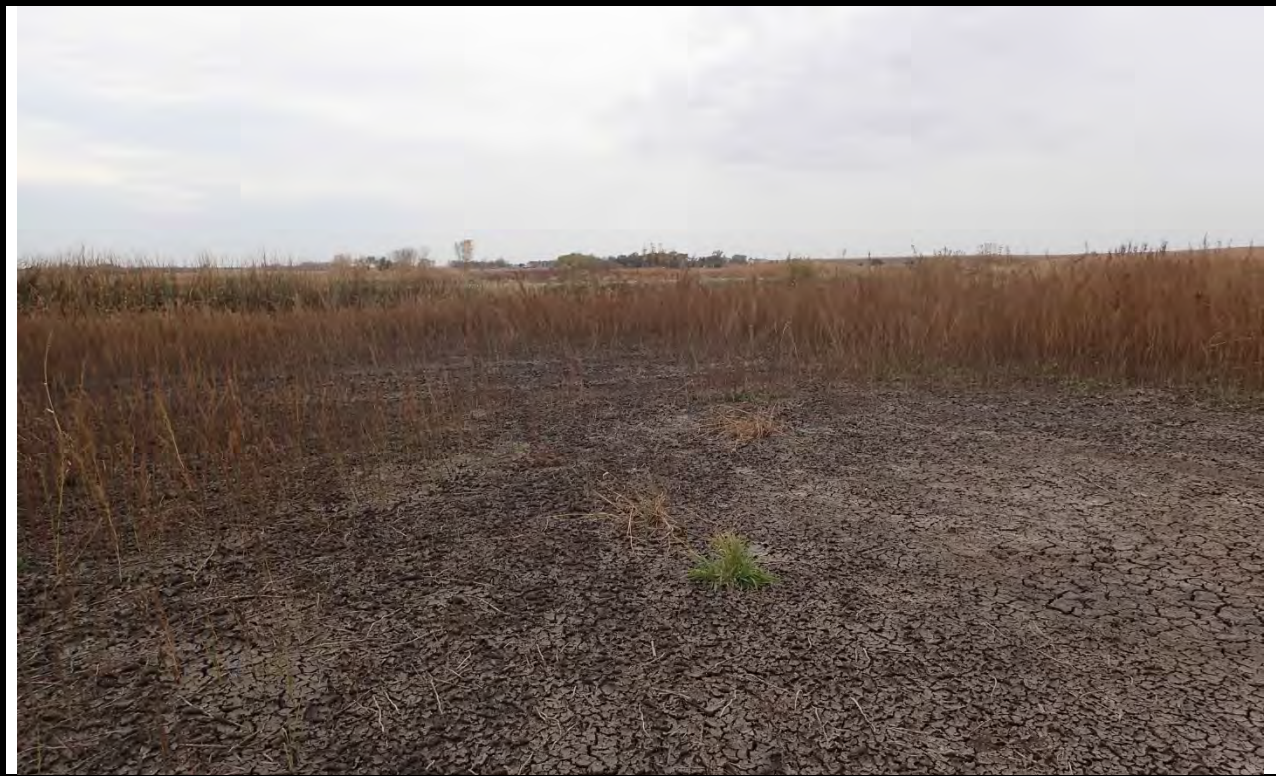
Photo 10B: View of the farmed wetland area associated with S10. Facing north.

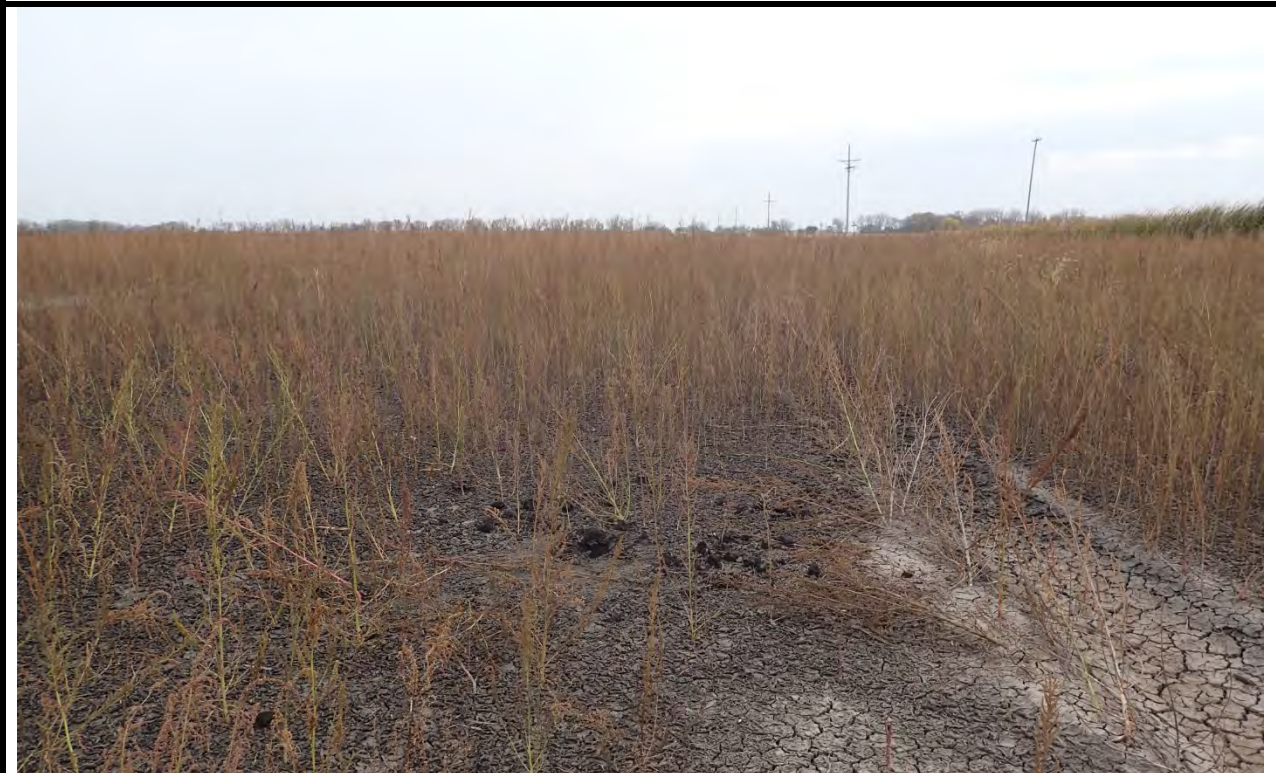
Photo 11A: View of the area associated S11 removed from consideration as a wetland based on a lack of hydric soil criteria. Facing south.

Field has been converted to row crop agriculture, and so the vegetation present may not be representative of normal circumstances. Photo 11A

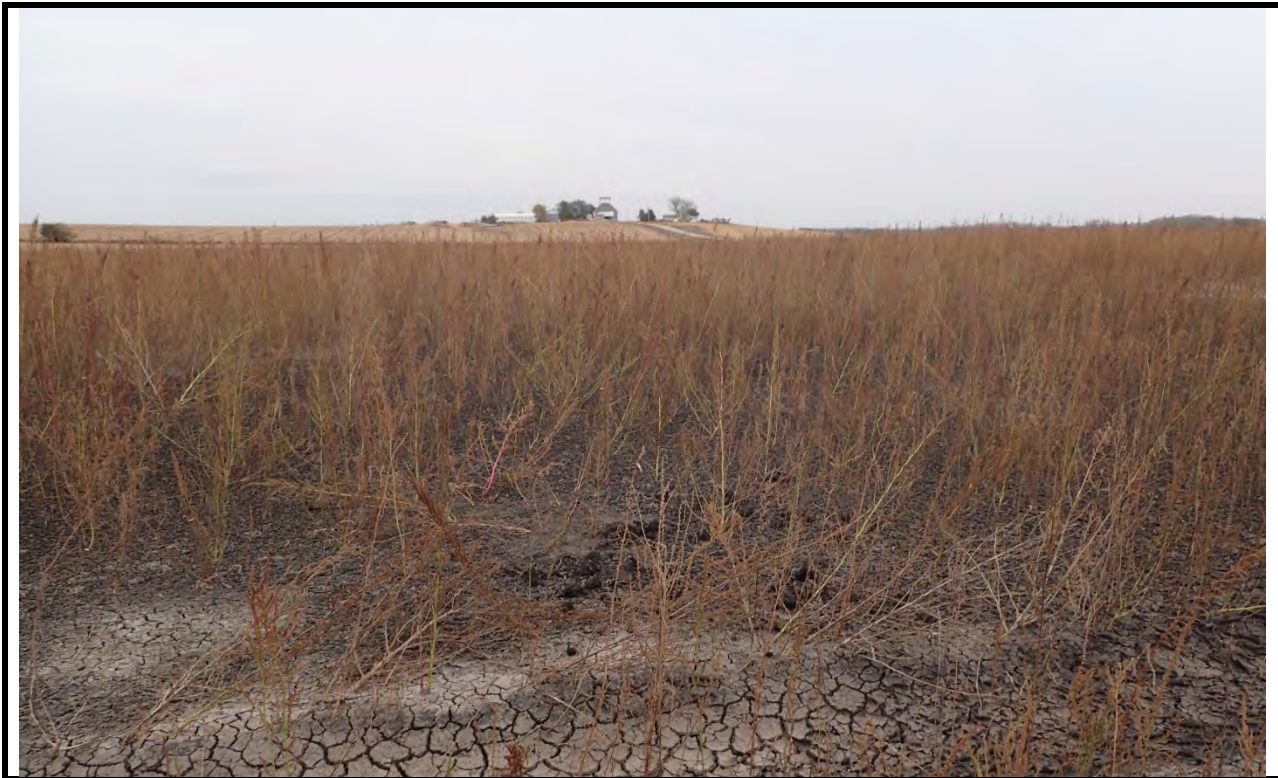
Photo 11B: View of the area associated S11 removed from consideration as a wetland based on a lack of hydric soil criteria. Facing east.

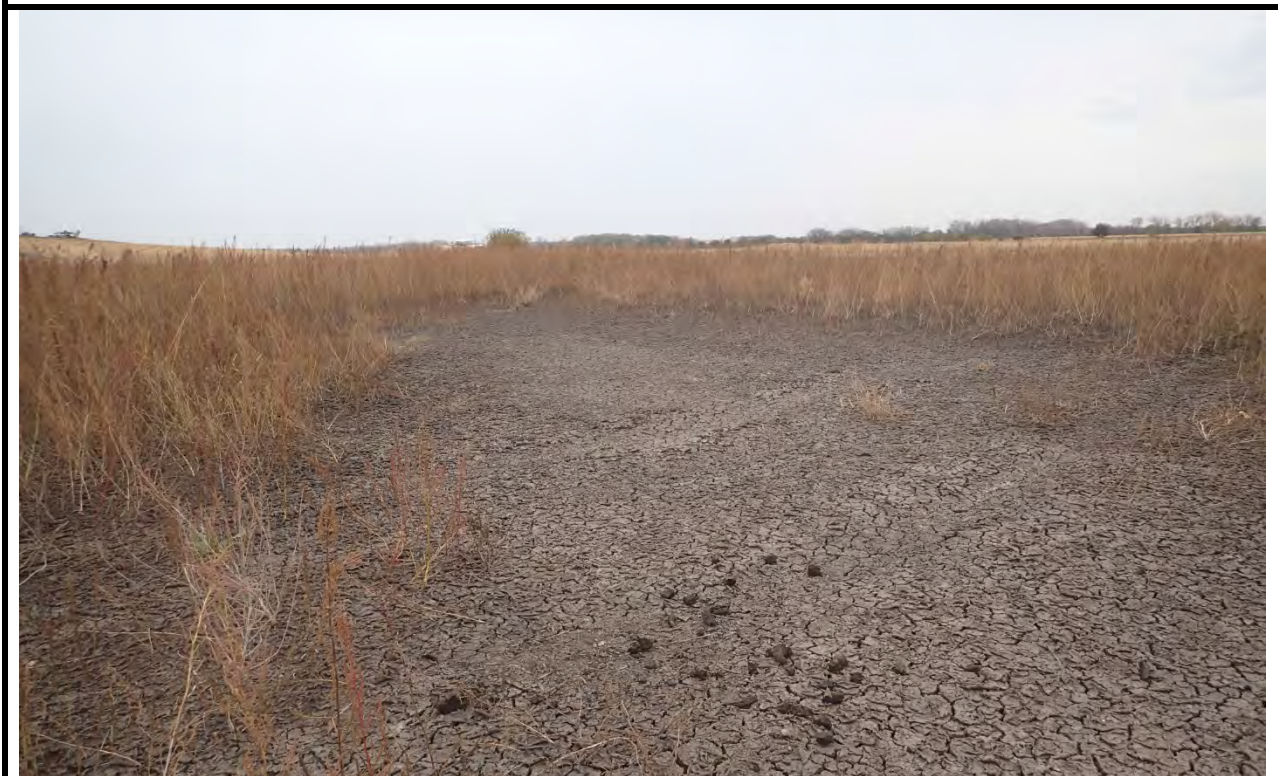
Photo 12: View of the farmed wetland area associated with S12 and S13, in the vicinity of S12. Facing southeast.

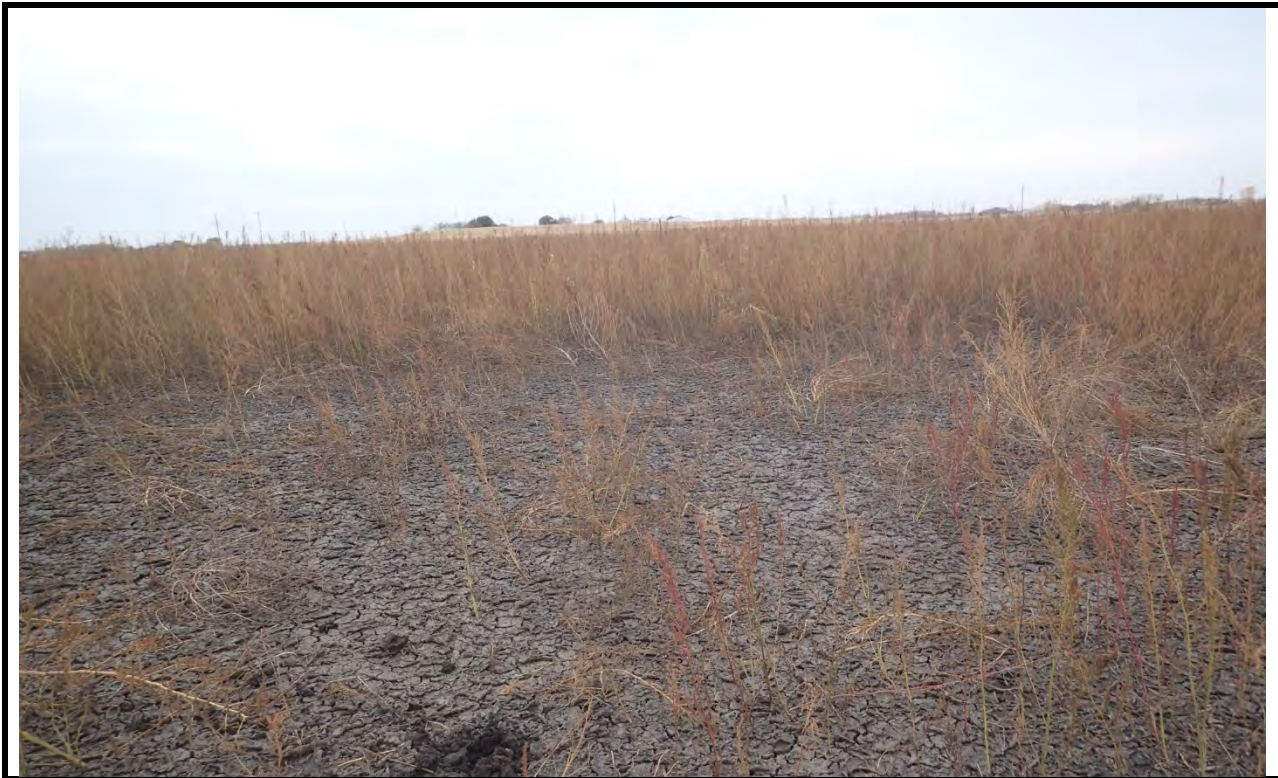
Photo 13: View of the farmed wetland area associated with S12 and S13, in the vicinity of S13. Facing southwest.

Field has been converted to row crop agriculture, and so the vegetation present may not be representative of normal circumstances. Photo 13.

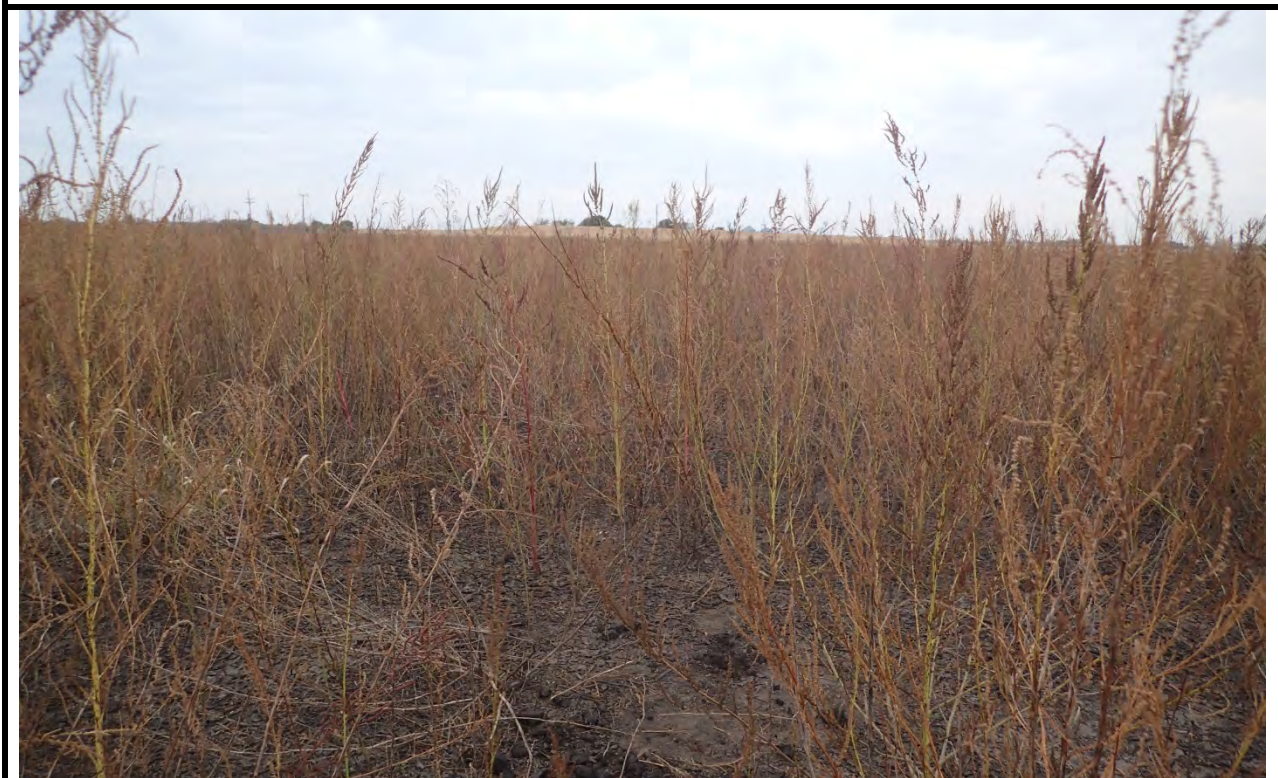
Photo 14: View of the upland area associated with S14. Facing west.

Photo 14.

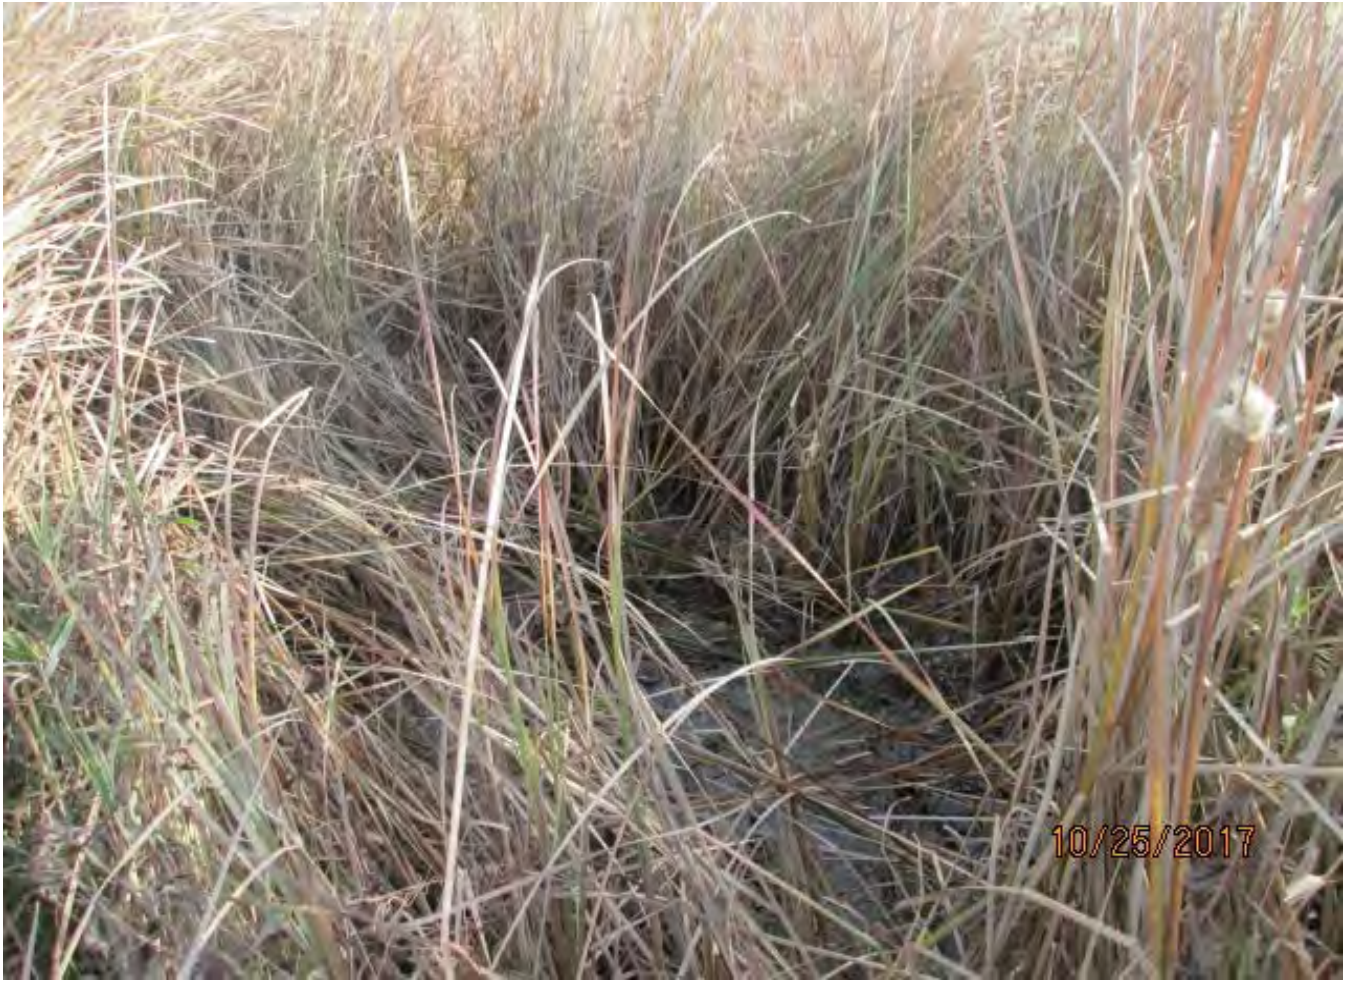
T1-1

Description: Wetland roadside ditch dominated by cattails

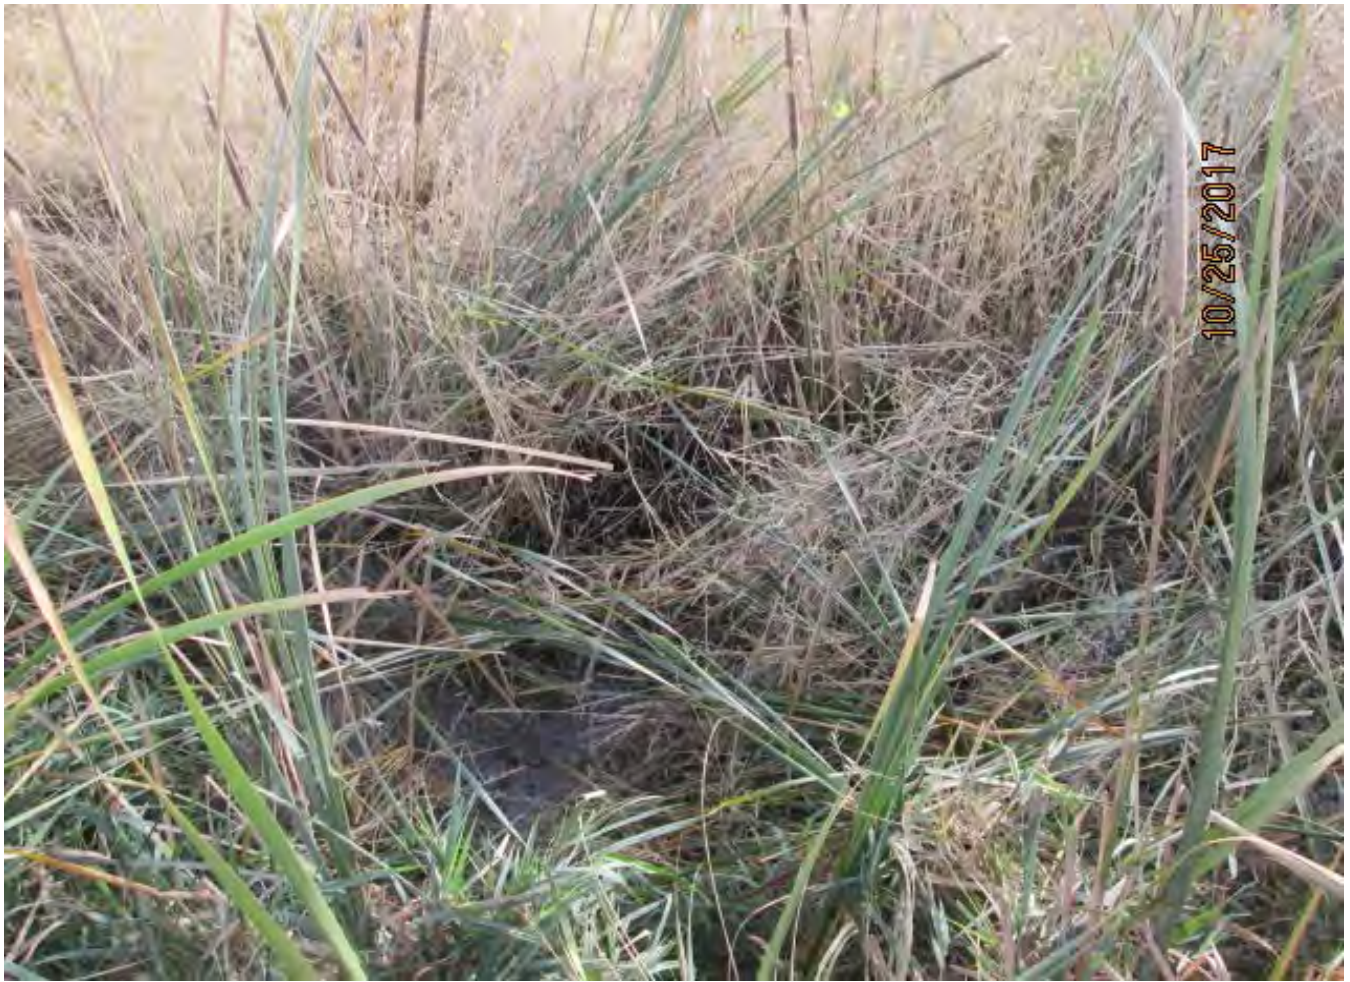
T3-1

Description: Wetland roadside ditch.

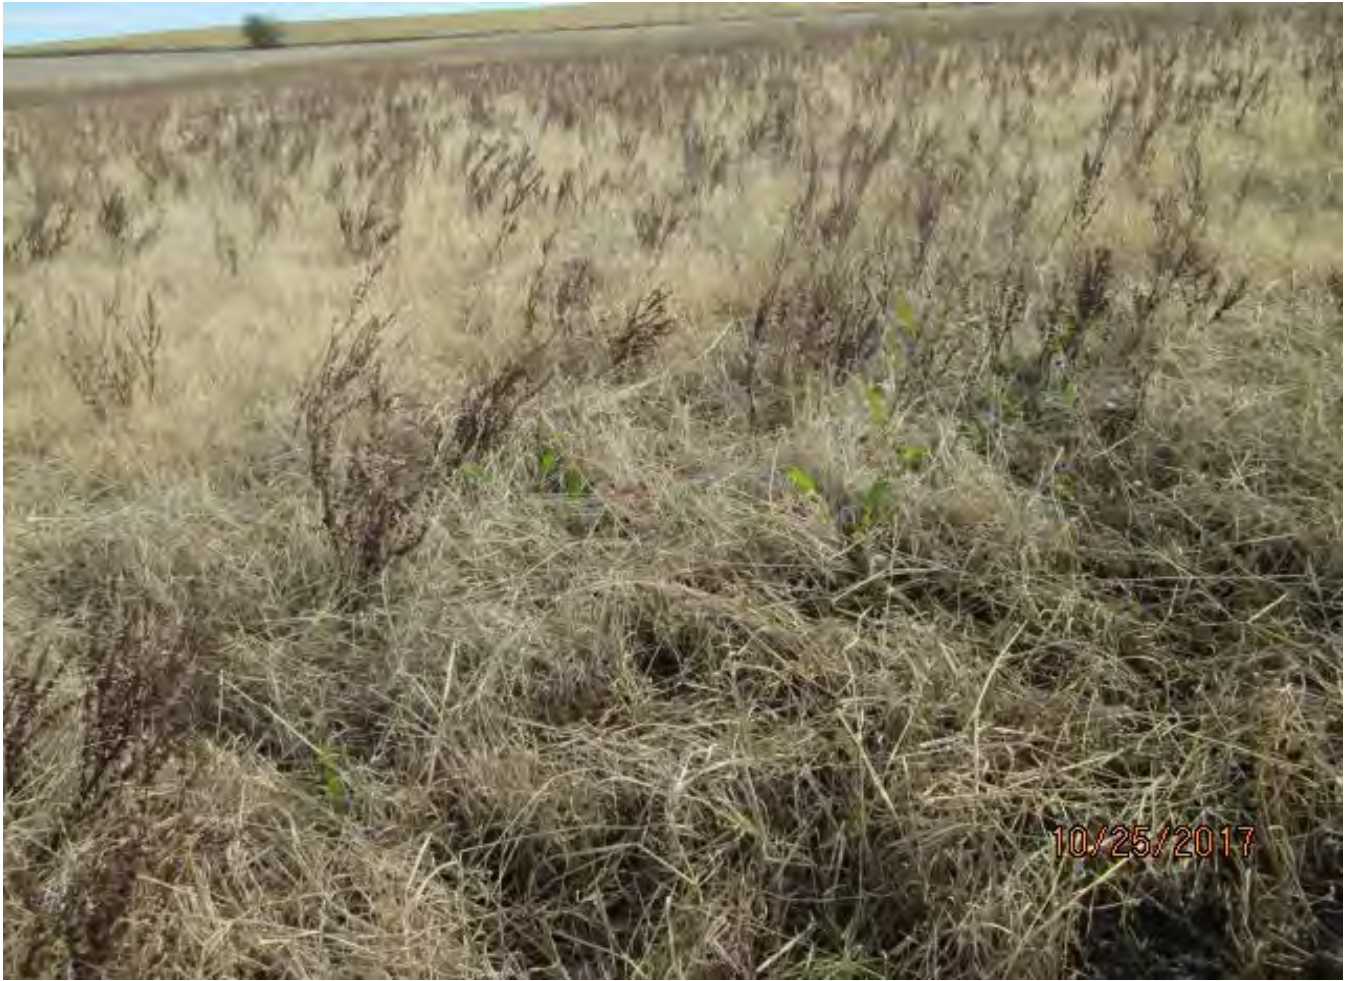
T3-3

Description: Transect 3 plot 3

Depth (inches)	Matrix		Redox Features				Texture	Remarks
	Color (moist)	%	Color (moist)	%	Type ¹	Loc ²		
0-17	2.5Y 2.5/1	100					Clay loam	
17-23	10YR 4/1	95	10YR 4/6	5	C	M	Clay	
23-40	10YR 2/1	99	10YR 4/6	1	C	M	Clay

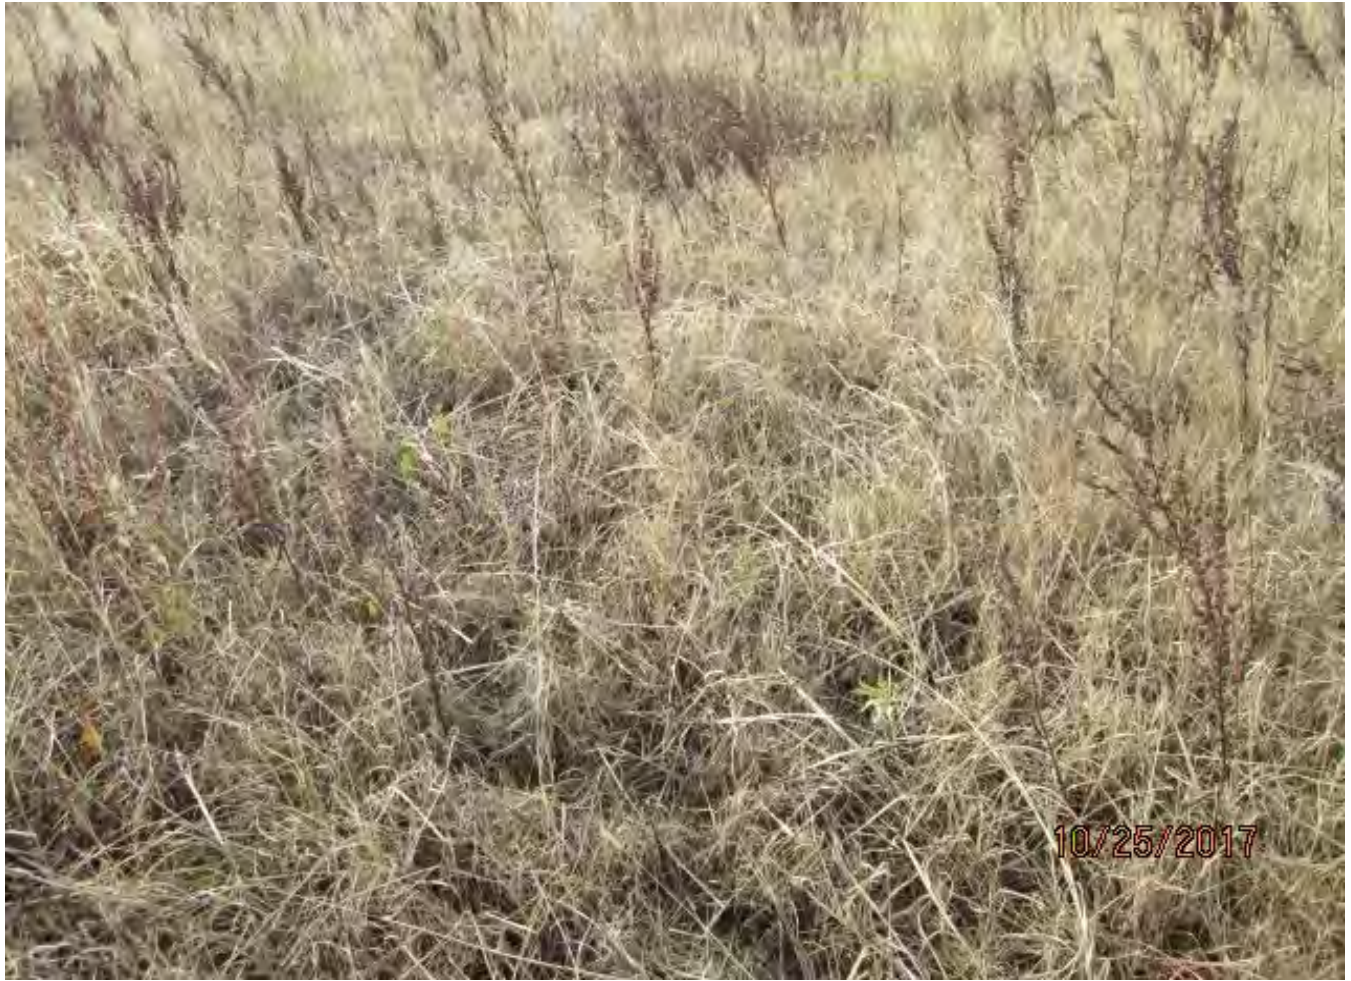
T3-4

Description: Transect 3 plot 4

Depth (inches)	Matrix		Redox Features				Texture	Remarks
	Color (moist)	%	Color (moist)	%	Type ¹	Loc ²		
0-12	10YR 2/1	96	10YR 4/6	4	C	M	Clay loam

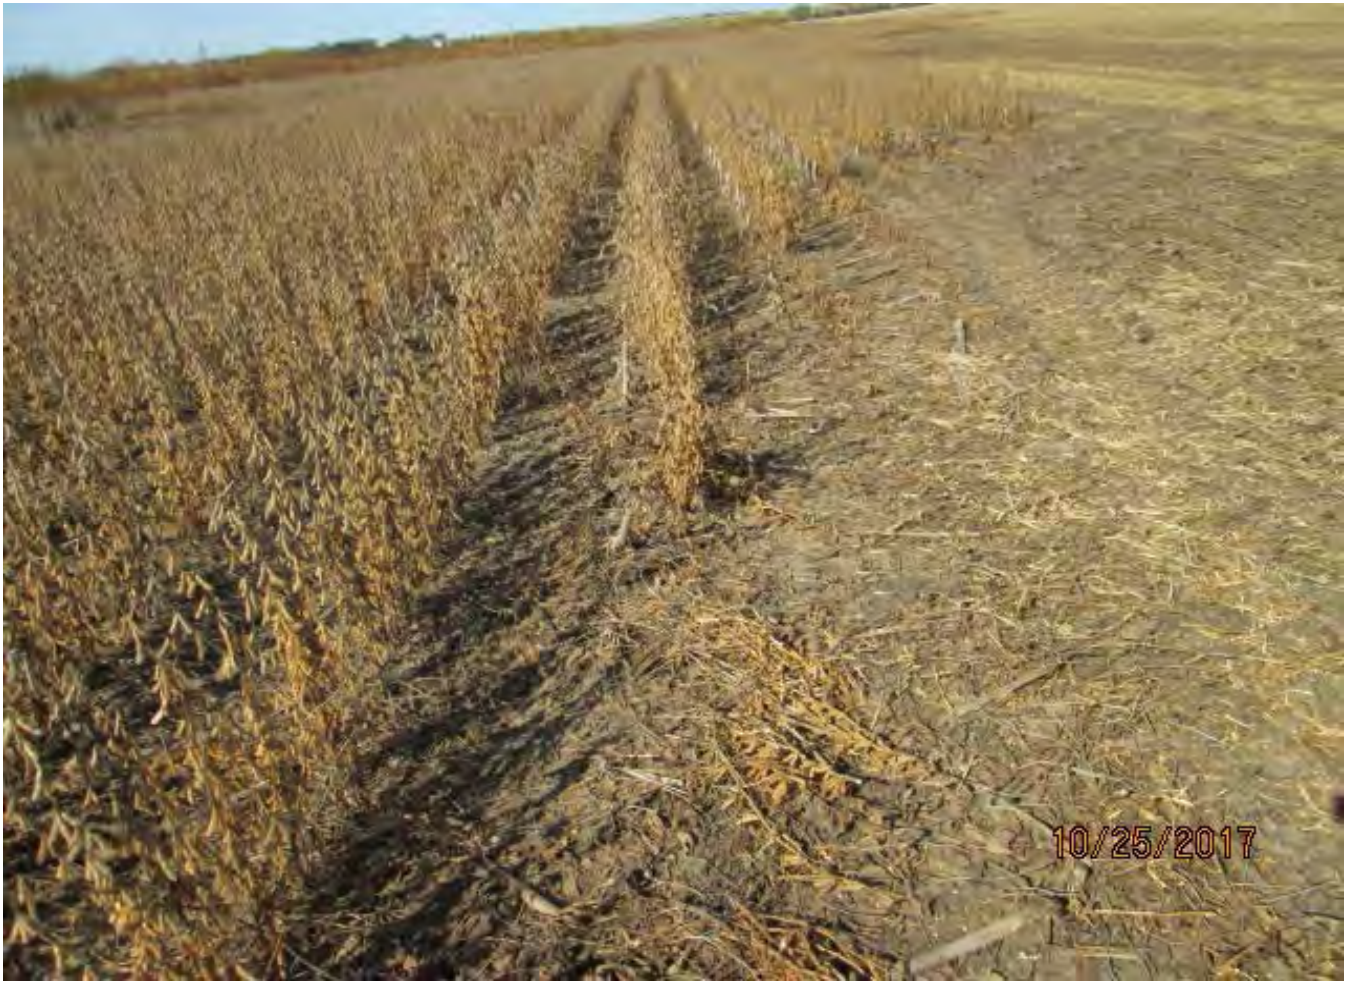
T3-5

Description: Transect 3 plot 5

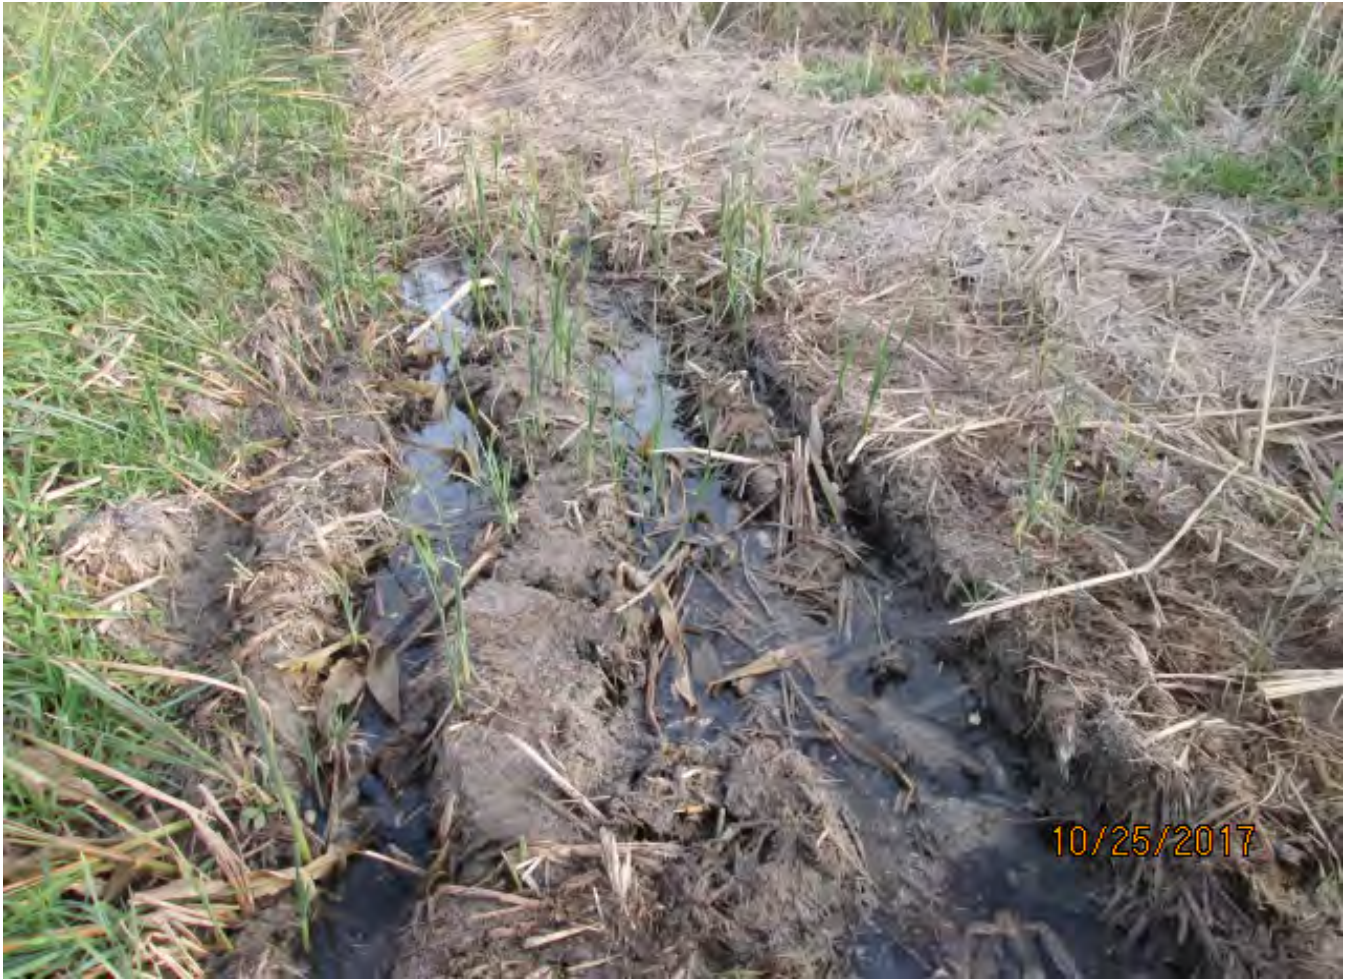
T4-1

Description: Wetland roadside ditch dominated by cattails

Depth (inches)	Matrix		Redox Features				Texture	Remarks
	Color (moist)	%	Color (moist)	%	Type ¹	Loc ²		
0-14	2.5Y 2.5/1	100					Clay Loam	
14-26	10YR 3/1	98	10YR 5/6	2	C	M	Clay Loam	
26-38	10YR 4/2	50	10YR 5/6	2	C	M	Silty Clay Loam	
	10YR 3/1	48						
38-40	10YR 3/1	70	10YR 5/6	2	C	M	Silty Clay Loam	
	10YR 4/2	28

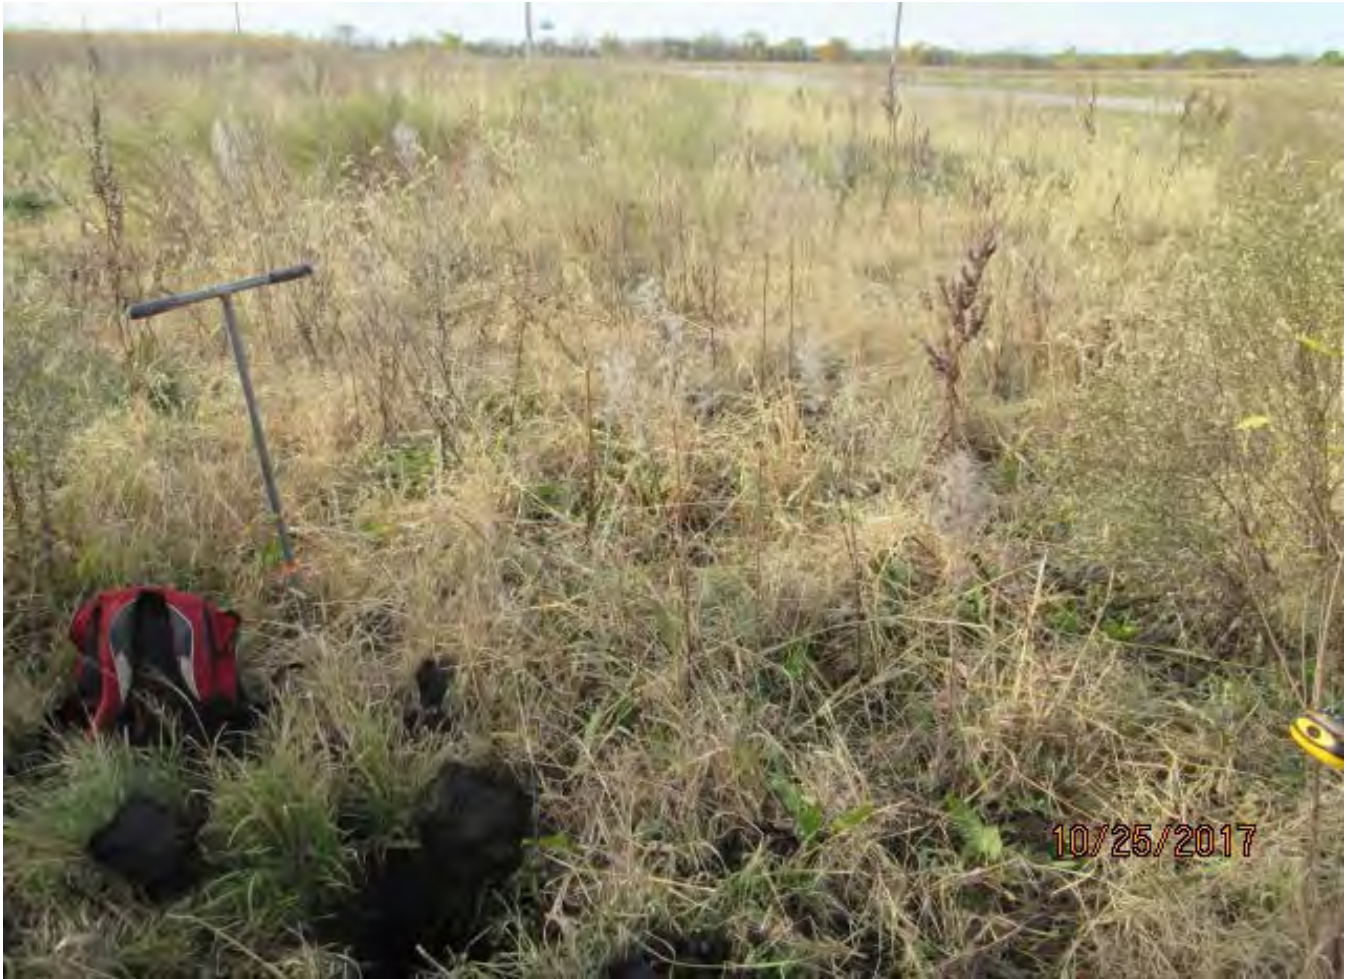
T4-2

Description: Transect 4 plot 2

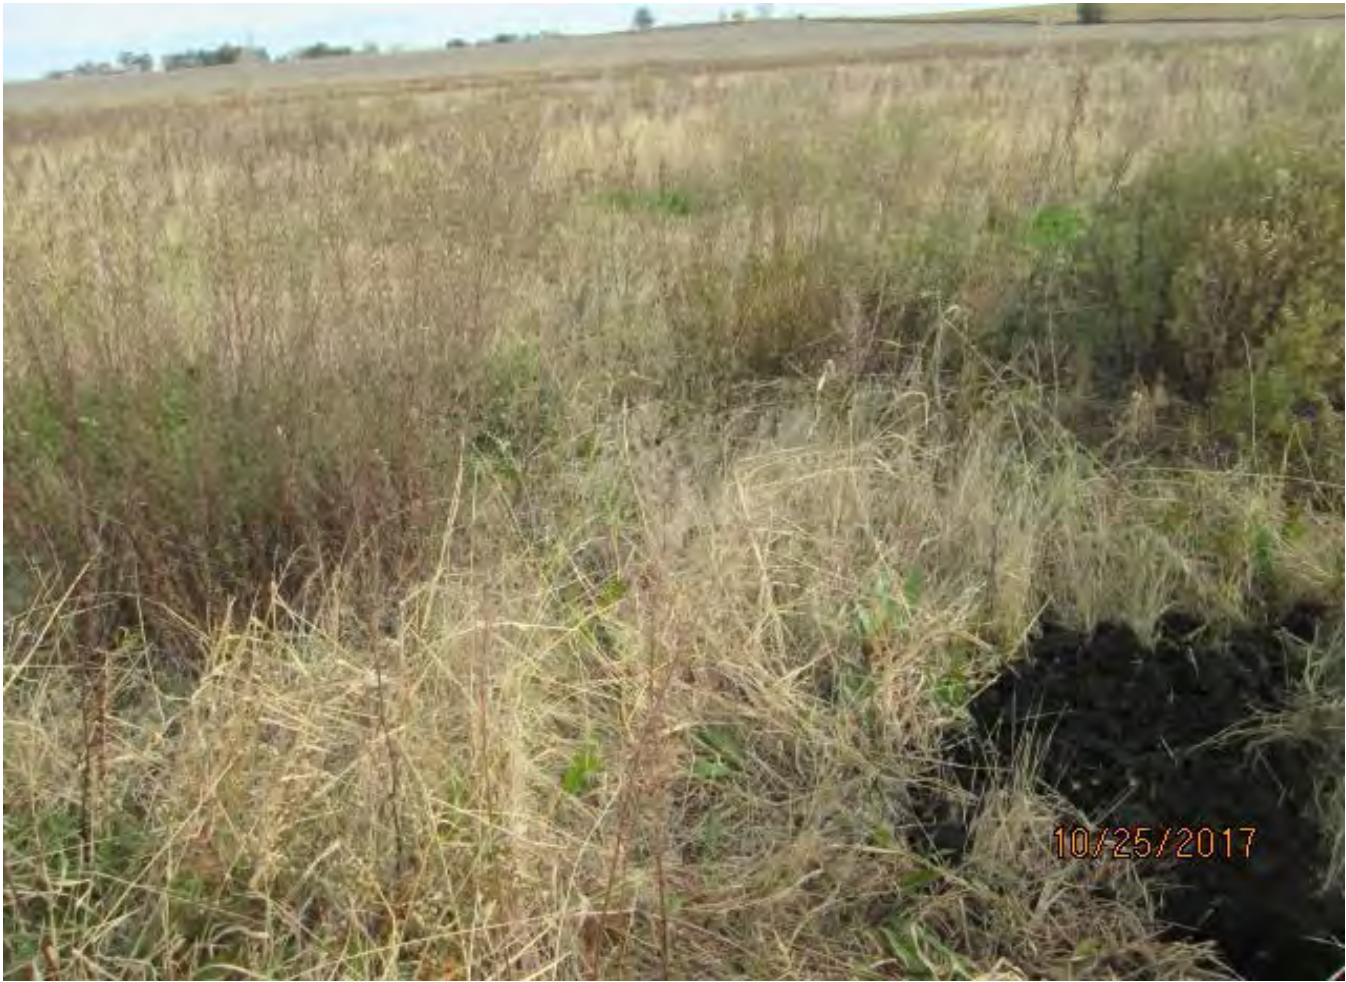
T4-3

Description: Transect 4 plot 3

Remarks: FAC-Neutral test is present, otherwise no further wetland indicators were observed.

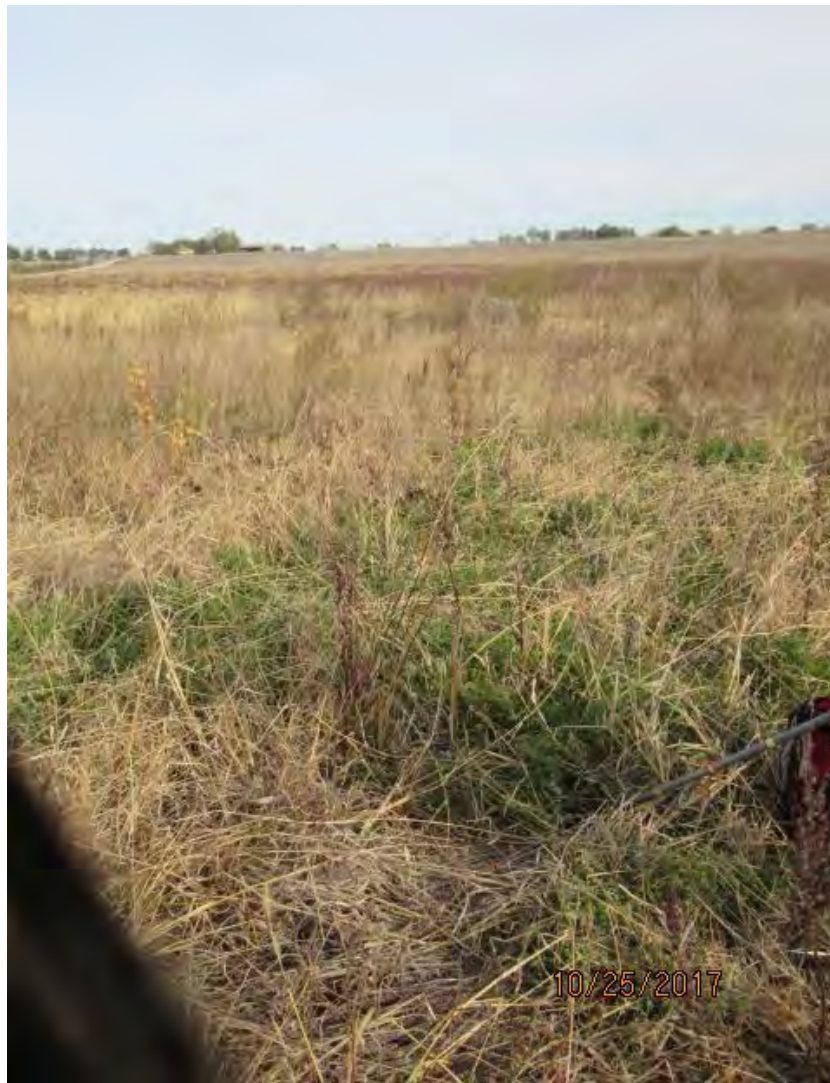
T4-4

Description: Transect 4 plot 4

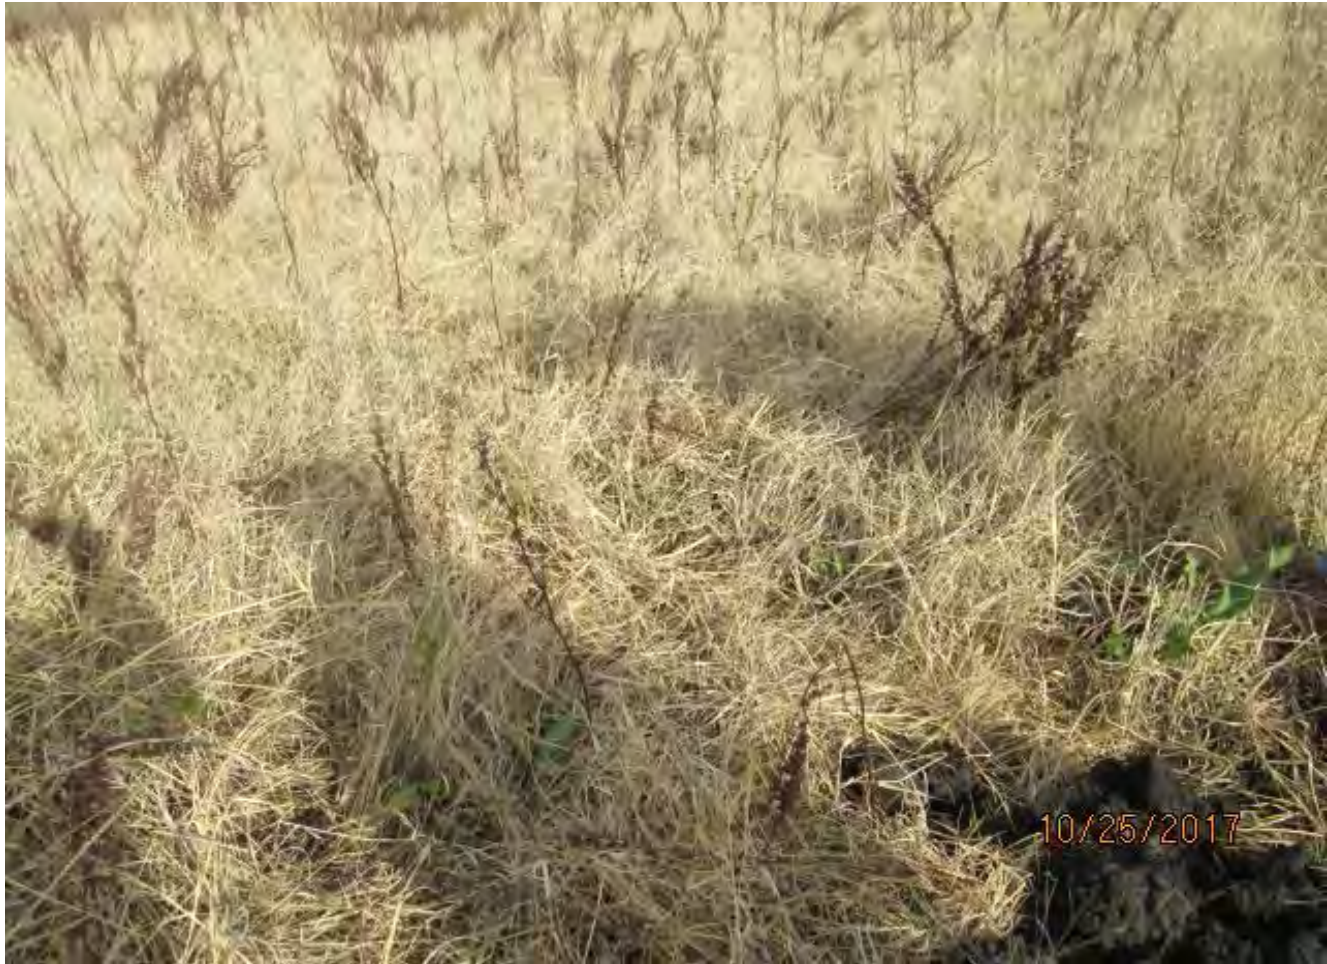
T4-5

Description: Transect 4 plot 5
