SITE DEVELOPMENT PLAN

ASHLAND WETLAND MITIGATION BANK SAUNDERS COUNTY, NEBRASKA

**Prepared for
Nebraska Department of Transportation**

**Benesch Project No. 00120472.00
NDOT Project No. STWD (1044)
NDOT Control No. 10584B
USACE Project No. 2018-01099-WEH**

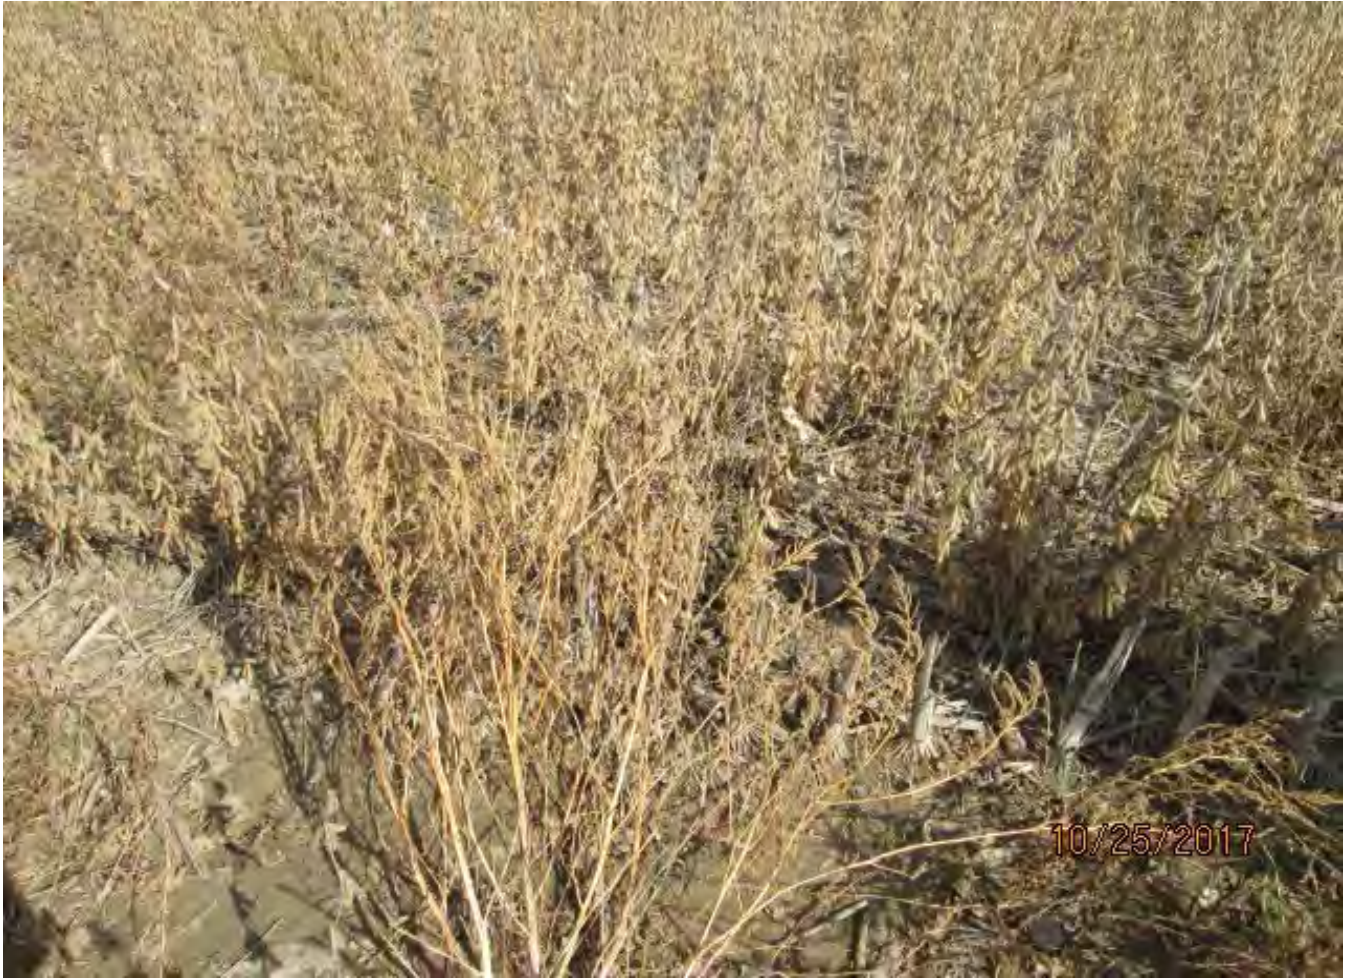
T4-6

Description: Transect 4 plot 6

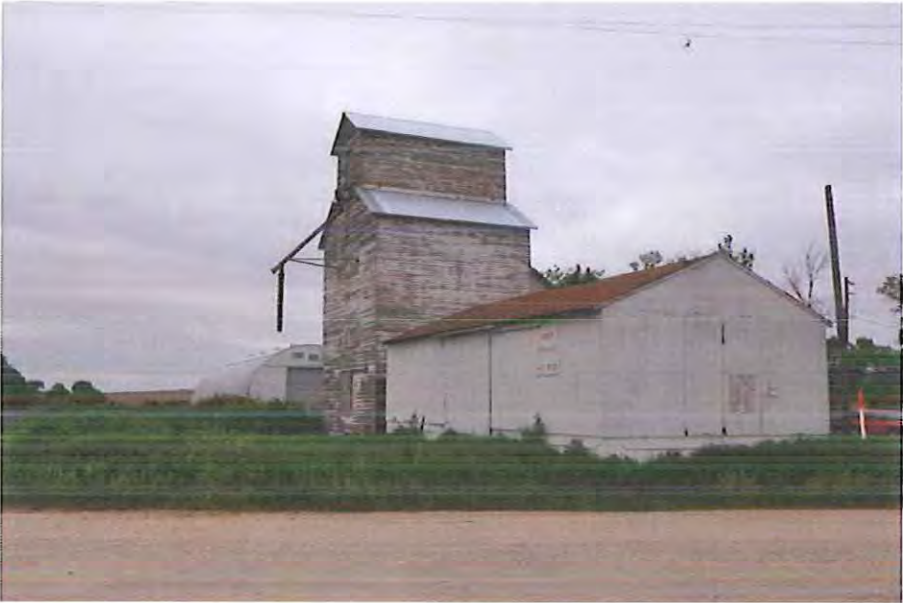
Control No.	Property		County	Address, Town
10584A	Grain Elevator		Lancaster	6815 W AGNEW RD
NHRSI No.	Direction of View	Photo by, Date		Map Ref.
LC01-002	SW	Hilger, 051915		APE Detail Map 2
Description				
<p>Previously Recommended NRHP Eligible under Criterion A, Commerce. Contributing elements are Grain Elevator and associated outbuildings. c1900 Wood grain elevator and metal quoinset hut. Previously pictured metal silos are now gone. Shed roof addition on the west side of the grain elevator with entry. Eligibility is recommended despite the loss of the metal silos.</p>

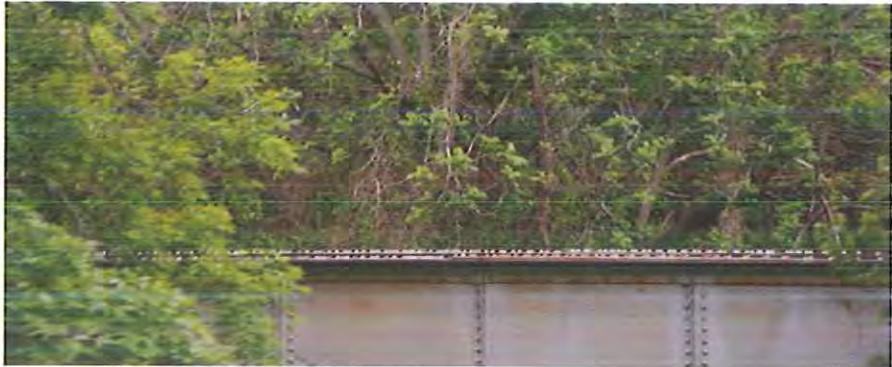
Control No.	Property		County	Address, Town
10584A	Railroad Bridge		Lancaster	North of Agnew
NHRSI No.	Direction of View	Photo by, Date		Map Ref.
LC00-287	W	Hilger, 051915		APE Detail Map 3
Description				
<p>Recommended NRHP Ineligible, lacks significance under Criterion A, B, or C. c1940 Railroad Bridge with metal support and girder system</p>

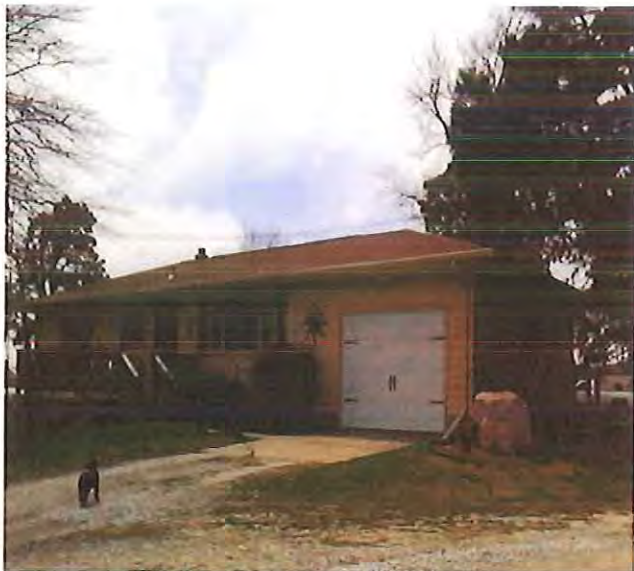
Control No.	Property		County	Address, Town
10584A	House		Lancaster	17701 NW 56 St
NHRSI No.	Direction of View	Photo by, Date		Map Ref.
CN 10584A FN2	NE	Lancaster County Assessor, 042613		APE Detail Map 1
Description				
<p>Recommended NRHP ineligible, lacks significance under Criterion A, B, or C. c1956 Ranch, one-story, hip roof with asphalt shingling Aluminum or hard-board siding and concrete block foundation. One-over-one and picture window styles, appear modern. Central entry under the roofline with an open-air deck. Attached one-car garage with double door entry.</p>
