OBSERVATION REPORT

Tecumseh Historic Square Preservation – Structural Evaluation

Submitted by Olsson Inc.

February 18, 2022

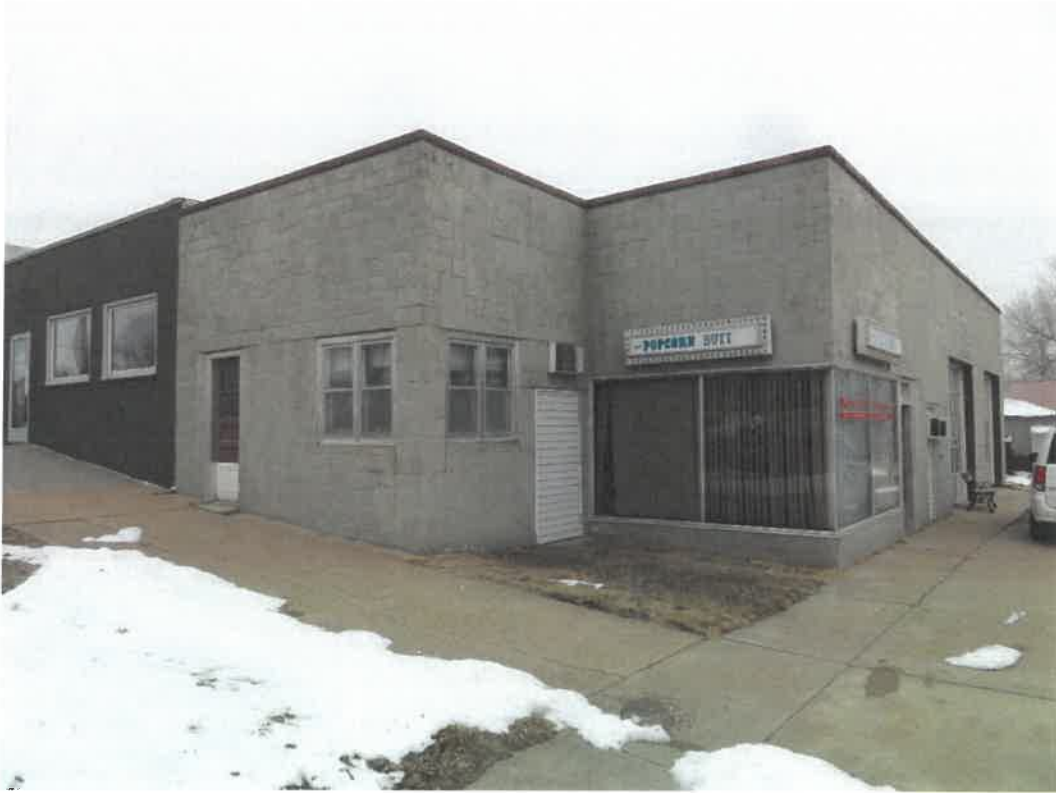
This one-story structure on a corner lot does not have a basement. The building appears to be in good condition. Olsson does not anticipate any problems with construction of sidewalk improvements.

Photo 1 **Building No. 1 – Popcorn Hut/Kernal Crazy (408 Clay St)**
Frontage Looking Northeast

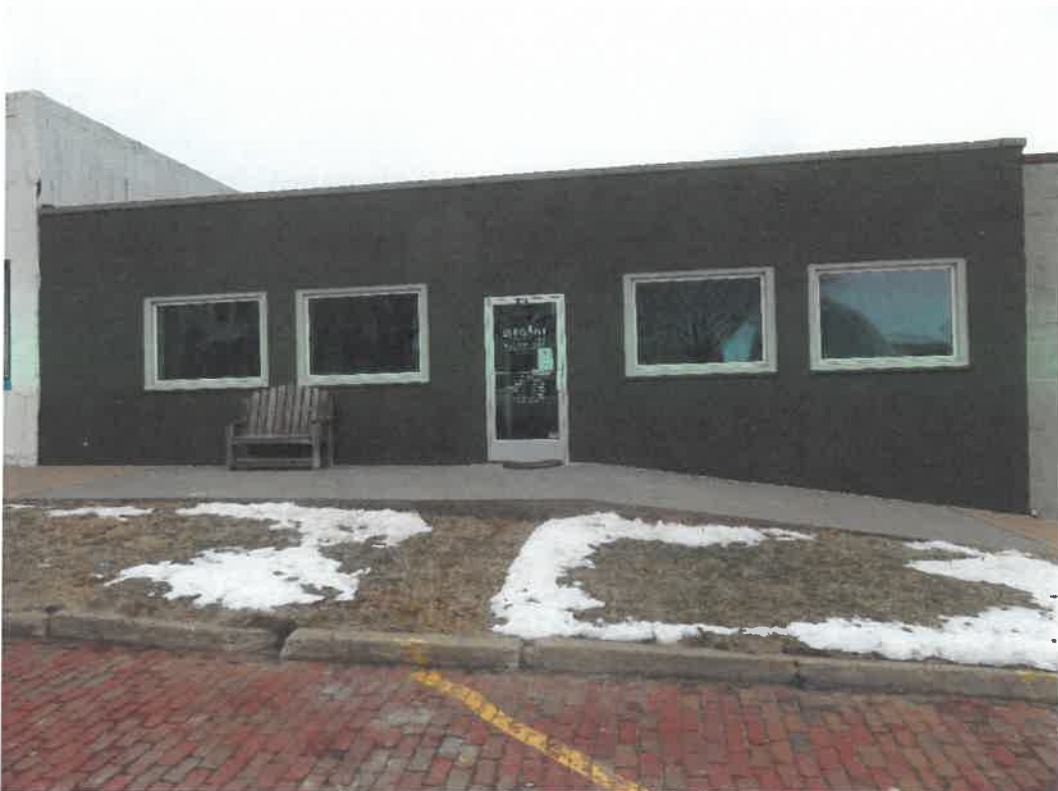
This one-story structure does not have a basement. The building appears to be in good condition. Olsson does not anticipate any problems with construction of sidewalk improvements.

Photo 2 **Building No. 2 – Elegant Salon & Spa (186 S 4th St)**
Frontage Looking East

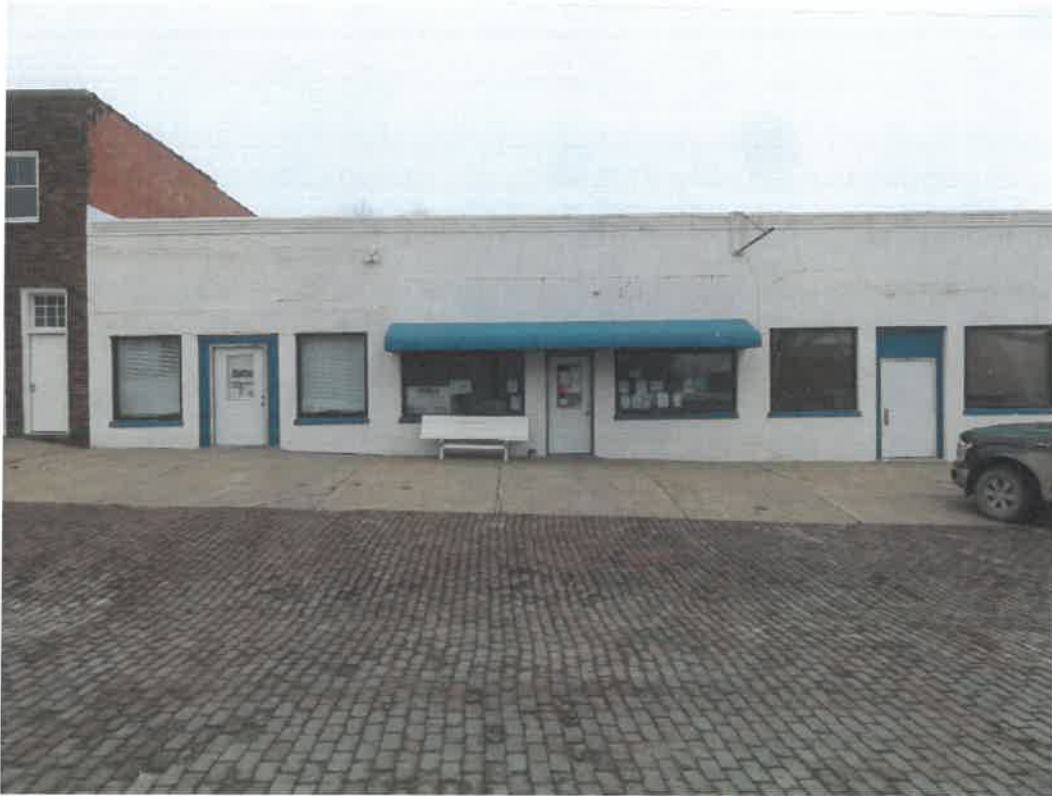
This one-story structure does not have a basement. The building appears to be in good condition. Olsson does not anticipate any problems with construction of sidewalk improvements.

**Photo 3 Building No. 3 – Senca Community Action (172 S 4th St)
Frontage Looking East**

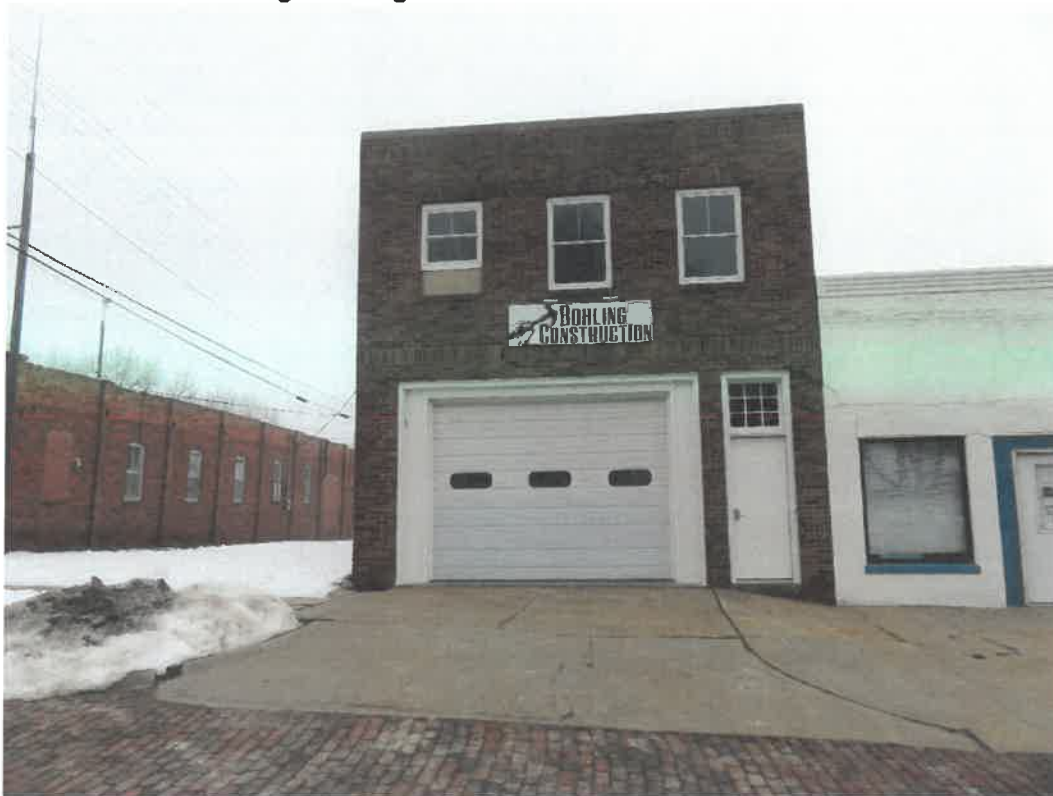
This two-story structure does not have a basement. The building appears to be in good condition. Olsson does not anticipate any problems with construction of sidewalk improvements.

**Photo 4 Building No. 4 – Bohling Construction (160 S 4th St)
Frontage Looking East**

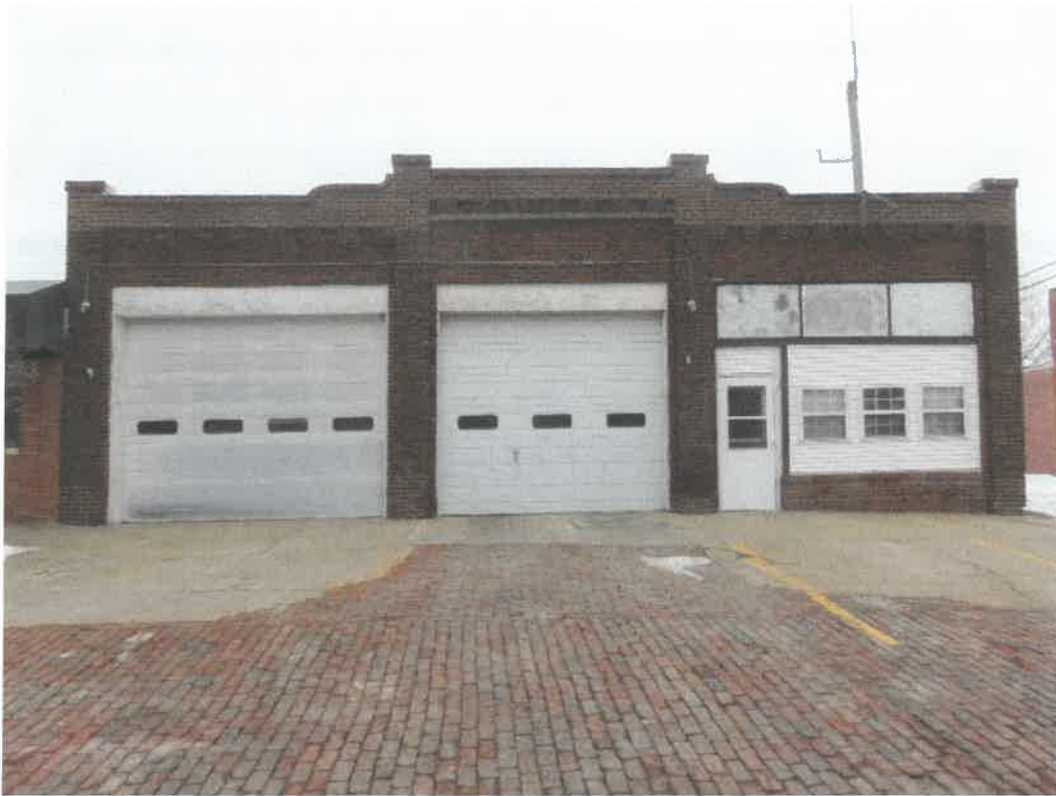
This one-story structure does not have a basement. City personnel indicated the building had a basement in its earlier years, but it was filled in many years ago. The building appears to be in good condition. Olsson does not anticipate any problems with construction of sidewalk improvements.

Photo 5 **Building No. 5 – Old City Fire Station (148 S 4th St)**
Frontage Looking East

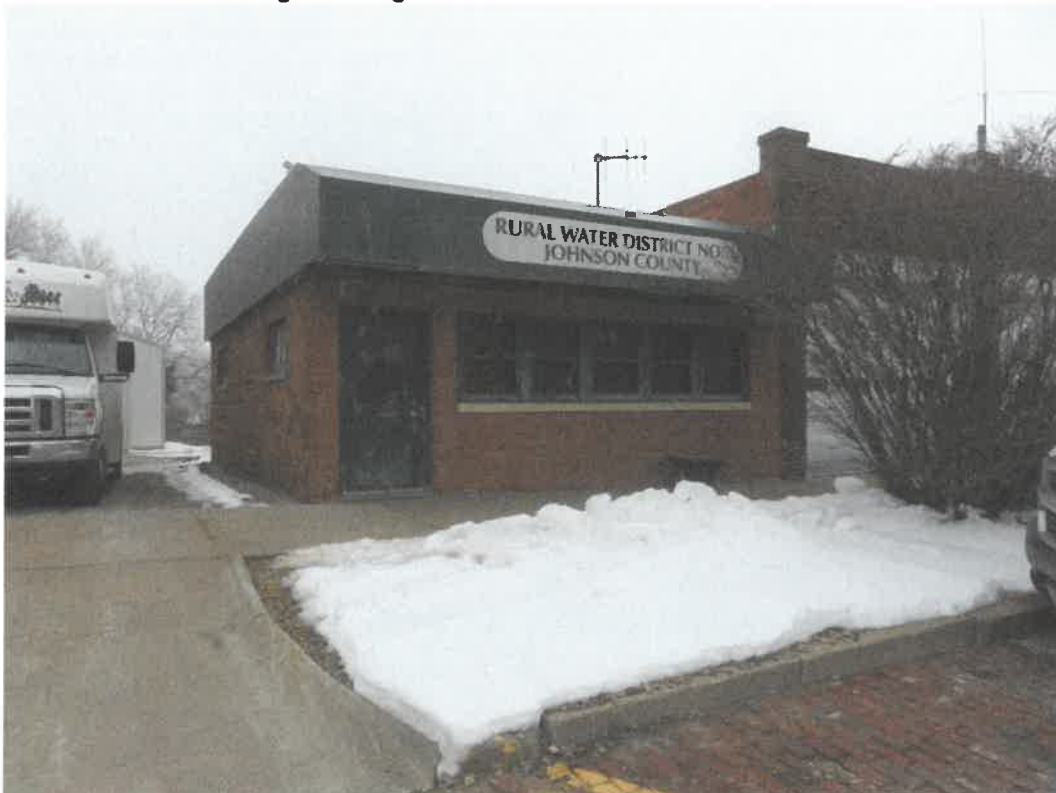
This one-story structure does not have a basement. The building appears to be in good condition. Olsson does not anticipate any problems with construction of sidewalk improvements.

Photo 6 **Building No. 6 – Johnson County Rural Water District (134 S 4th St)**
Frontage Looking East

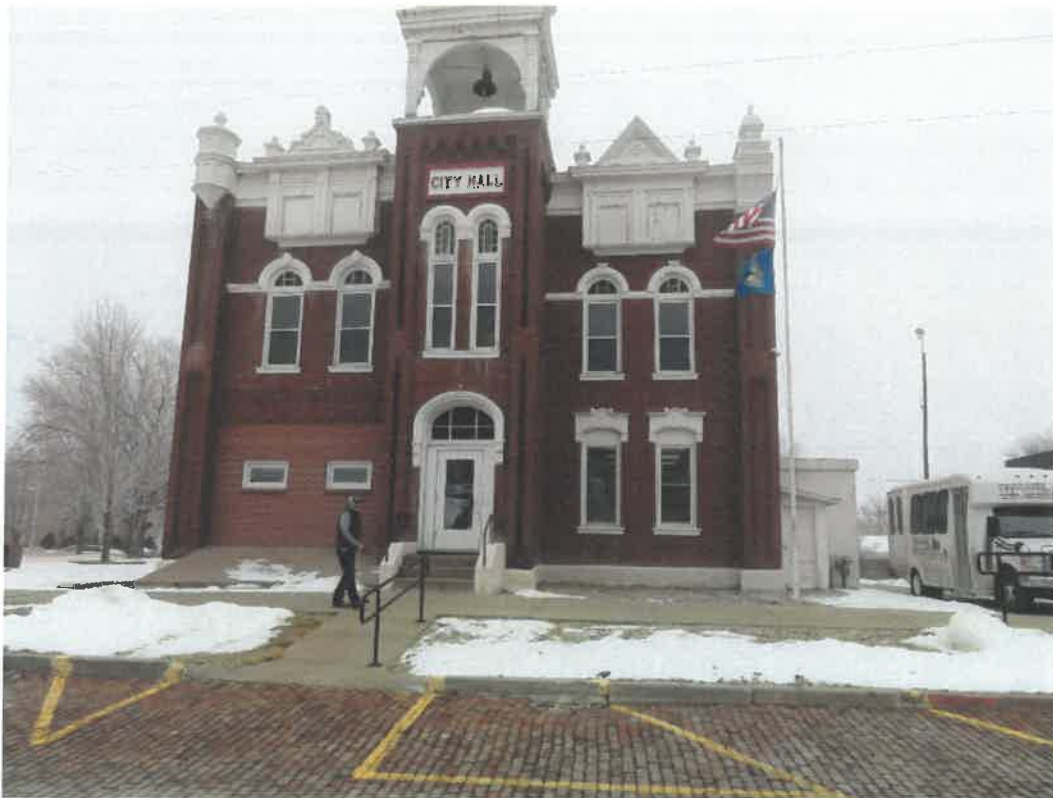
This two-story structure has a basement and sits on a corner lot. The building appears to be in good condition. The front edge of the building sits several feet away from the sidewalk; thus, any basement wall openings will not be directly affected by downtown improvements. Olsson does not anticipate any problems with construction of sidewalk improvements.

**Photo 7 Building No. 7 – Tecumseh City Hall (122 S 4th St)
Frontage Looking East**

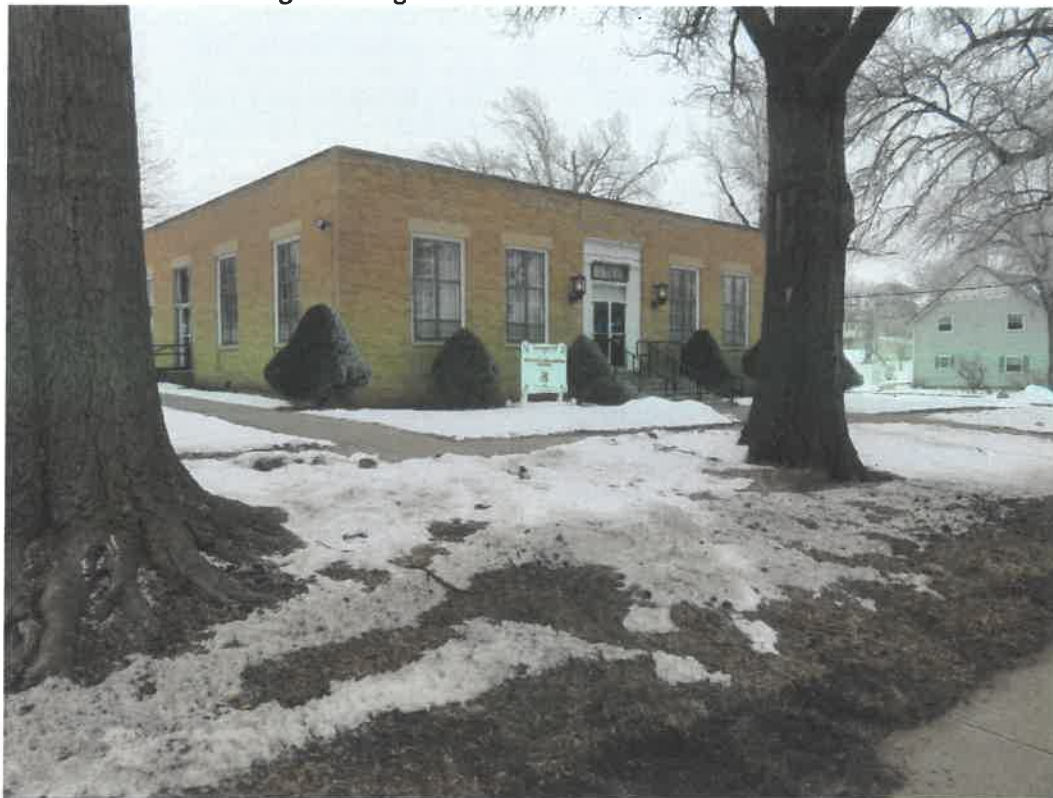
This one-story structure sits on a corner lot and without entering this building its unknown if a basement exists. The building appears to be in good condition. The front edge of the building sits well away from the sidewalk; thus, any basement wall openings will not be directly affected by downtown improvements. Olsson does not anticipate any problems with construction of sidewalk improvements.

**Photo 8 Building No. 8 – Tecumseh Post Office (484 Broadway St)
Frontage Looking Northeast**

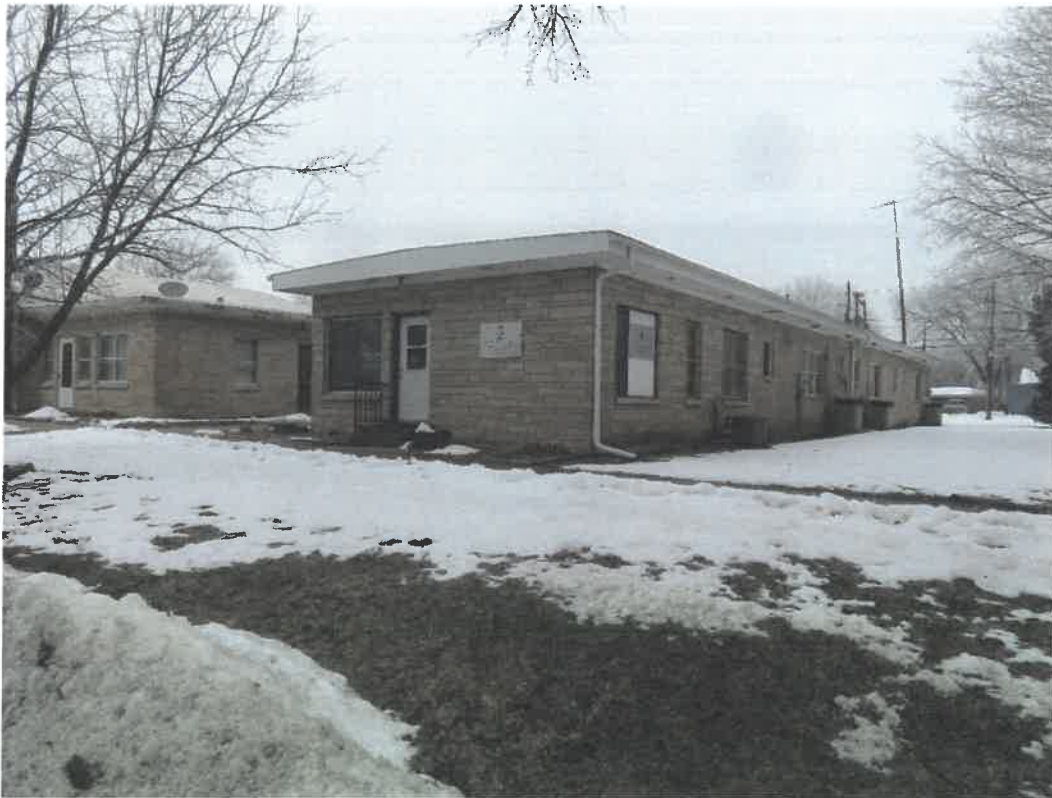
This one-story structure does not have a basement and sits several feet away from the sidewalk. The building appears to be in good condition. Olsson does not anticipate any problems with construction of sidewalk improvements.

**Photo 9 Building No. 9 – Richard R. Smith Law Office (454 Broadway St)
Frontage Looking Northwest**

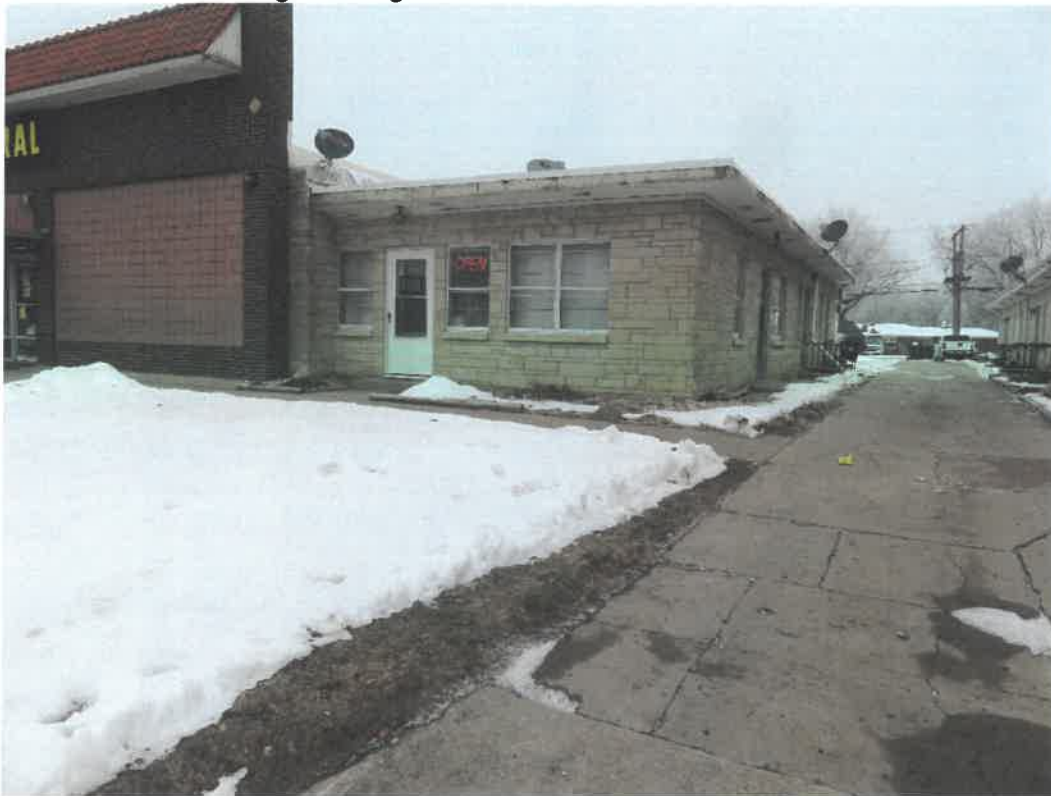
This one-story structure does not have a basement and sits several feet away from the sidewalk. The building appears to be in good condition. Olsson does not anticipate any problems with construction of sidewalk improvements.

**Photo 10 Building No. 10 – The Nail Spa (440 Broadway St)
Frontage Looking Northwest**

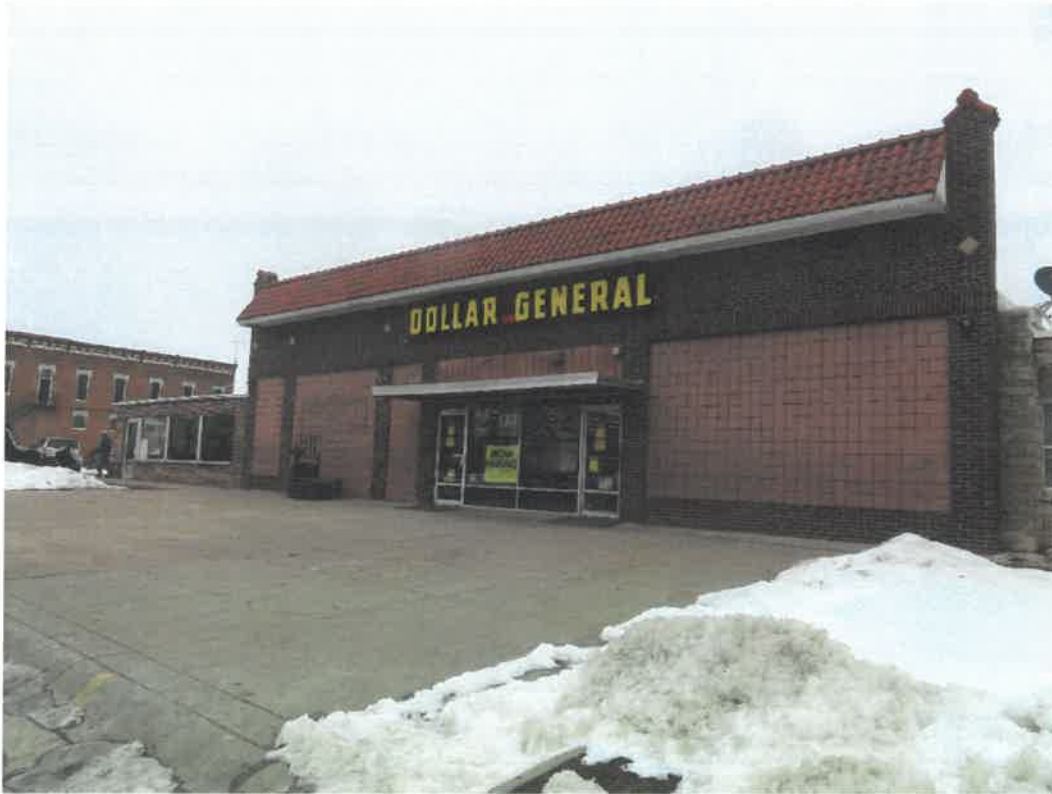
This one-story structure does not have a basement. The building appears to be in good condition. Olsson does not anticipate any problems with construction of sidewalk improvements.

**Photo 11 Building No. 11 – Dollar General (462 Broadway St)
Frontage Looking Northwest**

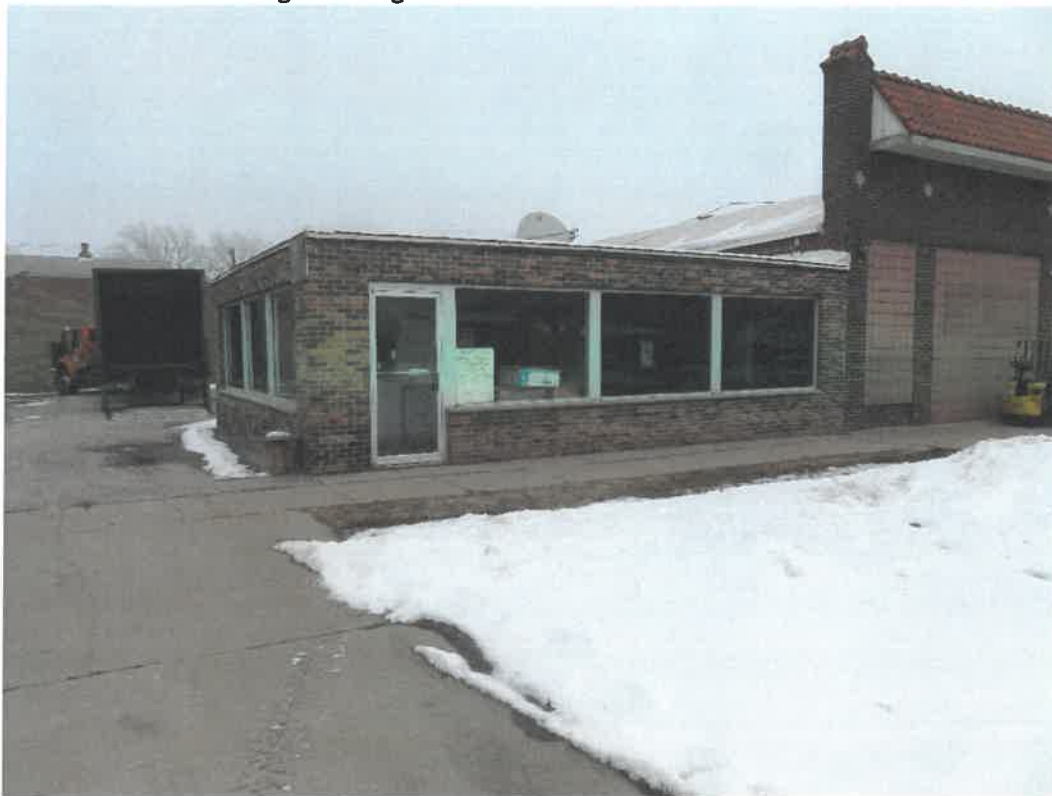
This one-story structure does not have a basement. The building appears to be in good condition. Olsson does not anticipate any problems with construction of sidewalk improvements.

**Photo 12 Building No. 12 – Sam Murante Building (462 Broadway St)
Frontage Looking Northeast**

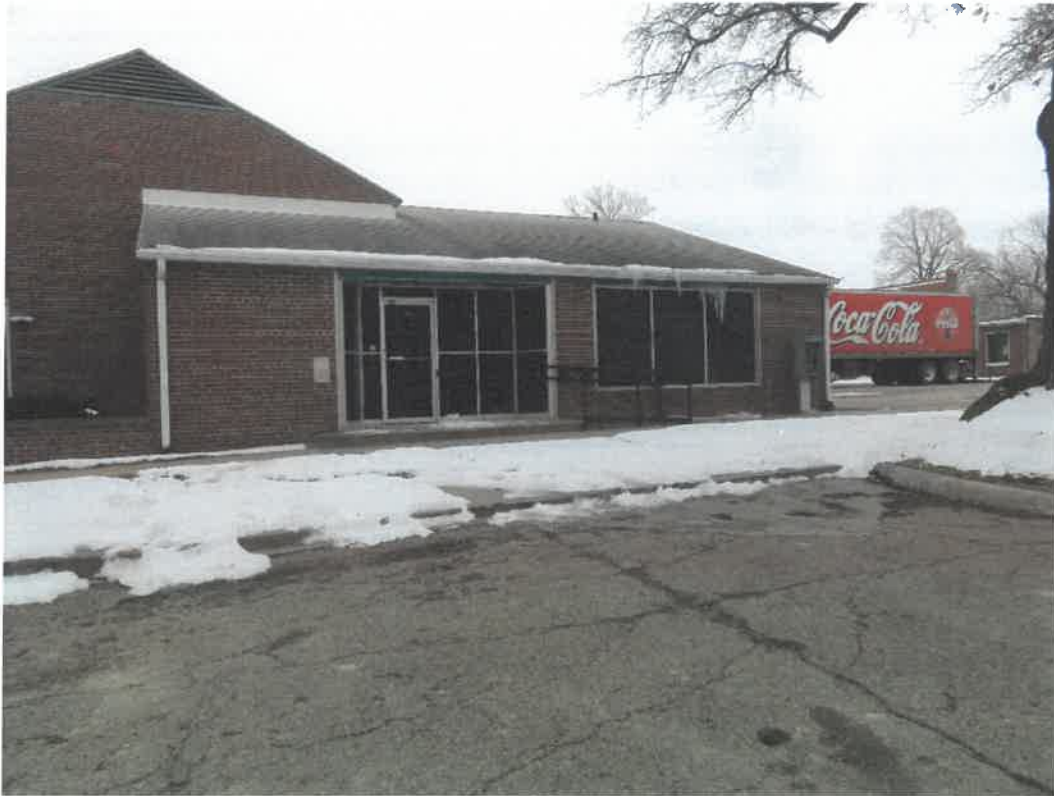
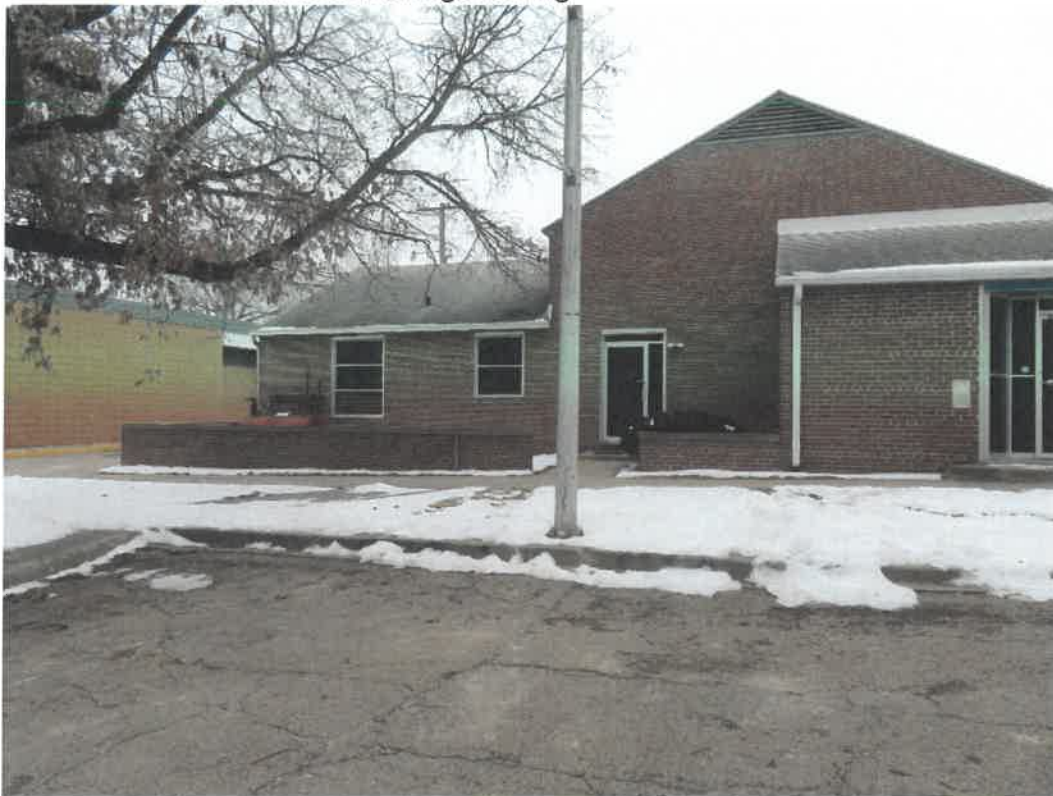
This one-story structure has a basement. The building appears to be in good condition. The front edge of the building with basement sits several feet away from the sidewalk; thus, any basement wall openings will not be directly affected by downtown improvements. A concrete handicap ramp with railing abuts the sidewalk. Olsson does not anticipate any problems with construction of sidewalk improvements.

Photo 13 Building No. 13 – Fire Rivers RC&D (140 N 4th St)
South Side of Frontage Looking East

Photo 14 Building No. 13 – Fire Rivers RC&D (140 N 4th St)
North Side of Frontage Looking East

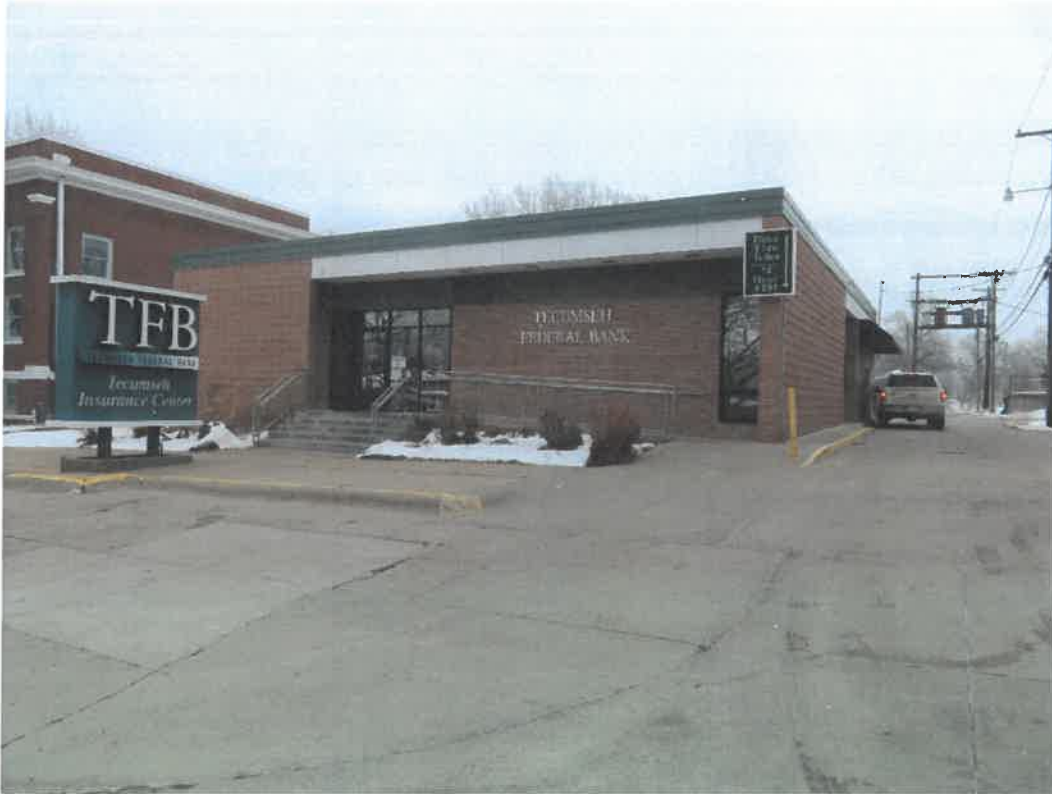
This one-story structure has a basement. The building appears to be in good condition. The front edge of the building sits several feet away from the sidewalk; thus, any basement wall openings will not be directly affected by downtown improvements. A concrete stairway with railing abuts the sidewalk. Olsson does not anticipate any problems with construction of sidewalk improvements.

**Photo 15 Building No. 14 – Tecumseh Federal Bank (160 N 4th St)
Frontage Looking East**

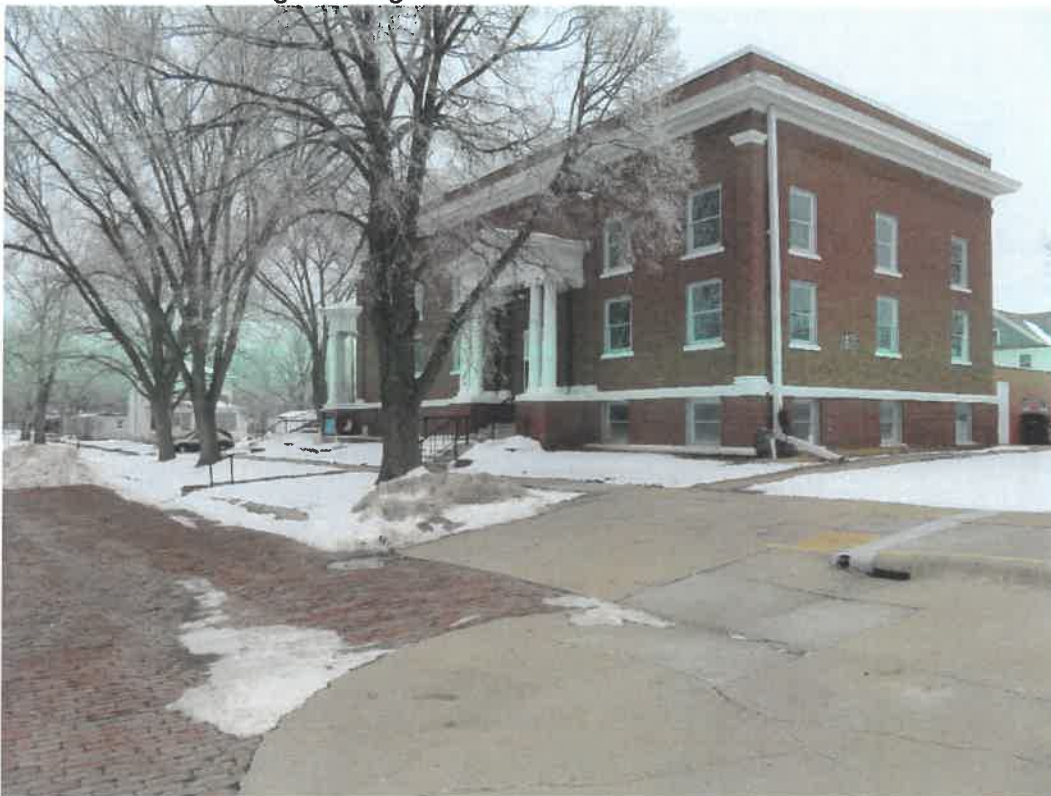
This two-story structure with a half basement sits on a corner lot. The building appears to be in good condition. The front edge of the building sits several feet away from the sidewalk; thus, any basement wall openings will not be directly affected by downtown improvements. Two concrete stairways with railings abut the sidewalk – one on the west side of the building and one on the northwest corner of the building.

**Photo 16 Building No. 15 – Methodist Church (190 N 4th St)
Frontage Looking Northeast**

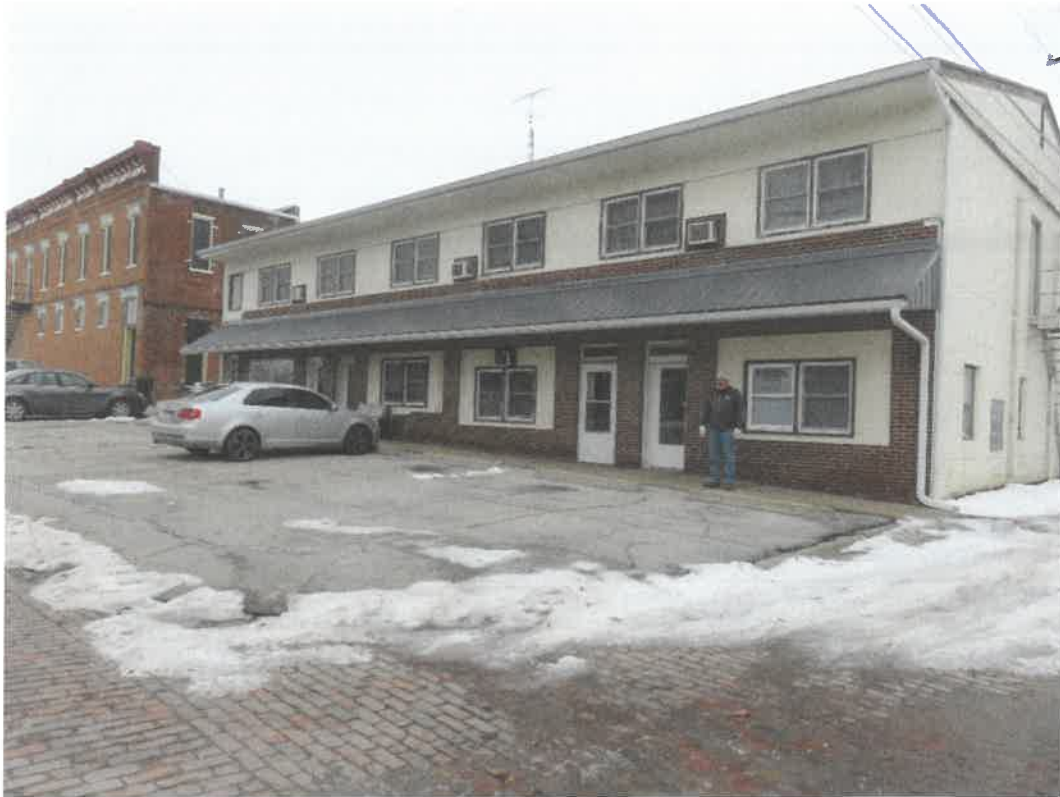
This one-story structure does not have a basement. The building appears to be in good condition. Olsson does not anticipate any problems with construction of sidewalk improvements.

**Photo 17 Building No. 16 – Town Square Apts./3 Other Businesses (131 N 4th St)
Frontage Looking Southwest**

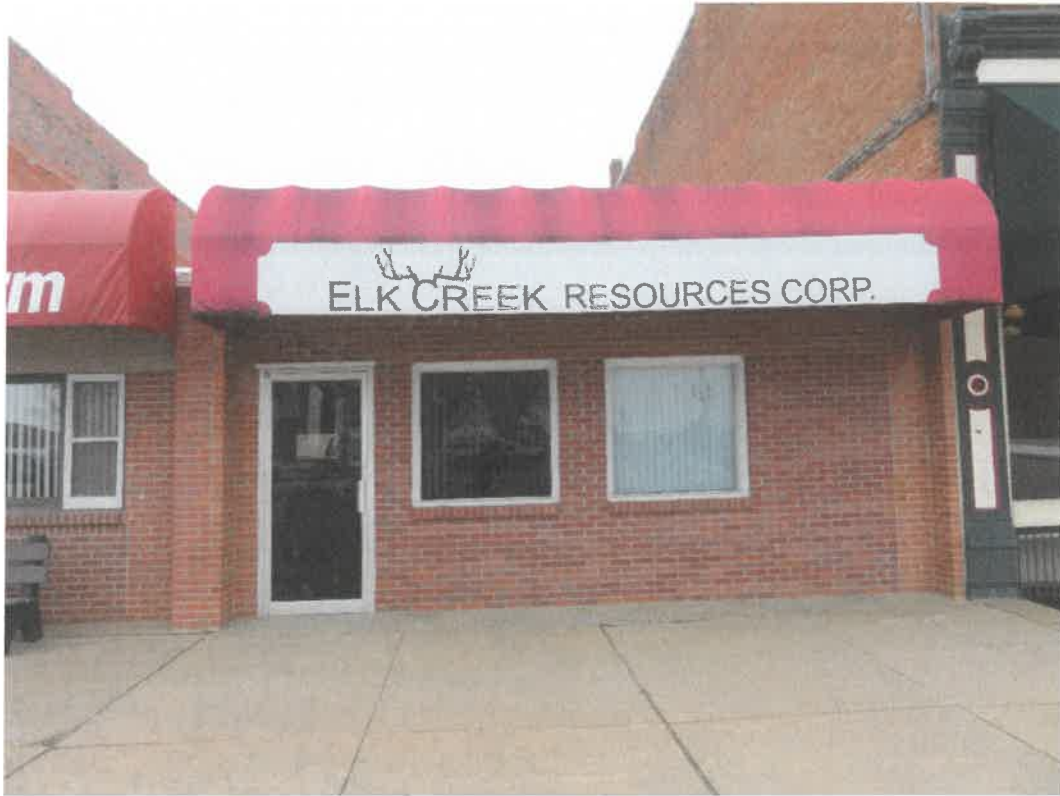
**Photo 35 Building No. 18 – Elk Creek Resources Corp. (386 Broadway St)
Frontage Looking North**

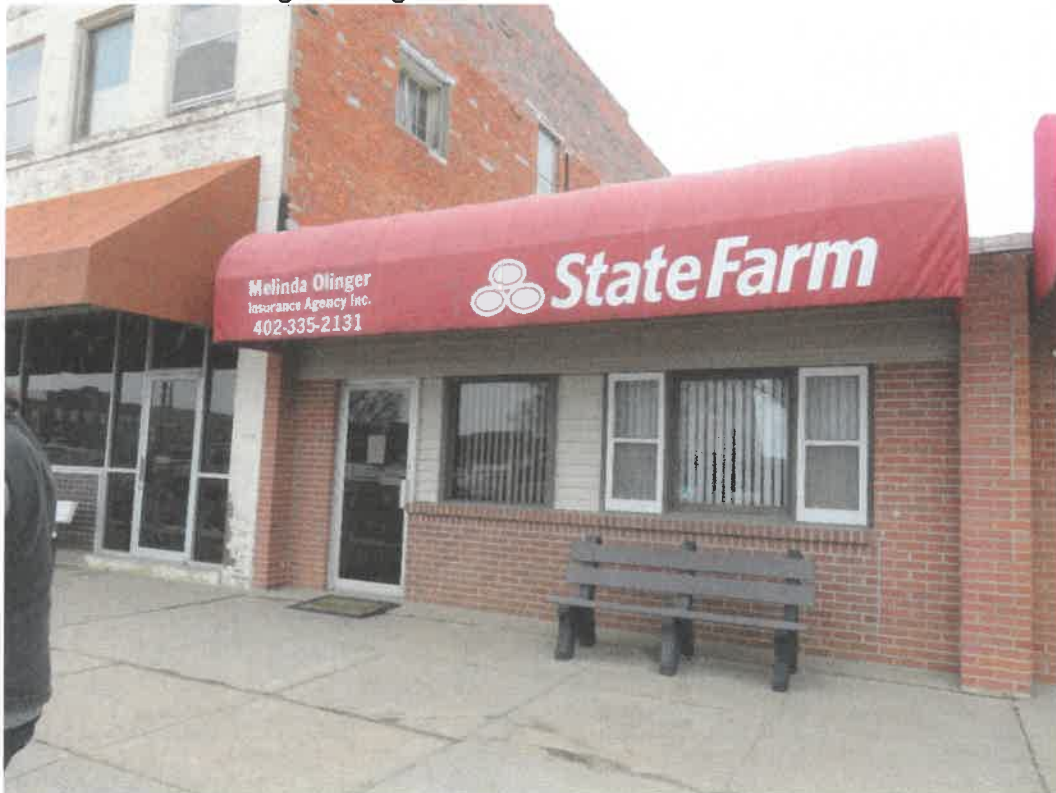
**Photo 36 Building No. 19 – Melinda Olinger State Farm Insurance (380 Broadway St)
Frontage Looking North**

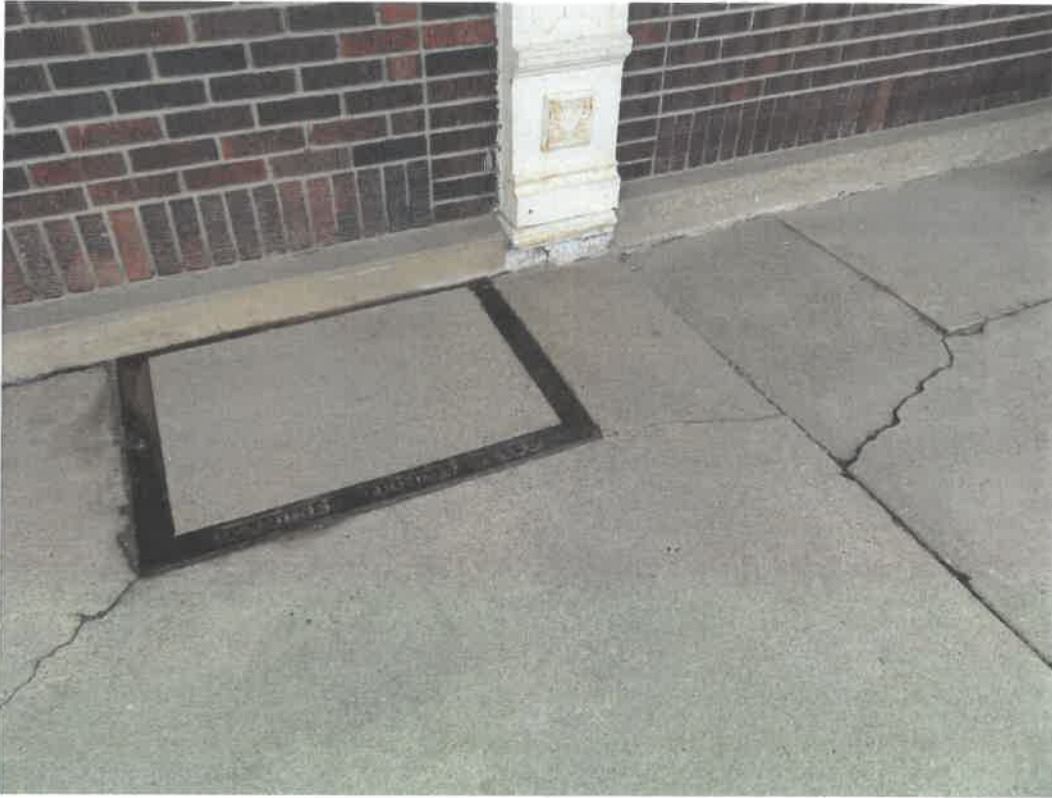
**Photo 39 Building No. 20 – TNT Smoke House (366 Broadway St)
Concrete Filled-In Coal Chute on West Half of Building**

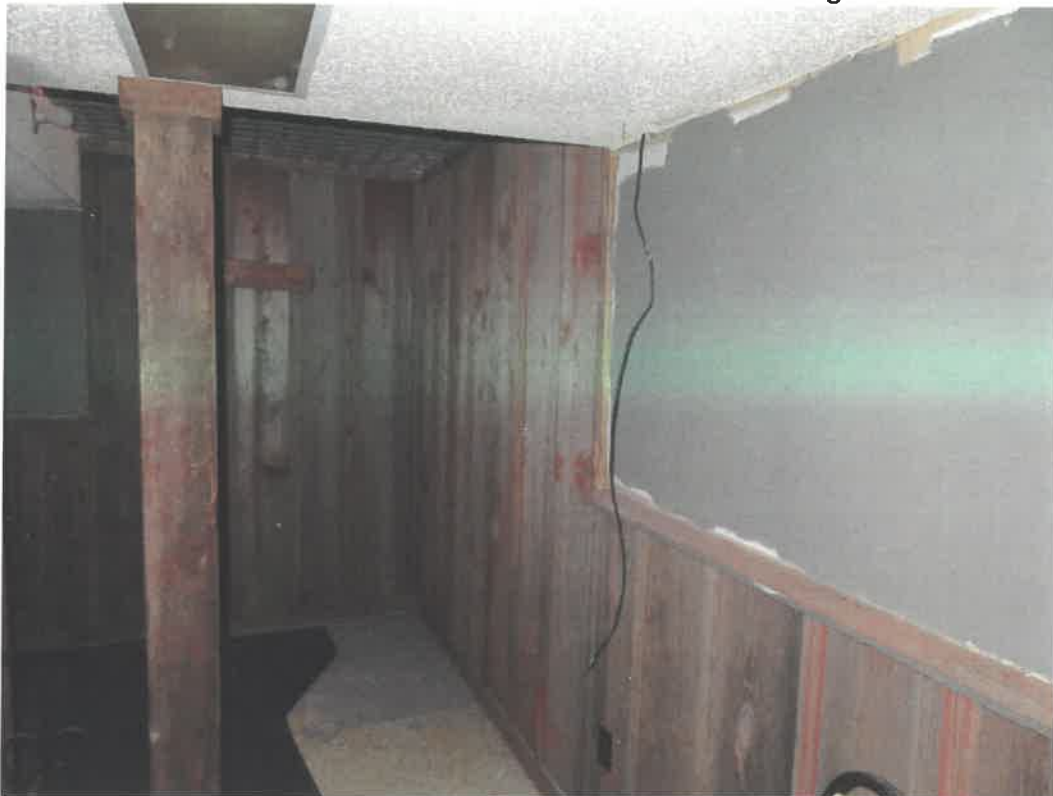
**Photo 40 Building No. 20 – TNT Smoke House (366 Broadway St)
Typical Finish Covering Up Coal Chute on East Half of Building**

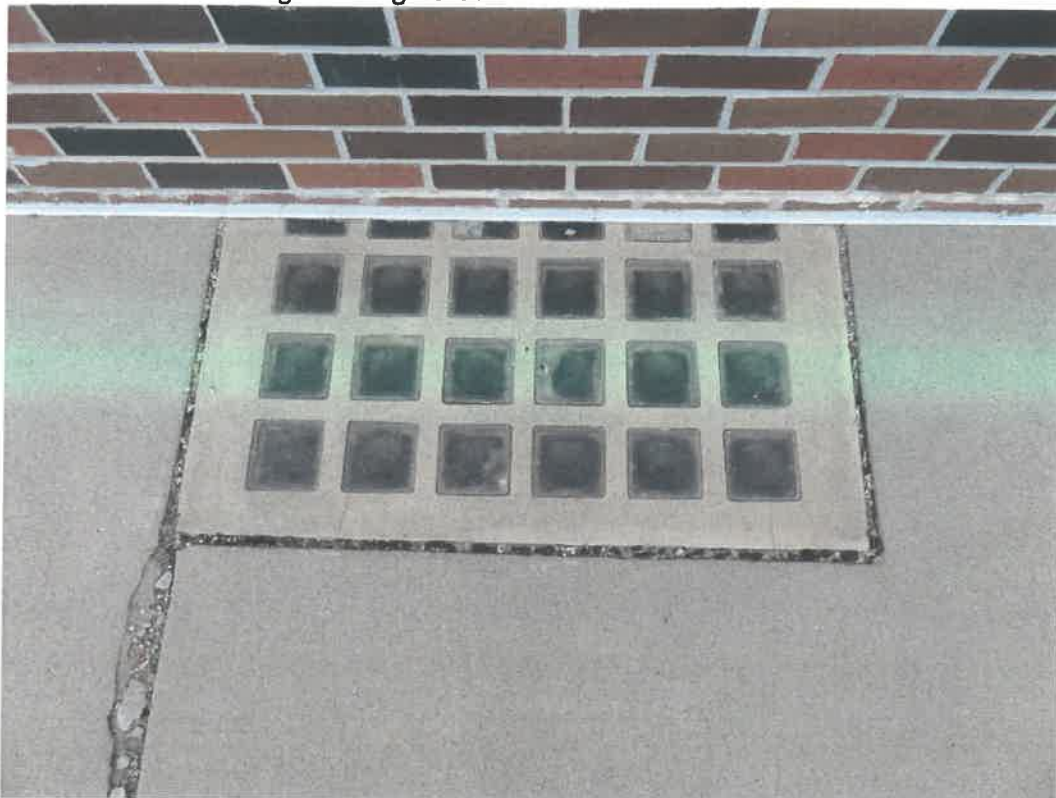
Photo 46 **Building No. 22 – Hopkins Block (340 Broadway St)**
Typical Lightwell in Sidewalk (Typical of 4)

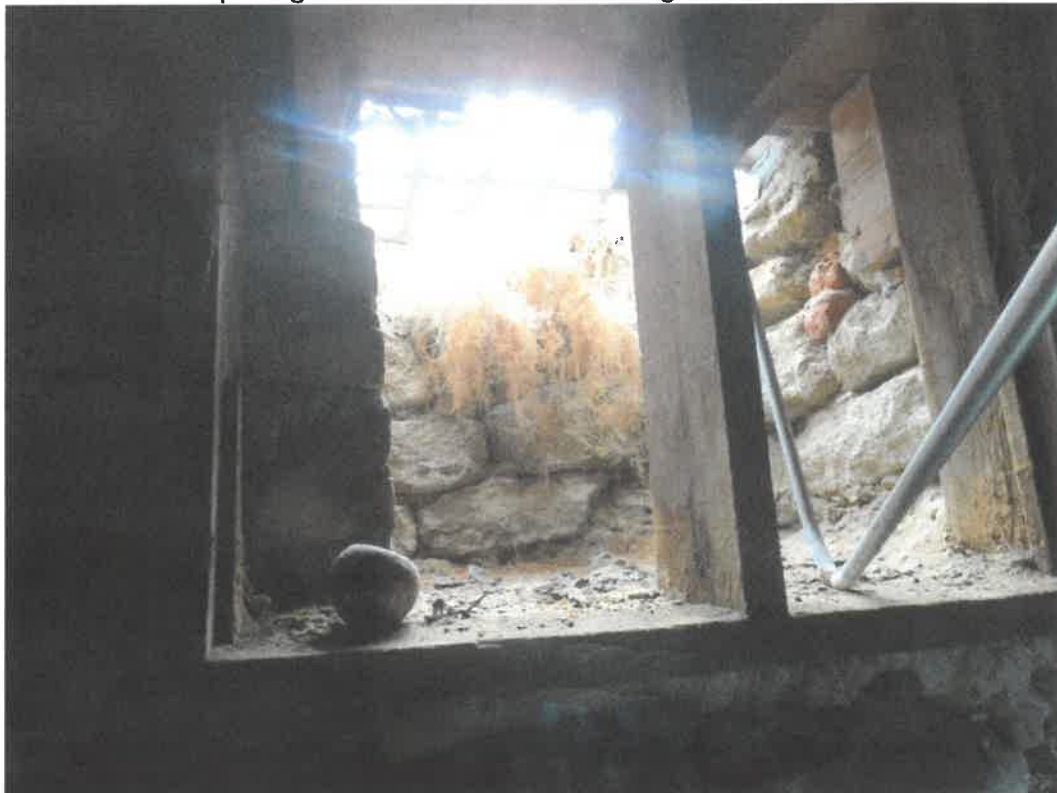
Photo 50 **Building No. 22 – Hopkins Block (340 Broadway St)**
Open Lightwell on West Half of Building

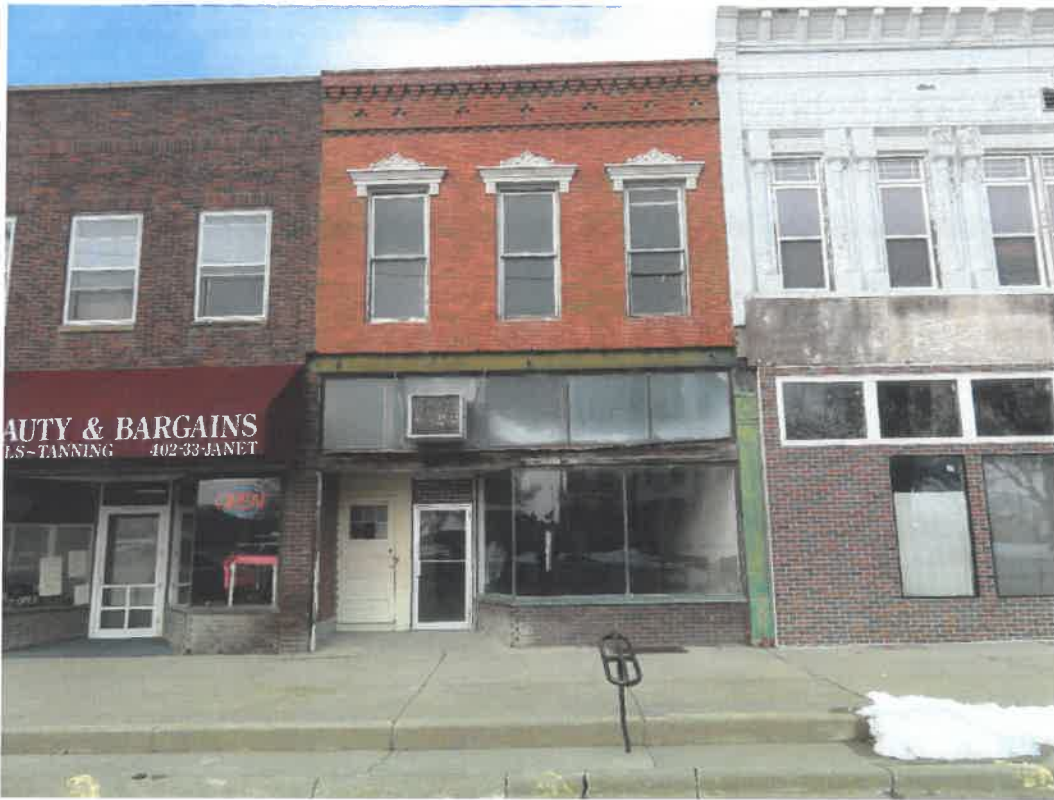
Photo 51 **Building No. 23 – Steve Young Building (334 Broadway St)**
Frontage Looking North

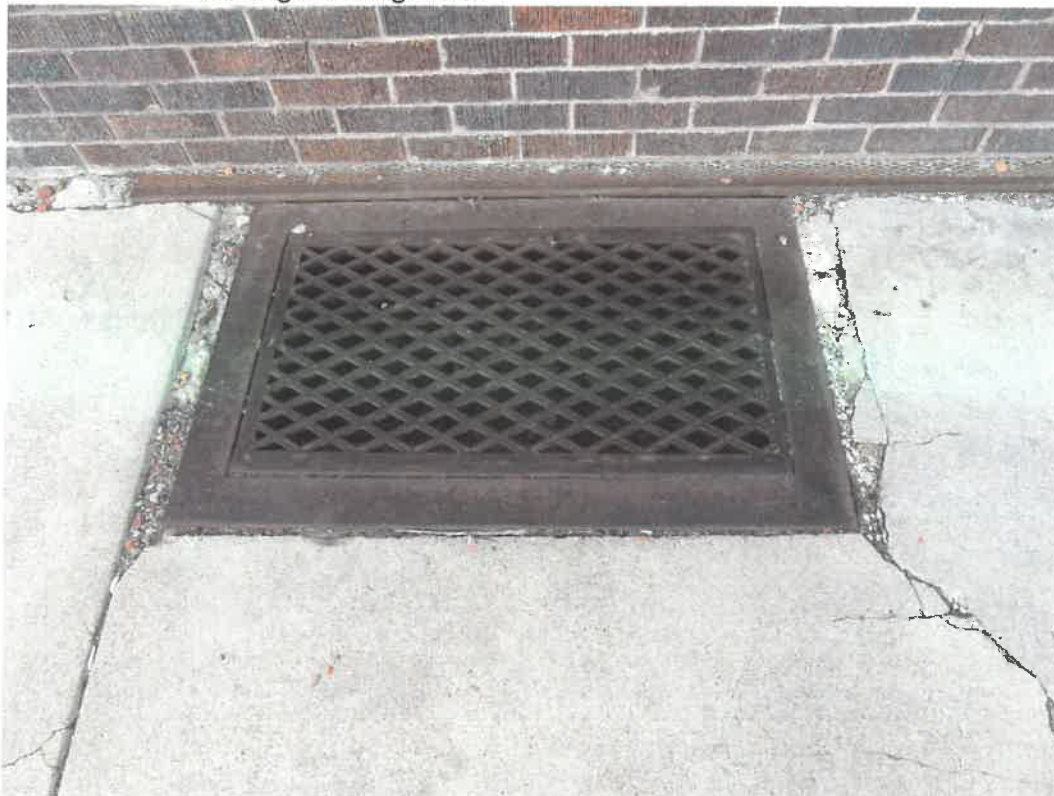
Photo 52 **Building No. 23 – Steve Young Building (334 Broadway St)**
Open Coal Chute in Sidewalk
