OBSERVATION REPORT

Tecumseh Historic Square Preservation – Structural Evaluation

Submitted by Olsson Inc.

February 18, 2022

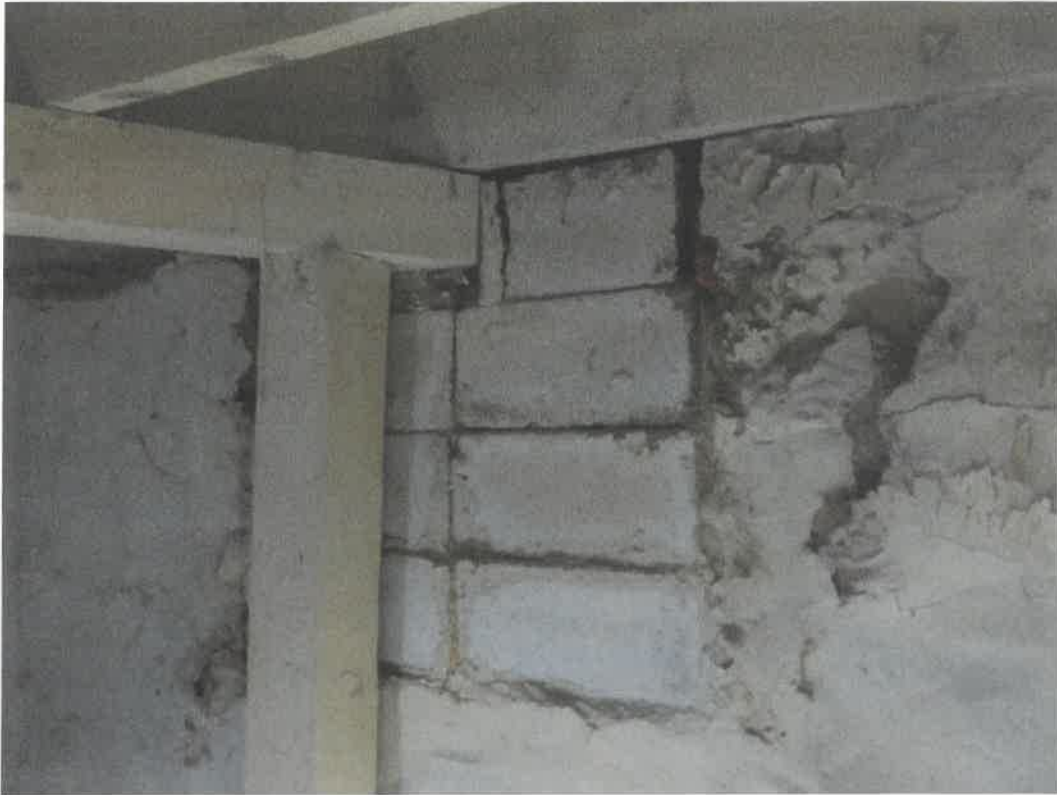
Photo 53 **Building No. 23 – Steve Young Building (334 Broadway St)**
CMU Filled-In Coal Chute in Basement

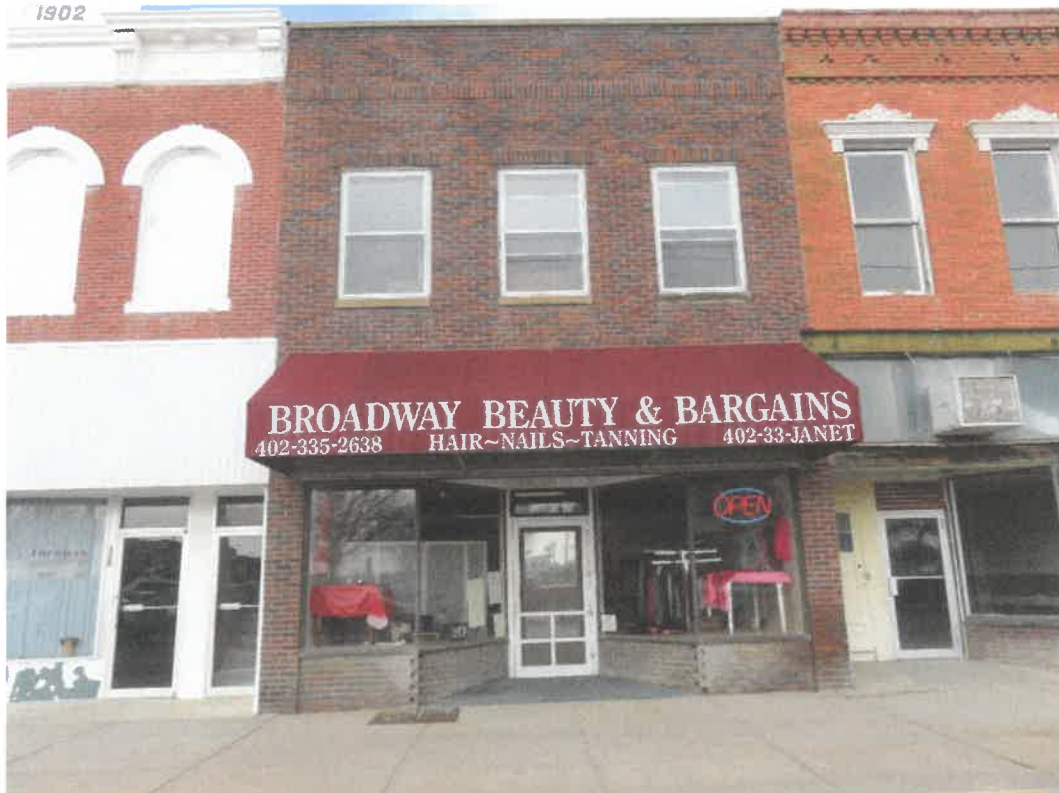
Photo 54 **Building No. 24 – Broadway Beauty & Bargains (318 Broadway St)**
Frontage Looking North

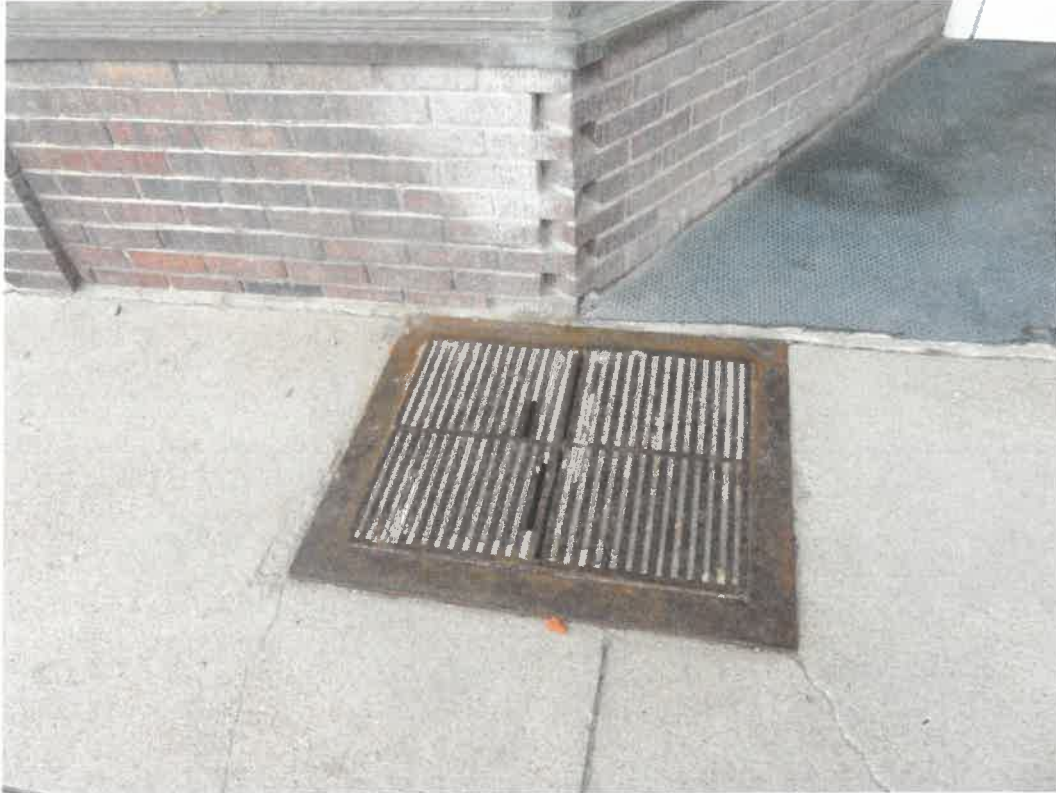
Photo 55 **Building No. 24 – Broadway Beauty & Bargains (318 Broadway St)**
Partially Filled-In Coal Chute in Sidewalk

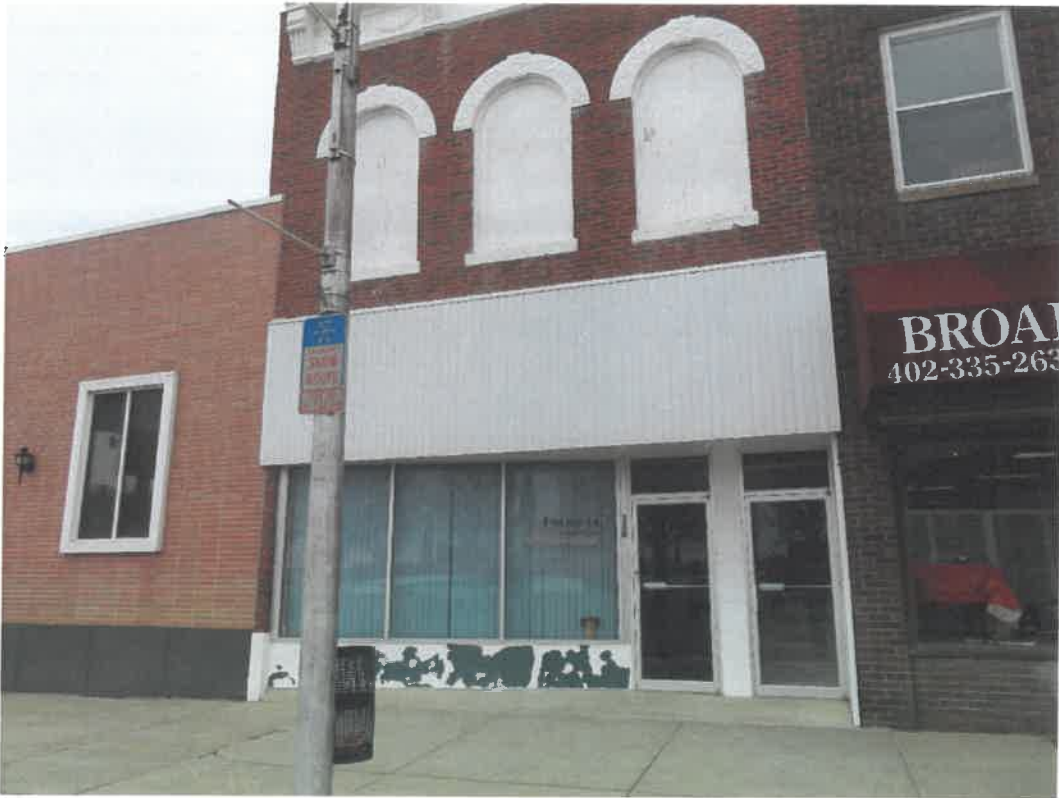
**Photo 57 Building No. 25 – American National Bank – East Annex (310 Broadway St)
Frontage Looking North**

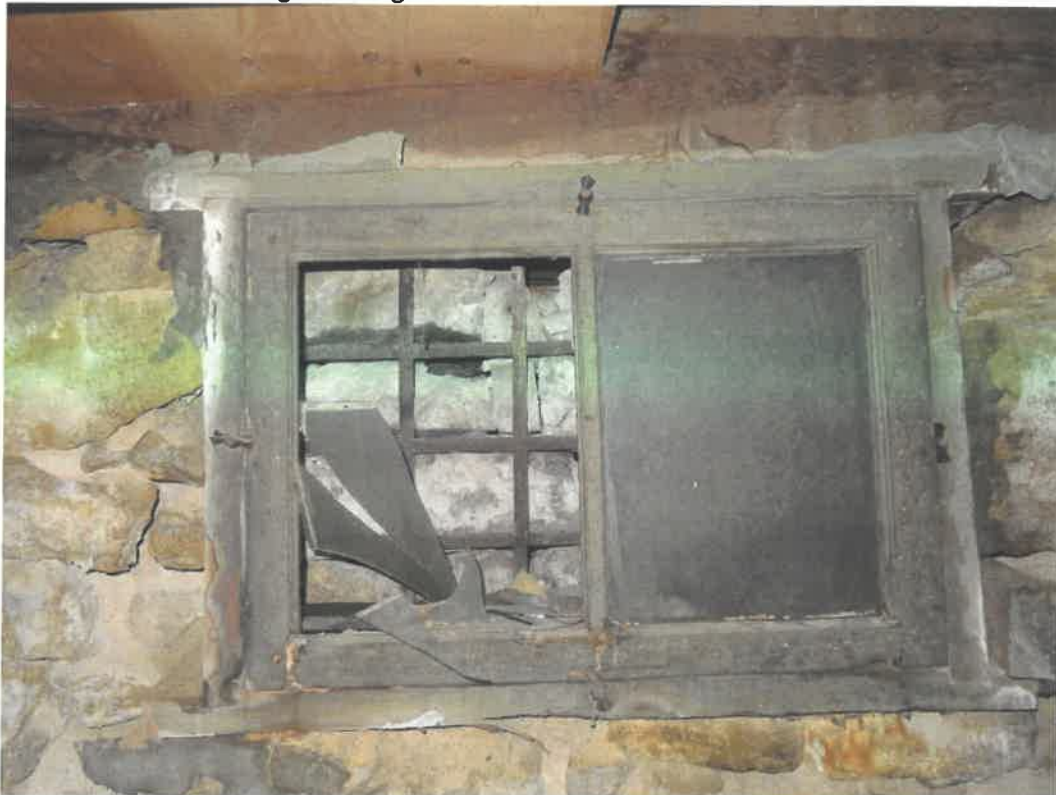
**Photo 58 Building No. 25 – American National Bank – East Annex (310 Broadway St)
Rubble Limestone Filled-In Window in Basement**

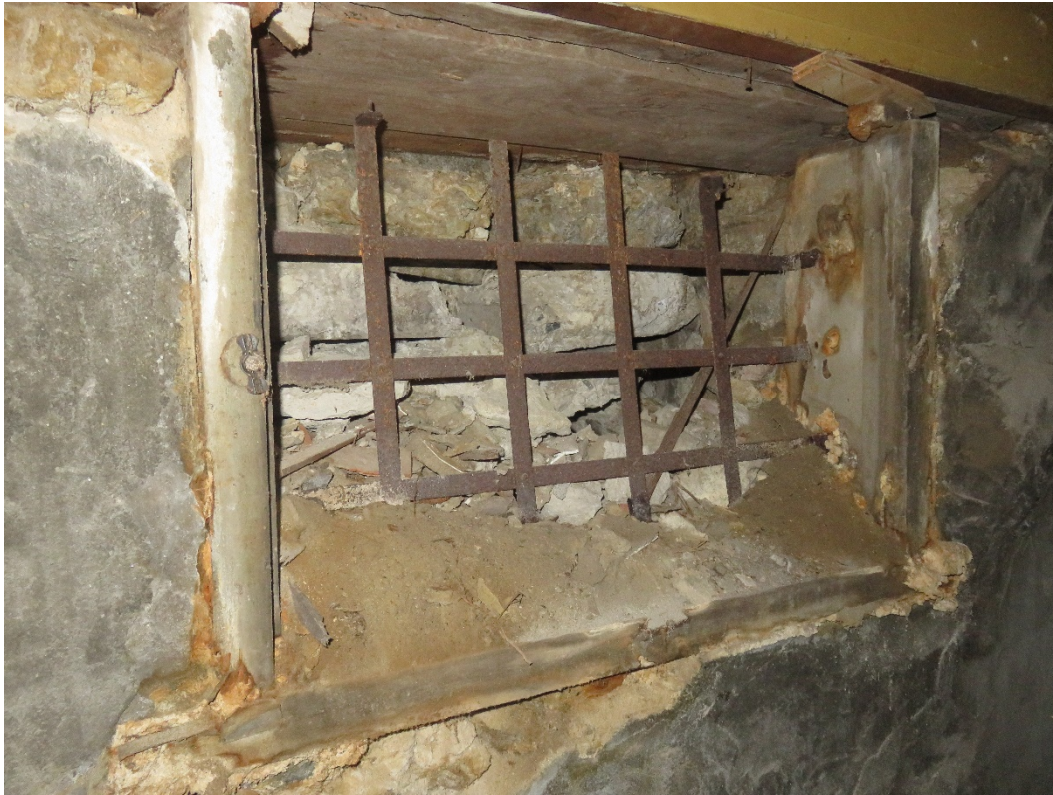
Photo 59 **Building No. 25 – American National Bank – East Annex (310 Broadway St)**
Rubble Limestone Filled-In Window in Basement

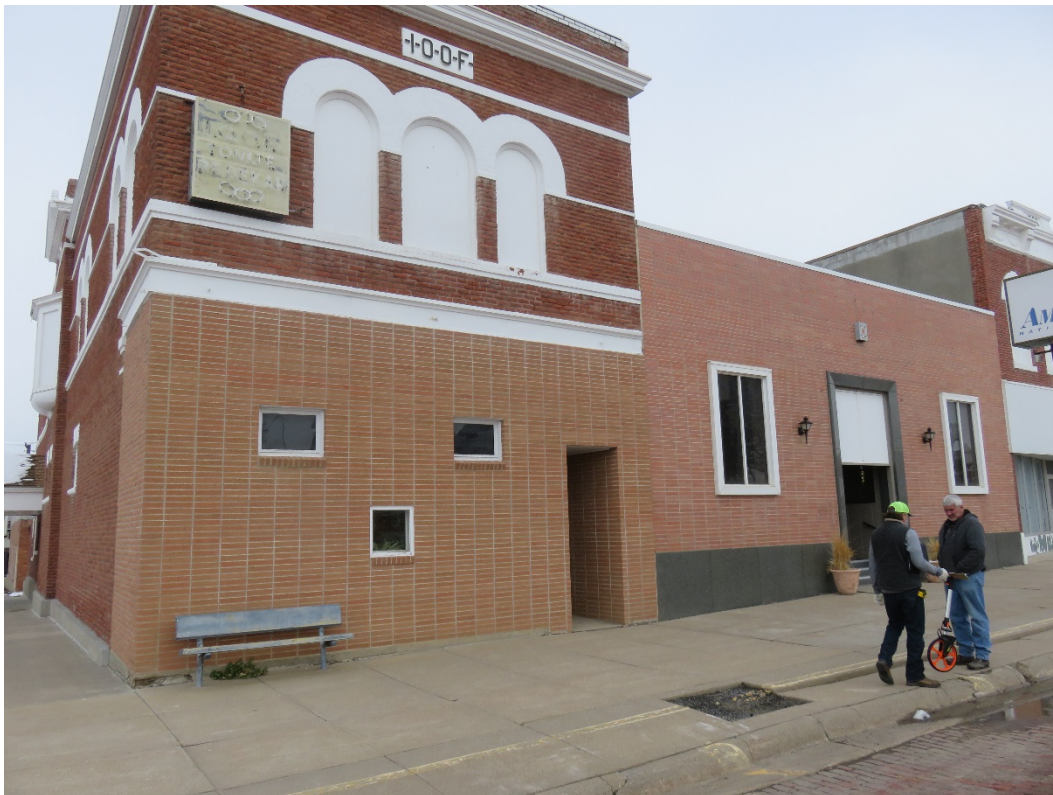
Photo 60 **Building No. 26 – American National Bank (306/310 Broadway St)**
Frontage Looking North

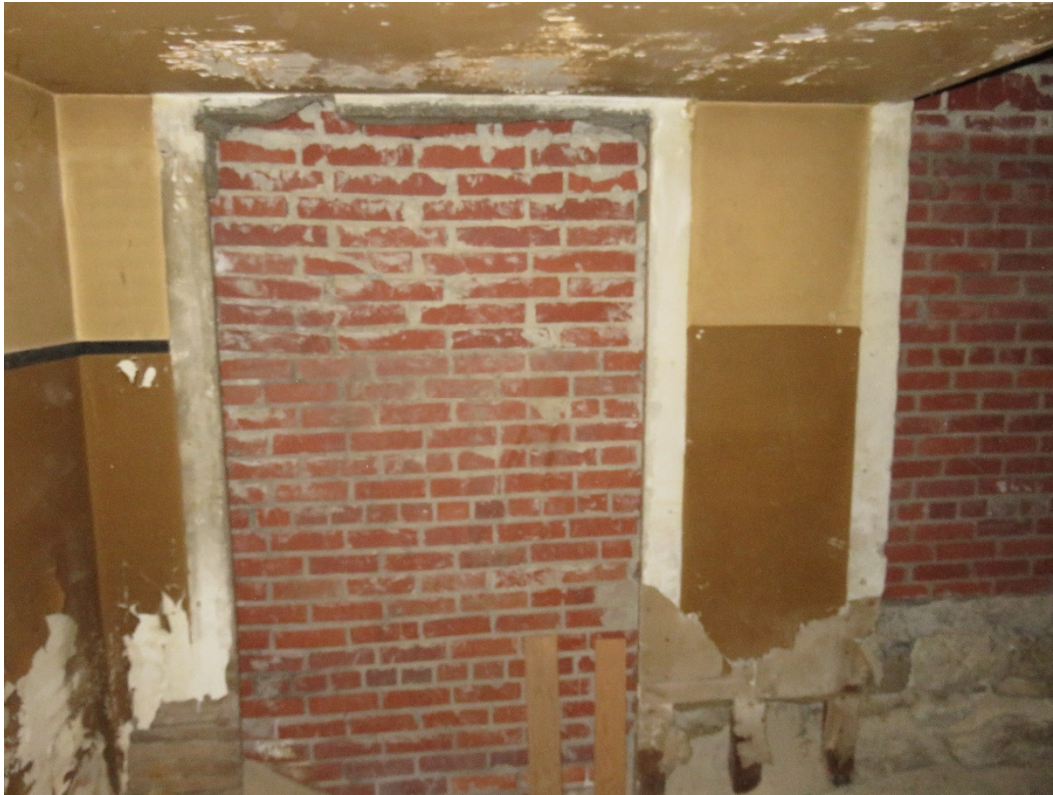
**Photo 61 Building No. 26 – American National Bank (306/310 Broadway St)
Brick Filled-In Vault at East End of South Wall in Basement**

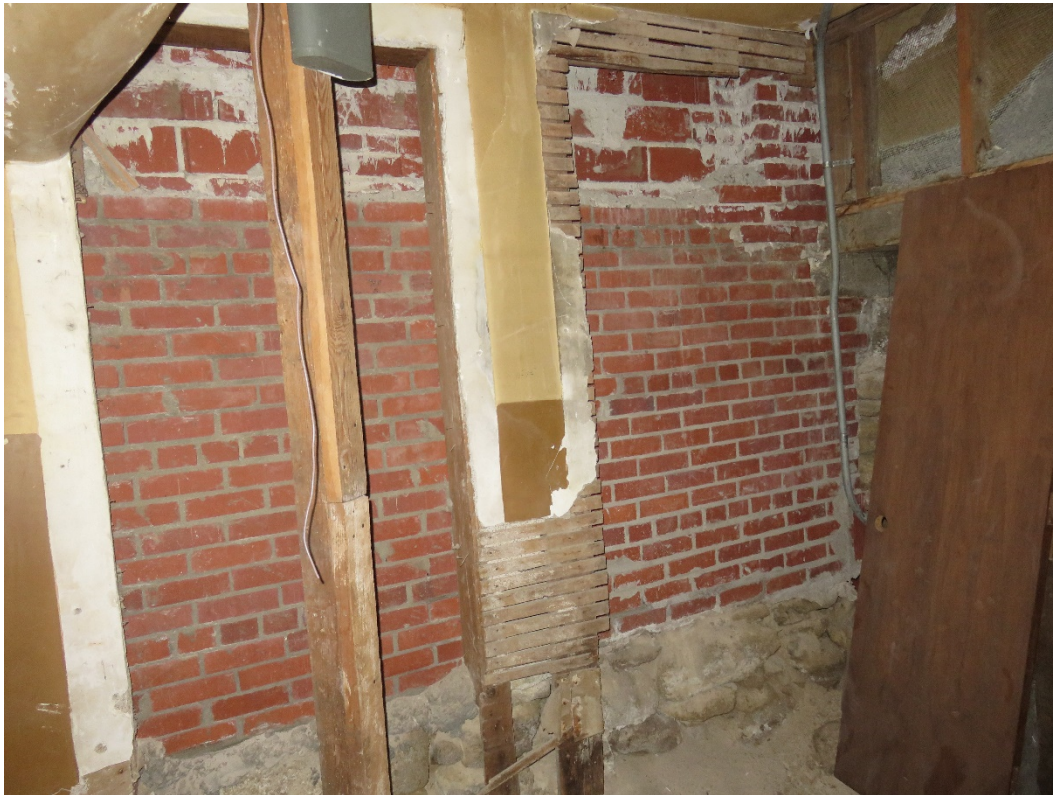
**Photo 62 Building No. 26 – American National Bank (306/310 Broadway St)
Brick Filled-In Vault at West End of South Wall in Basement**

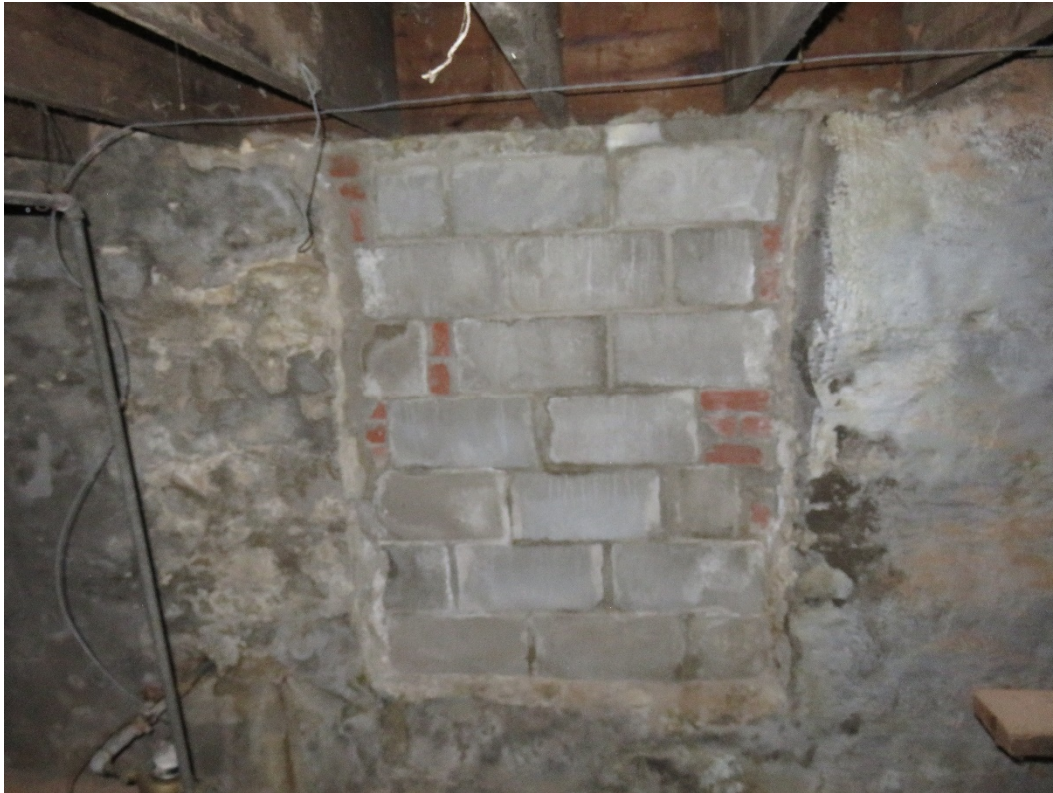
Photo 63 **Building No. 26 – American National Bank (306/310 Broadway St)**
CMU/Brick Filled-In Window at South End of West Wall in Basement

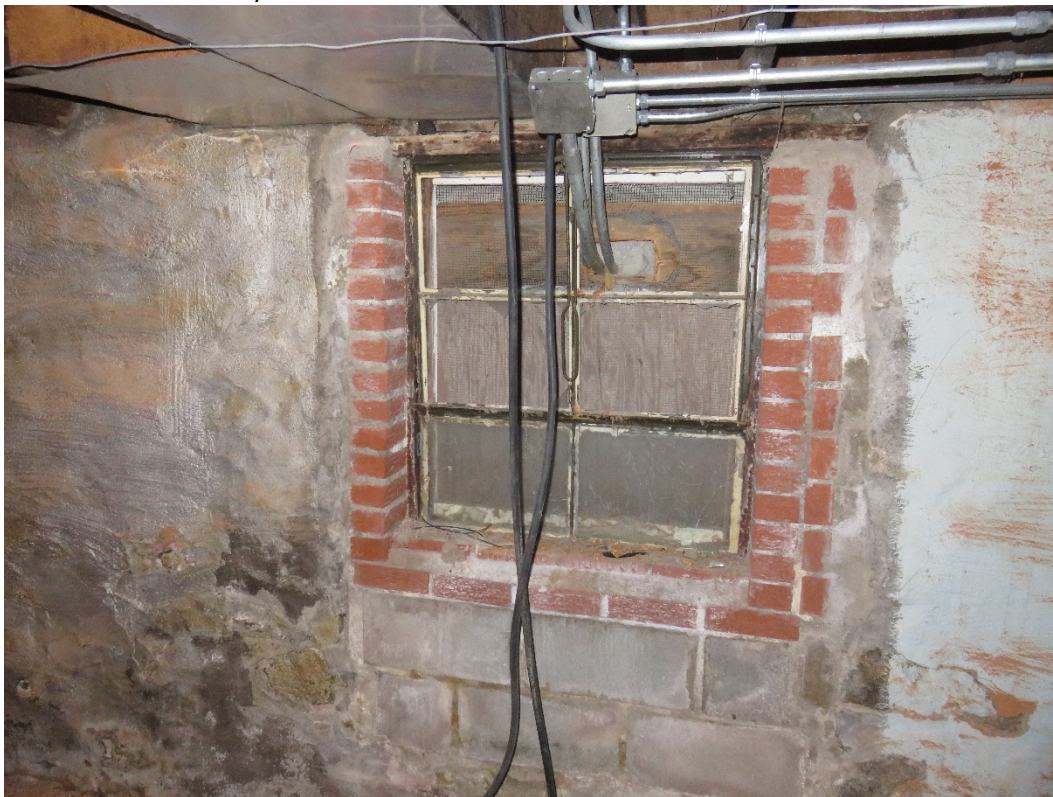
Photo 64 **Building No. 26 – American National Bank (306/310 Broadway St)**
Partially Brick Filled-In Window at North End of West Wall in Basement

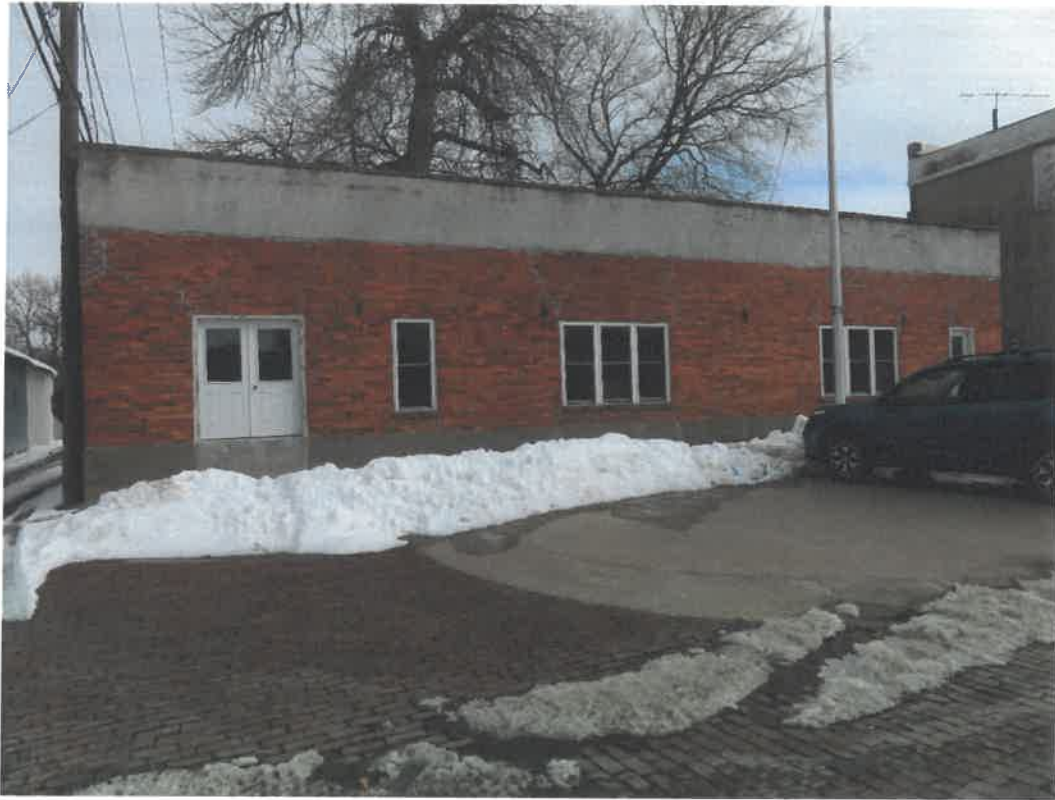
Building No. 27 – Keith Shuey Building, 130 N. Third Street (Photo 65)

**Photo 65 Building No. 27 – Keith Shuey Building (130 N 3rd St)
Frontage Looking East**

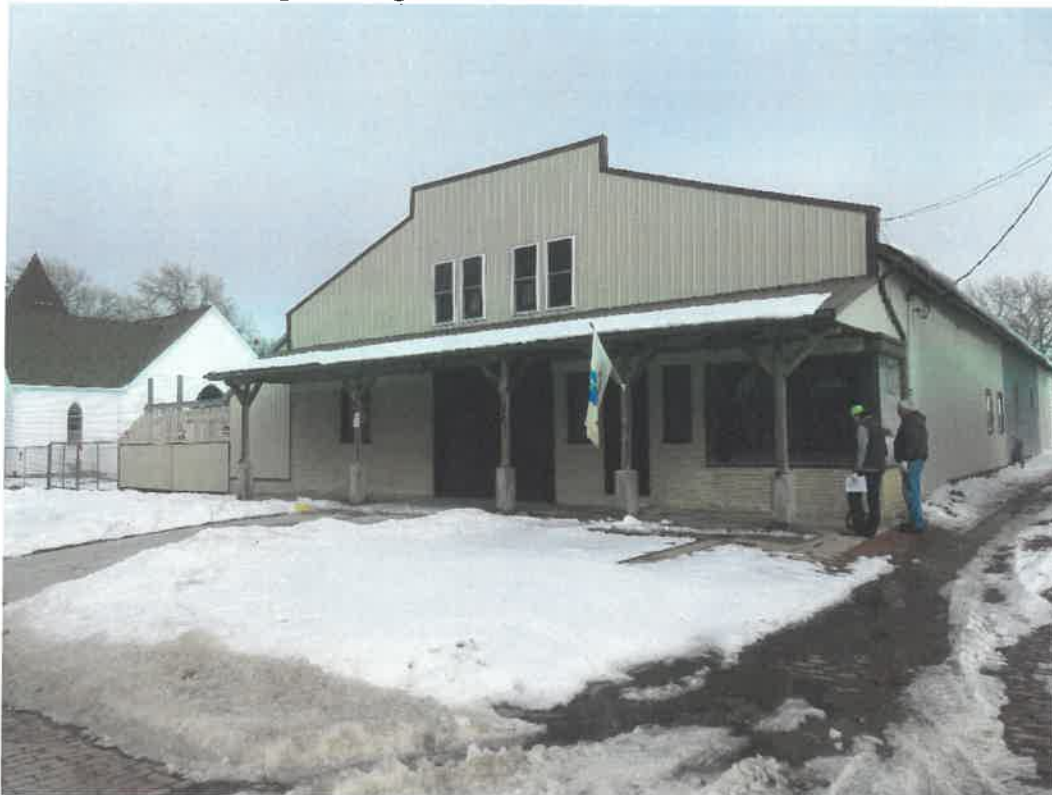
Building No. 28 – Greg Liberty Building, 132 N. Third Street (Photo 66)

**Photo 66 Building No. 28 – Greg Liberty Building (132 N 3rd St)
Frontage Looking Northeast**

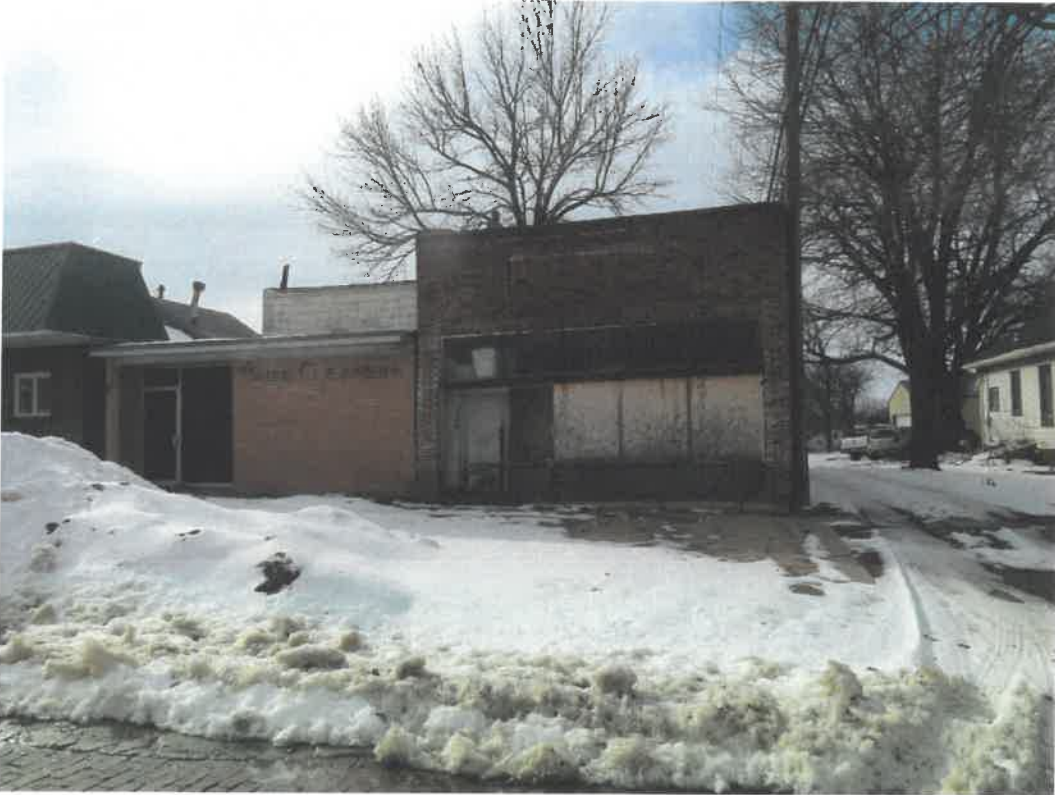
**Photo 67 Building No. 29 – 4 Building Complex (121 N 3rd St -Southern Most Building)
Frontage of Northern Two Buildings Looking West**

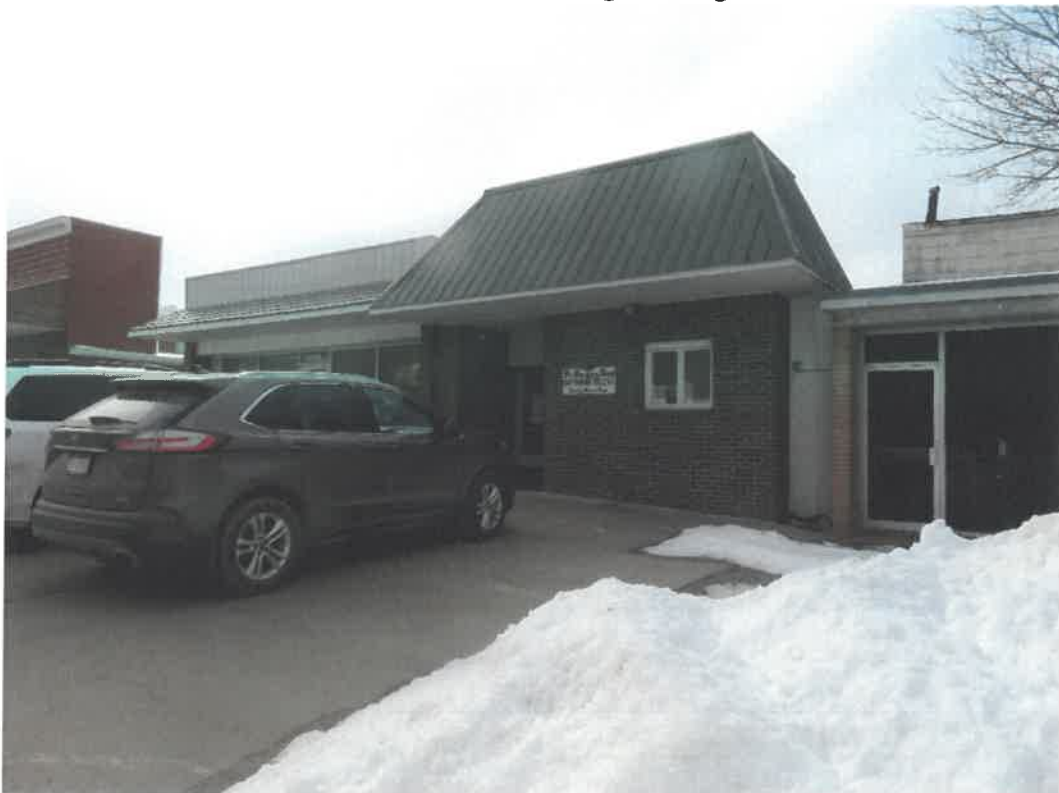
**Photo 68 Building No. 29 – 4 Building Complex (121 N 3rd St -Southern Most Building)
Frontage of Southern Two Buildings Looking West**

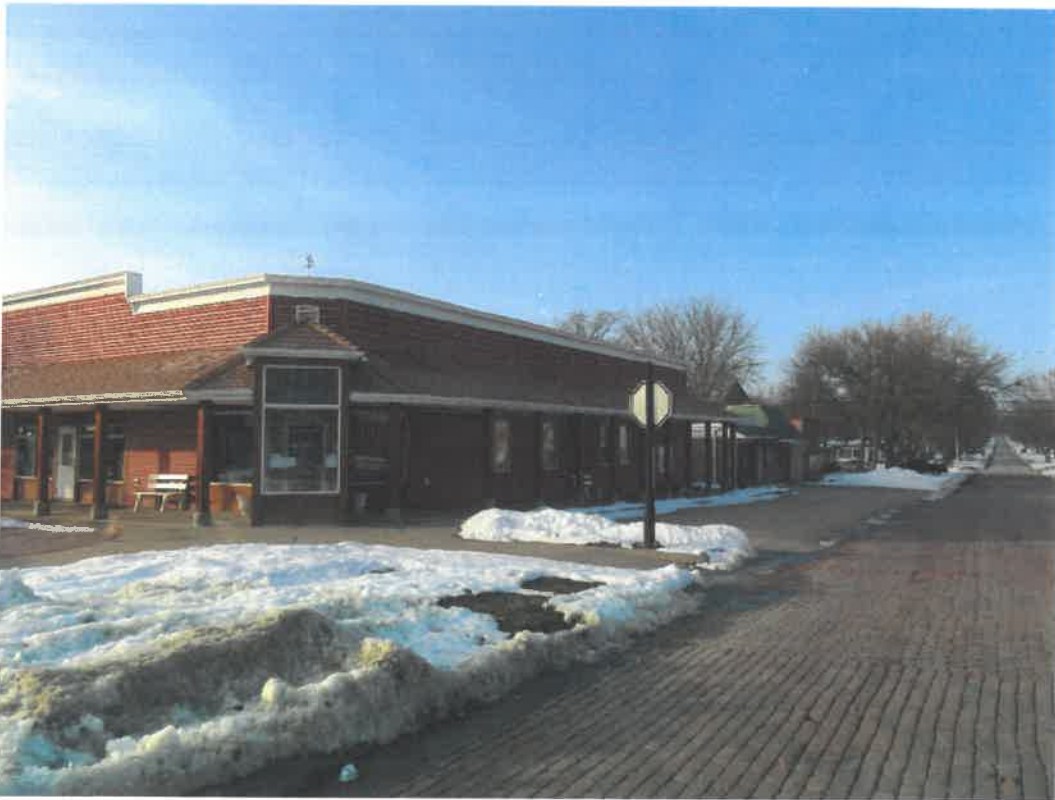
**Photo 69 Building No. 30 – Johnson Co. Hospital Home Healthcare (292 Broadway St)
Frontage Along North 3rd Street Looking Northwest**

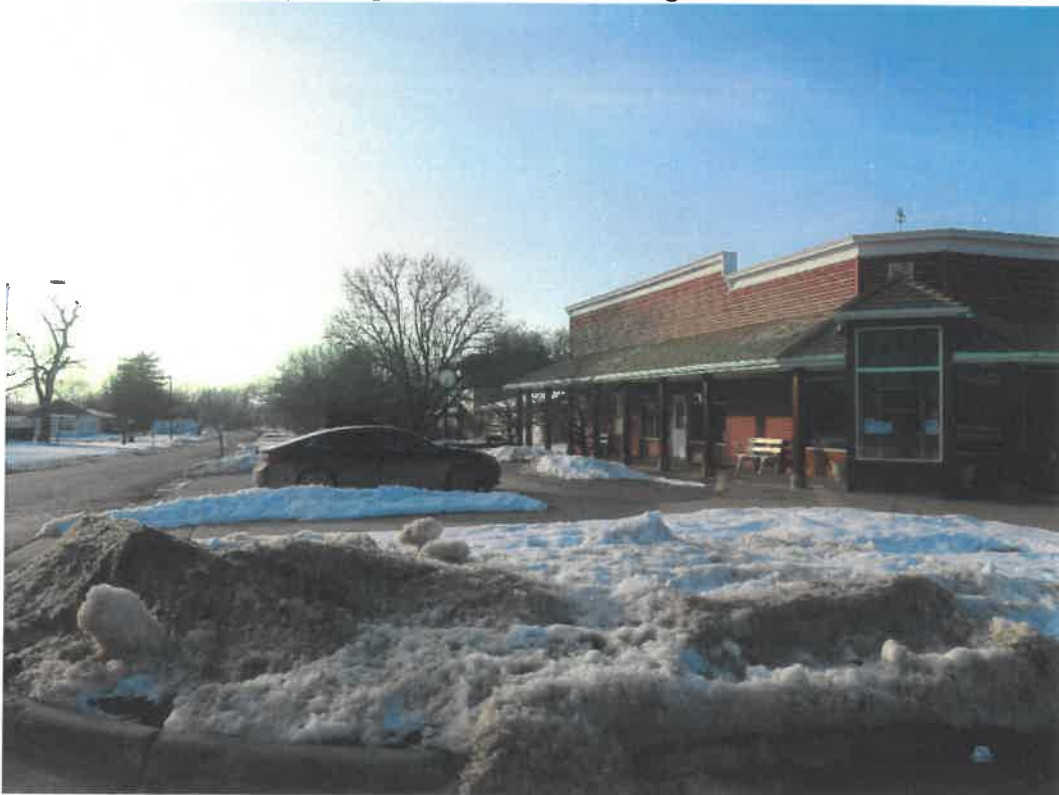
**Photo 70 Building No. 30 – Johnson Co. Hospital Home Healthcare (292 Broadway St)
Frontage Along Broadway Street Looking Northwest**

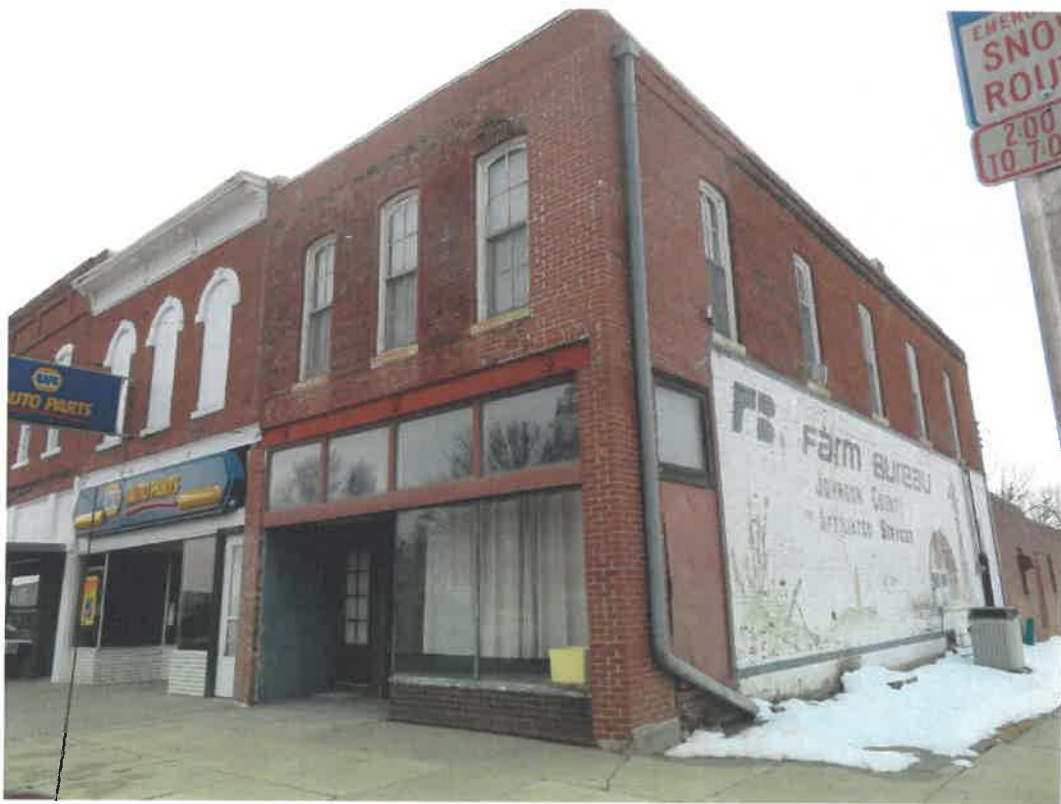
Building No. 31 – Jeff Mahoney Building, 107 S. Third Street (Photo 71)

**Photo 71 Building No. 31 – Jeff Mahoney Building (107 S 3rd St)
Frontage Looking Southwest**

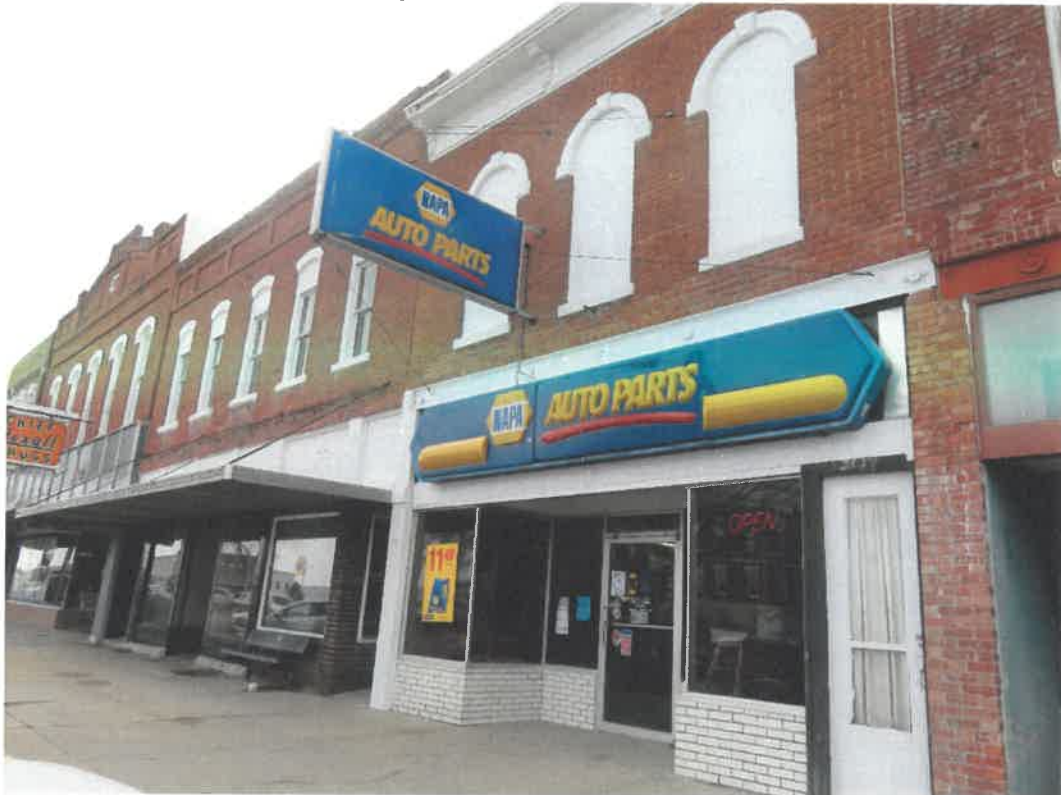
Building No. 32/32A – NAPA Auto Parts, 109 S. Third Street (Photo 72)

**Photo 72 Building No. 32 – NAPA Auto Parts (109 S 3rd St)
Frontage Looking Southwest**

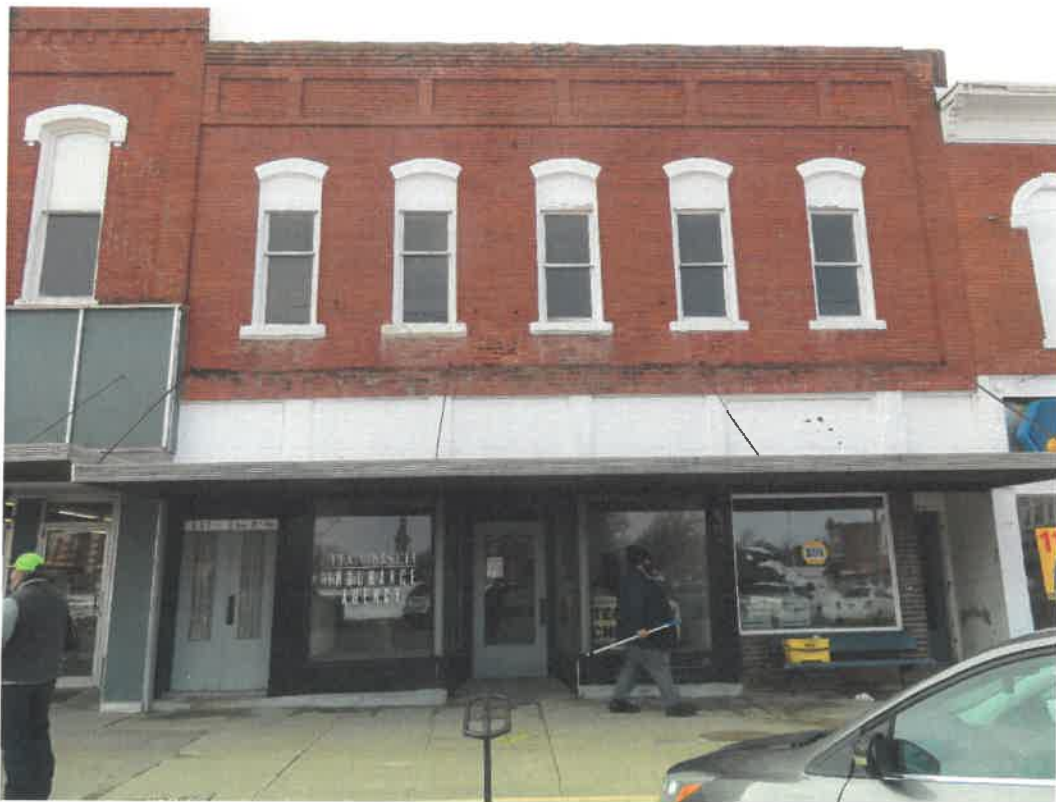
**Photo 73 Building No. 33 – Tecumseh Chieftain (117 S 3rd St)
Frontage Looking West**

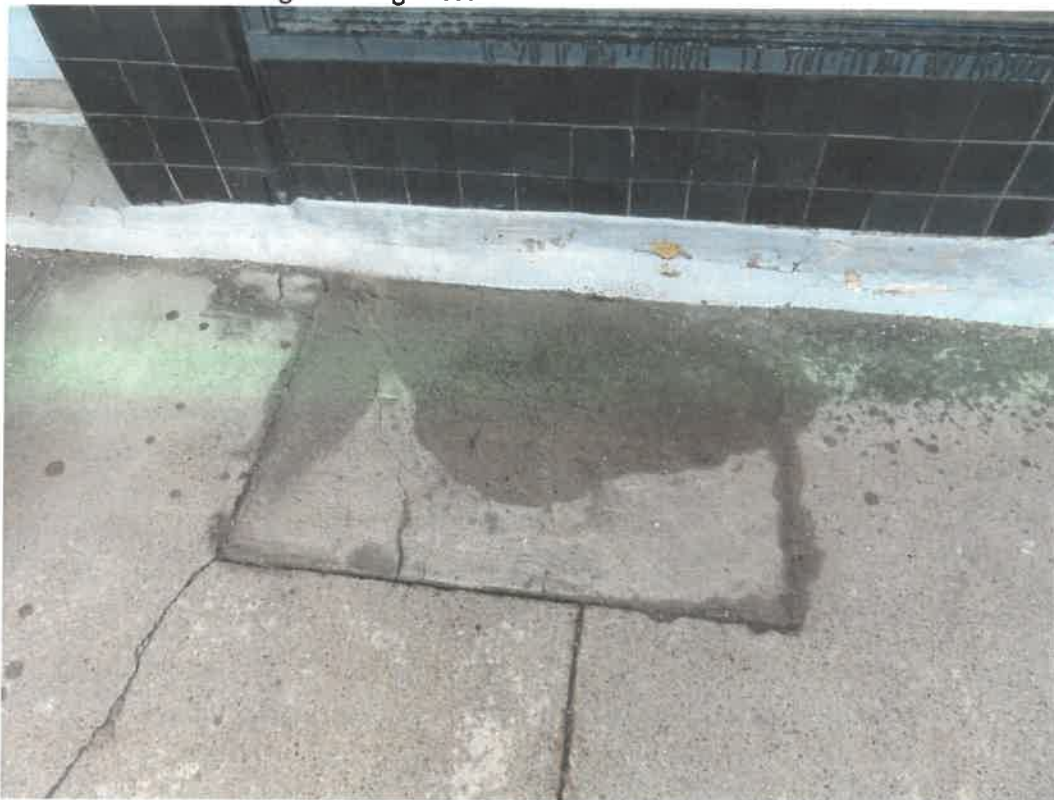
**Photo 74 Building No. 33 – Tecumseh Chieftain (117 S 3rd St)
Concrete Filled-In Coal Chute in Sidewalk**

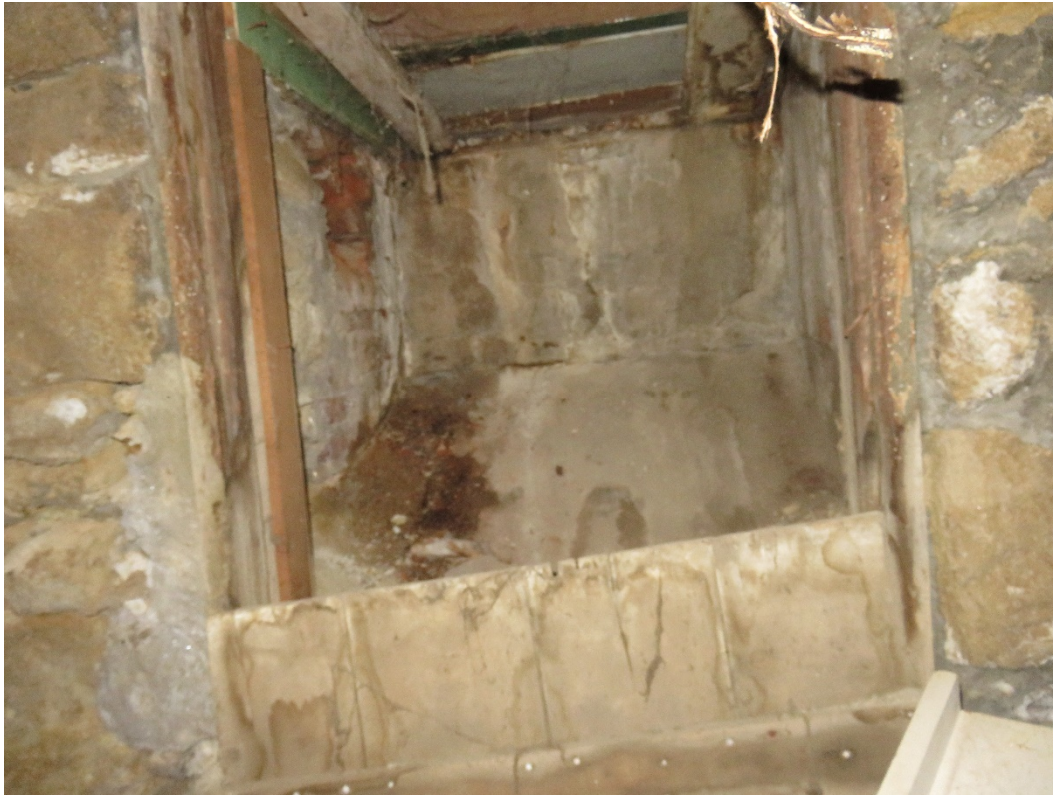
**Photo 75 Building No. 33 – Tecumseh Chieftain (117 S 3rd St)
Open Coal Chute in Basement**

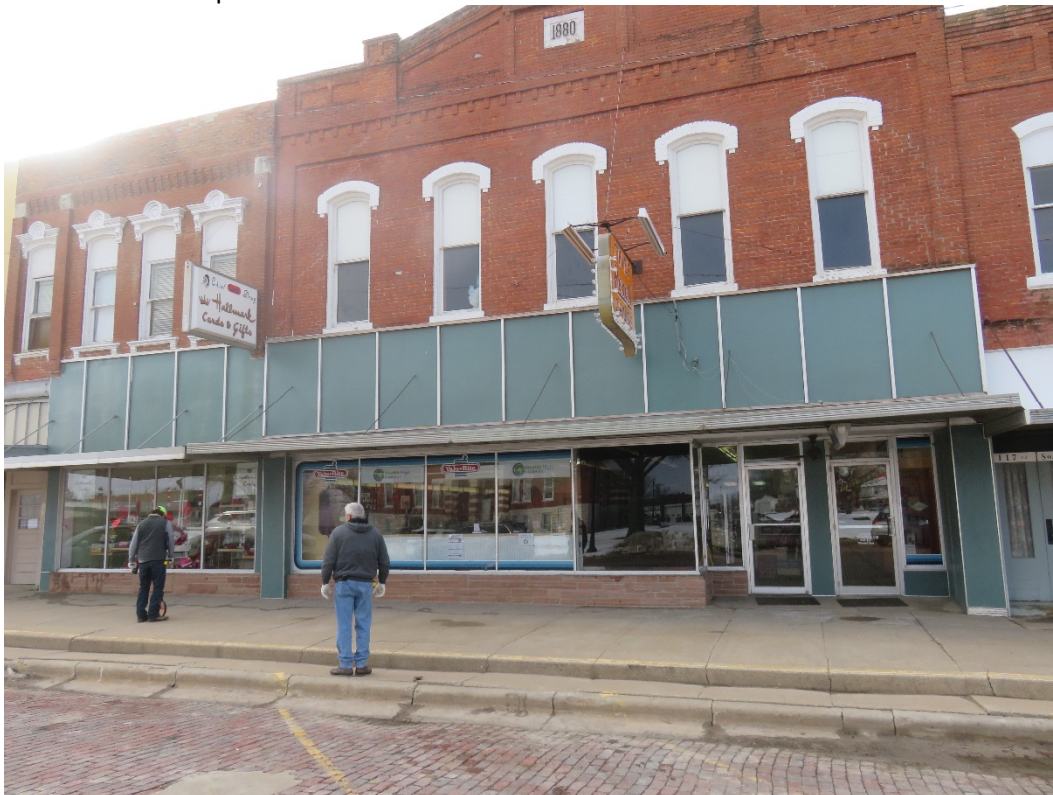
**Photo 76 Building No. 34 – Chief Rexall Drugs (123/125 S 3rd St)
Frontage Looking West**

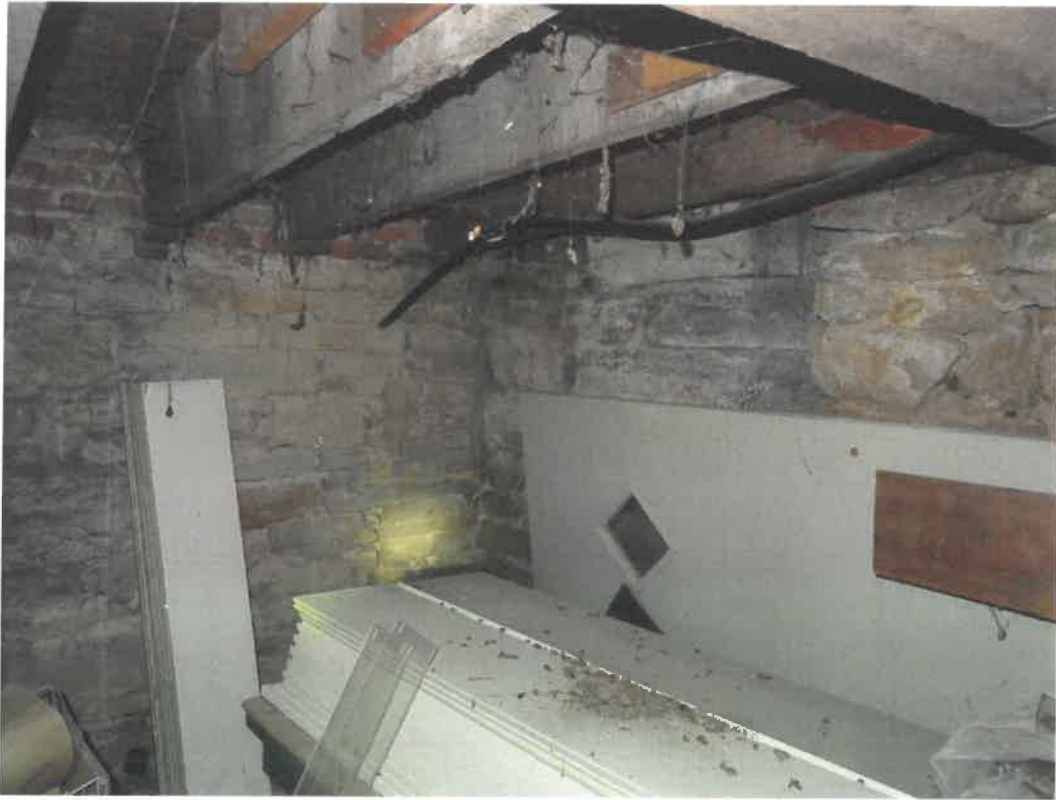
**Photo 77 Building No. 34 – Chief Rexall Drugs (123 S 3rd St)
Limestone Filled-In Coal Chute in Basement**

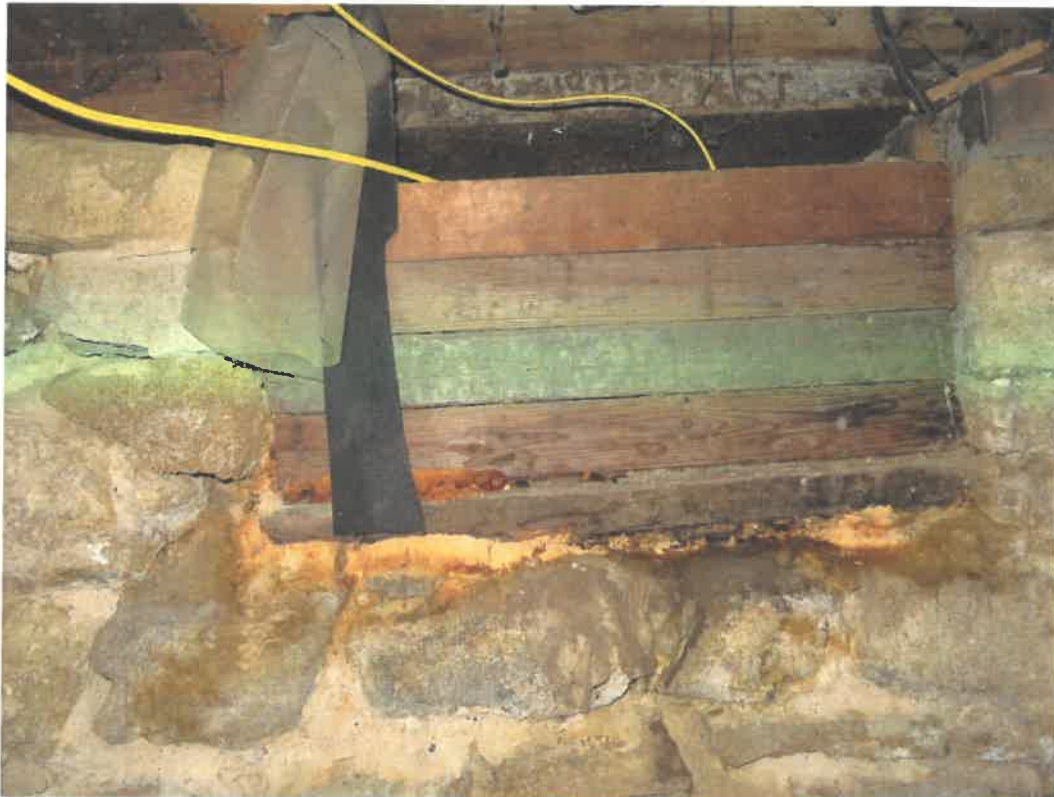
**Photo 78 Building No. 34 – Chief Rexall Drugs (123 S 3rd St)
Wood Plank Filled-In Coal Chute in Basement**

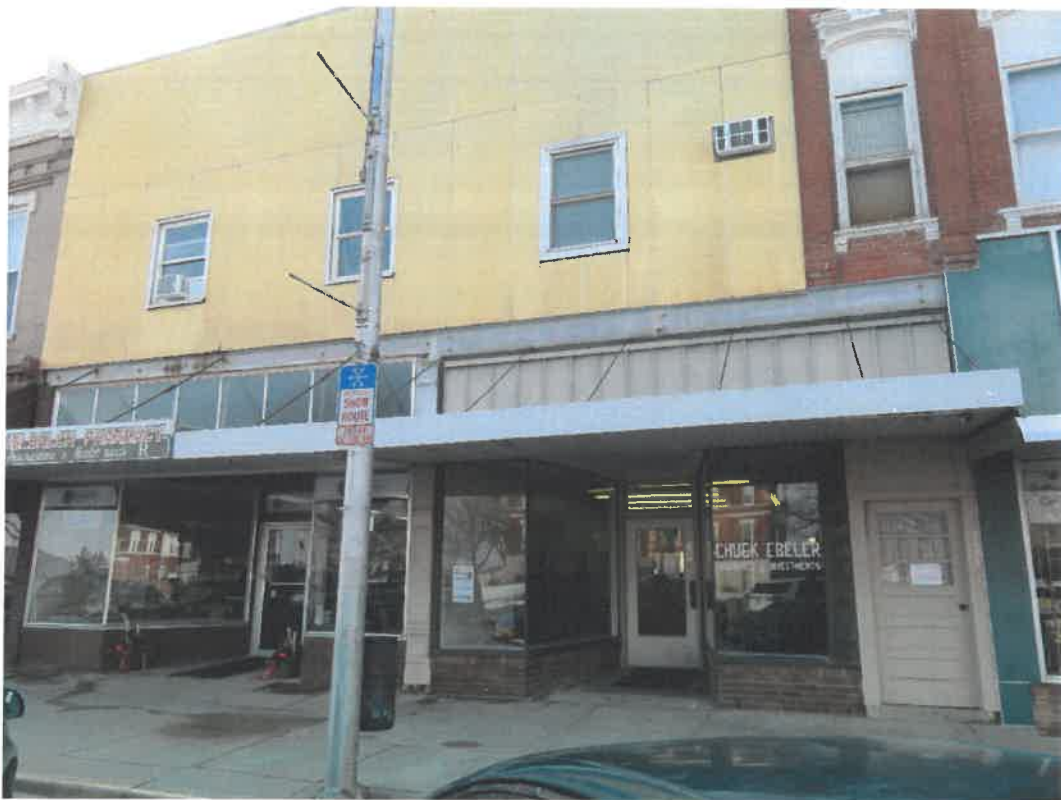
**Photo 79 Building No. 35 – Chuck Ebeler Insurance & Investments (137 S 3rd St)
Frontage Looking West**
