OBSERVATION REPORT

Tecumseh Historic Square Preservation – Structural Evaluation

Submitted by Olsson Inc.

February 18, 2022

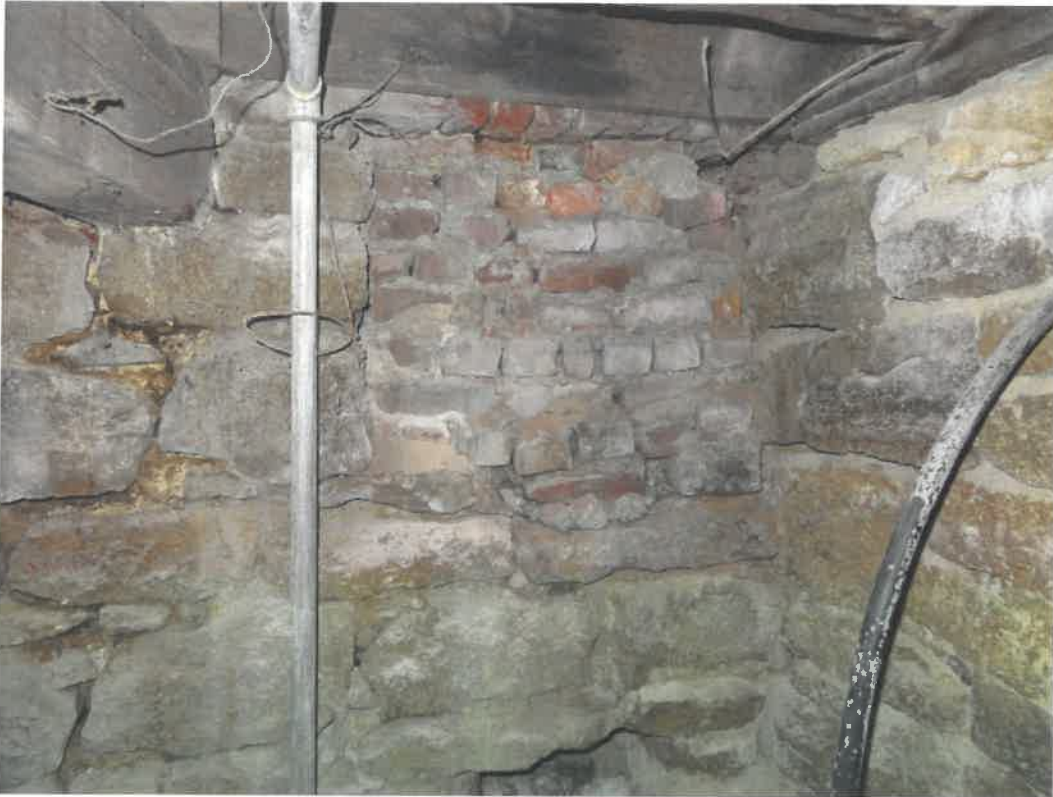
**Photo 81 Building No. 35 – Chuck Ebeler Insurance & Investments (137 S 3rd St)
Limestone/Brick Filled-In Coal Chute in Basement**

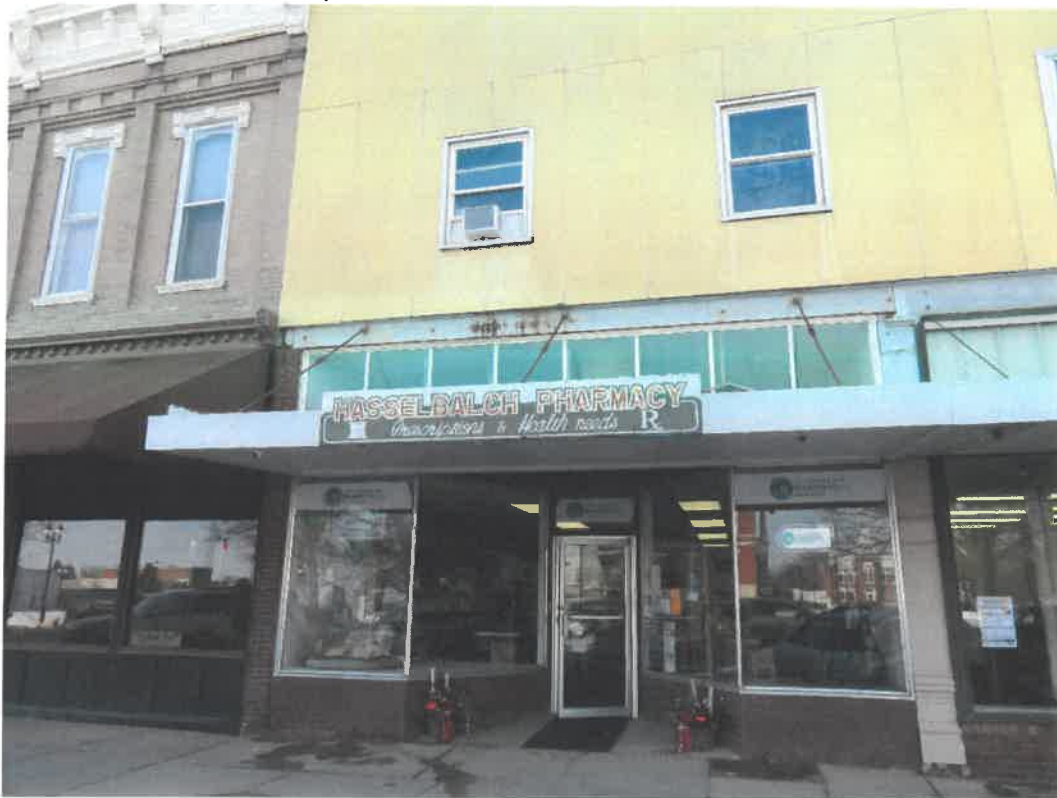
**Photo 82 Building No. 36 – Hasselbach Pharmacy (143 S 3rd St)
Frontage Looking West**

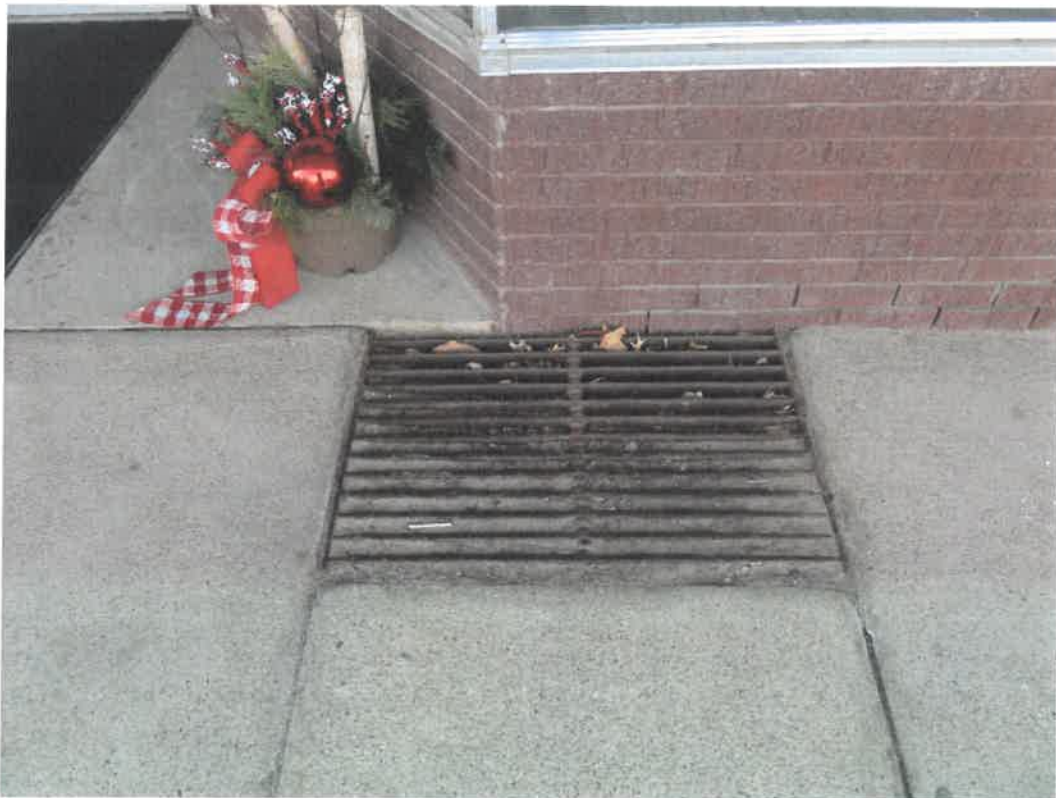
**Photo 83 Building No. 36 – Hasselbach Pharmacy (143 S 3rd St)
Soil Filled-In Coal Chute in Sidewalk**

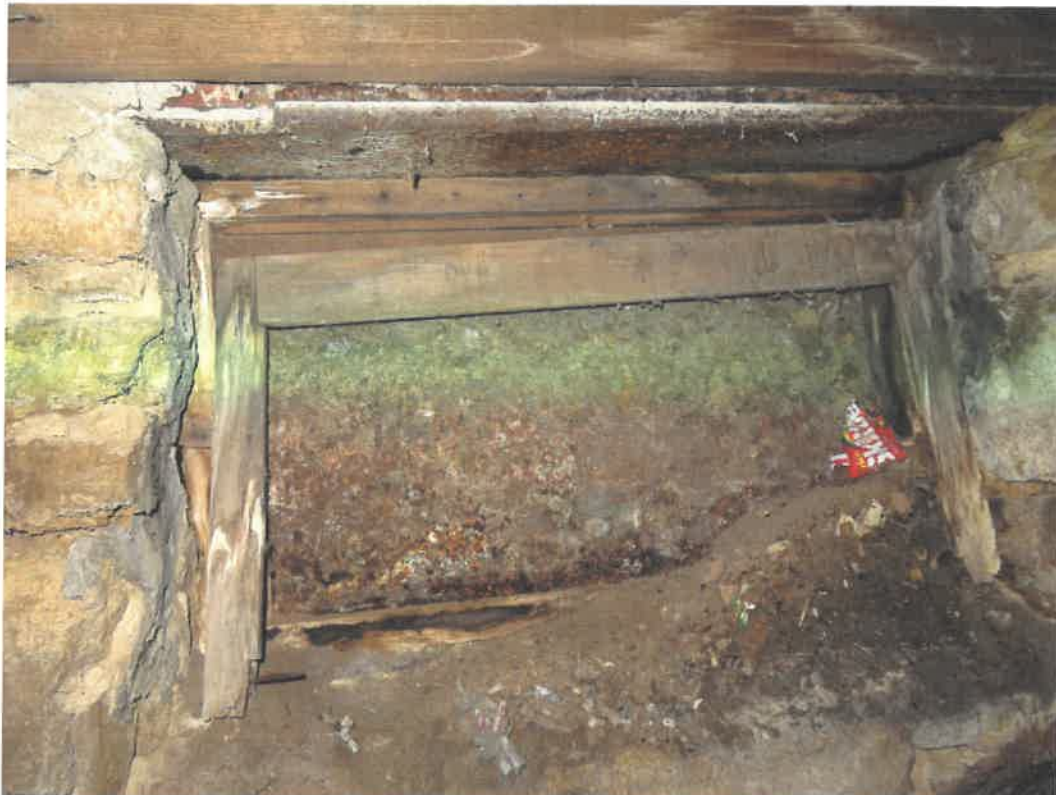
**Photo 84 Building No. 36 – Hasselbach Pharmacy (143 S 3rd St)
Soil Filled-In Window in Basement**

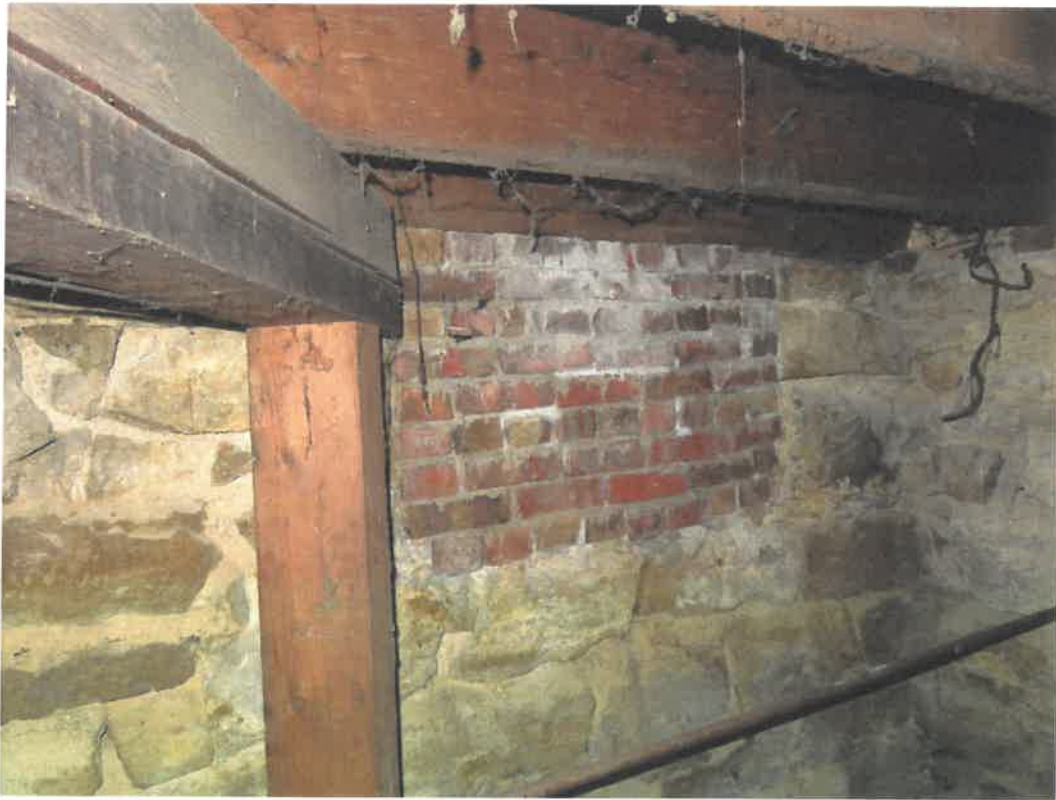
**Photo 85 Building No. 36 – Hasselbach Pharmacy (143 S 3rd St)
Brick Filled-In Coal Chute in Basement**

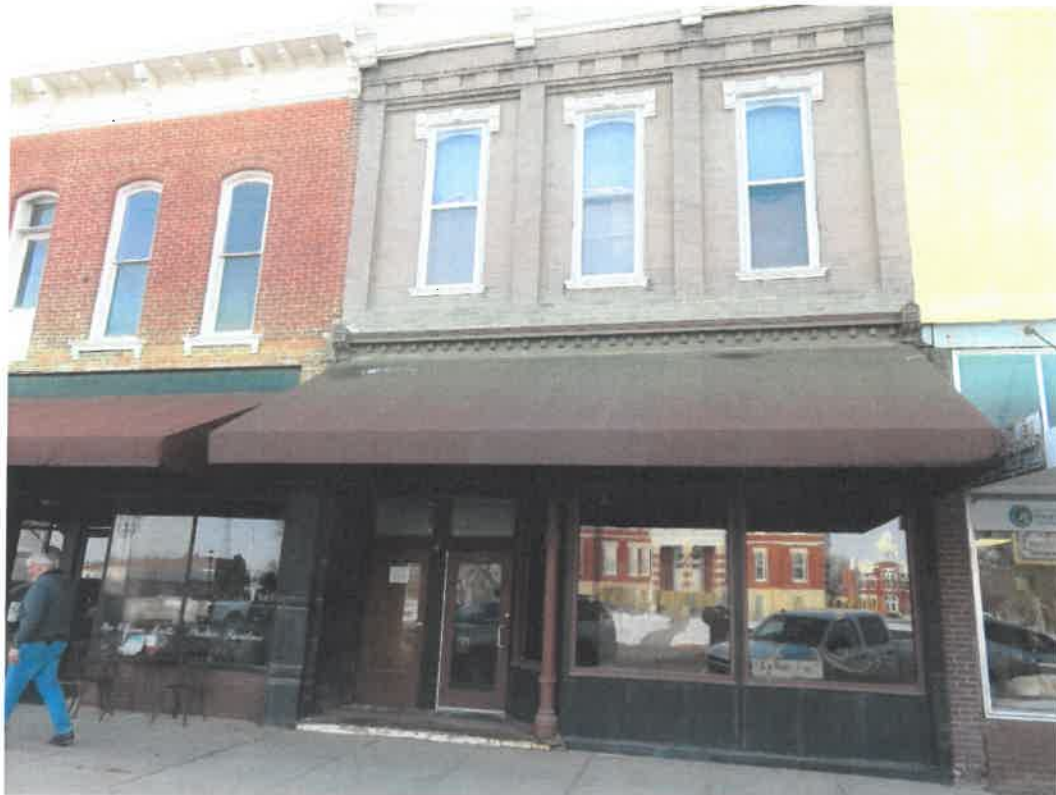
**Photo 86 Building No. 37 – Flanigan’s/Rachelle Images (151 S 3rd St)
Frontage Looking West**

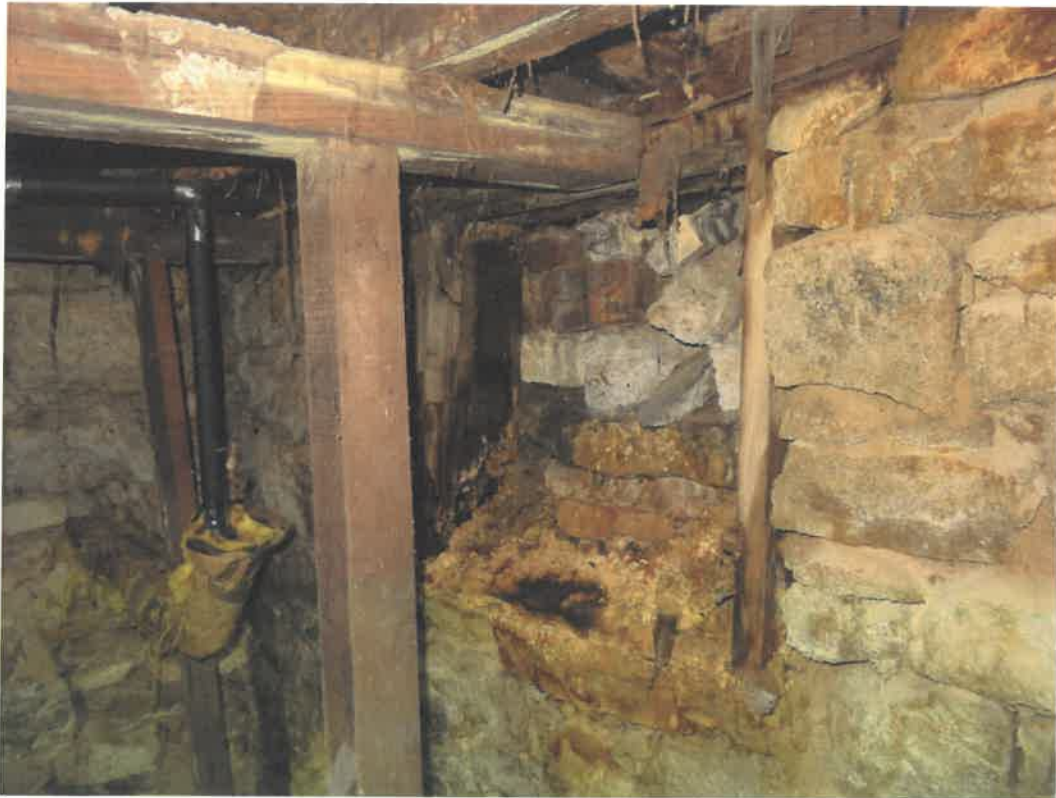
Photo 87 **Building No. 37 – Flanigan’s/Rachelle Images (151 S 3rd St)**
Limestone Rubble Filled-In Coal Chute in Basement

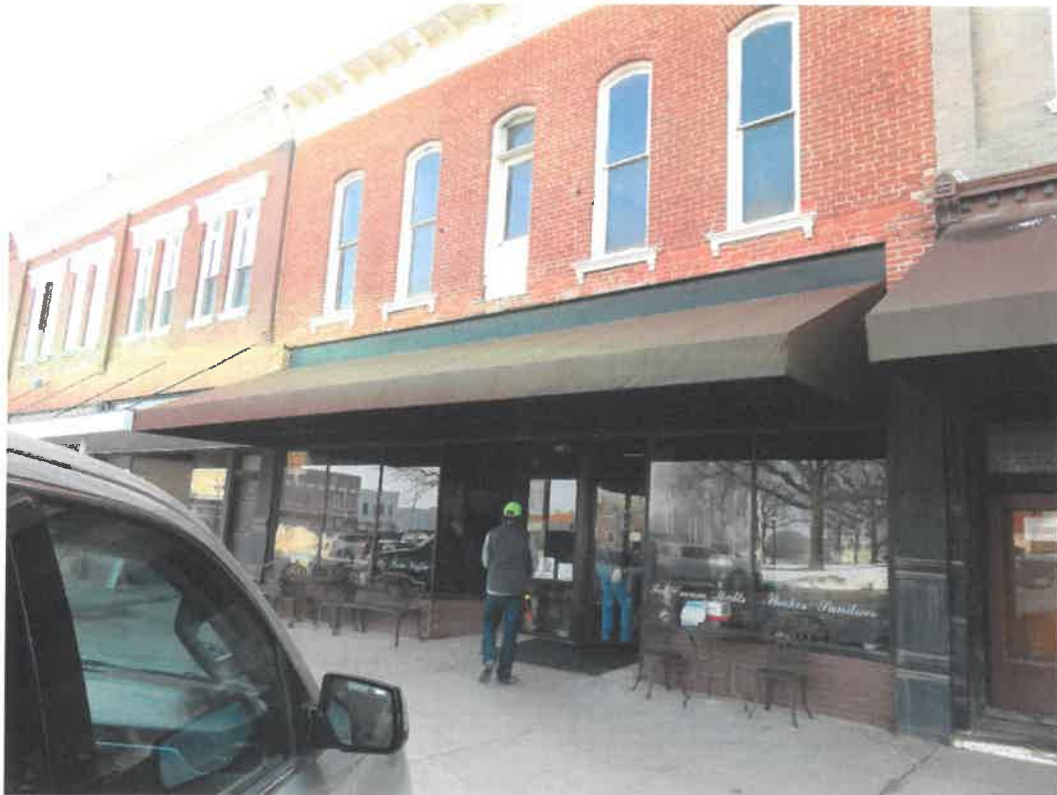
Photo 88 **Building No. 38 – Ramsey Family Fountain (155 S 3rd St)**
Frontage Looking Southwest

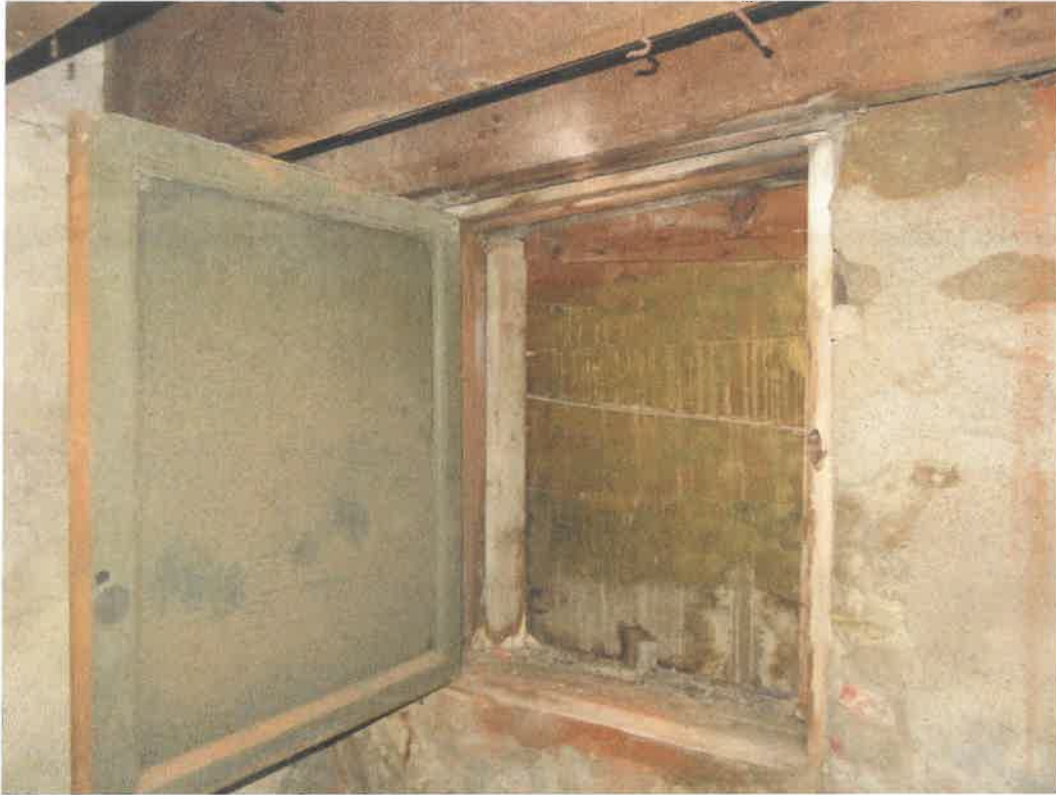
Photo 89 **Building No. 38 – Ramsey Family Fountain (155 S 3rd St)**
Wood Plank/Concrete Filled-In Coal Chute in Basement

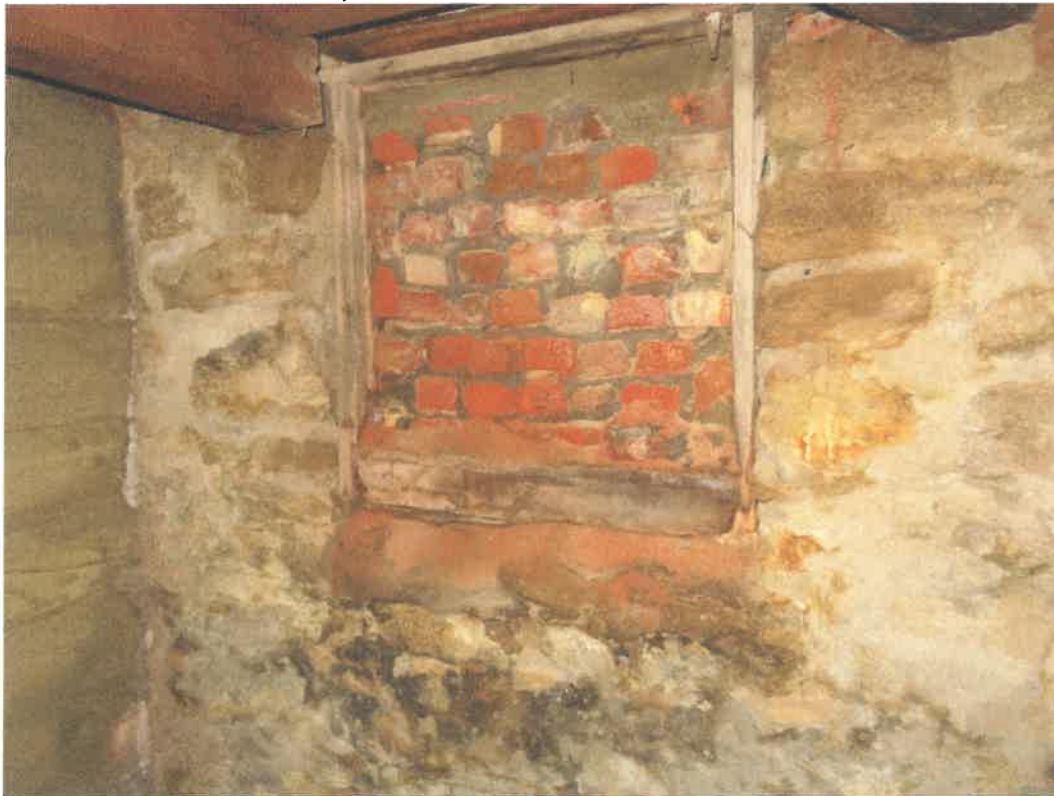
Photo 90 **Building No. 38 – Ramsey Family Fountain (155 S 3rd St)**
Brick Filled-In Coal Chute in Basement

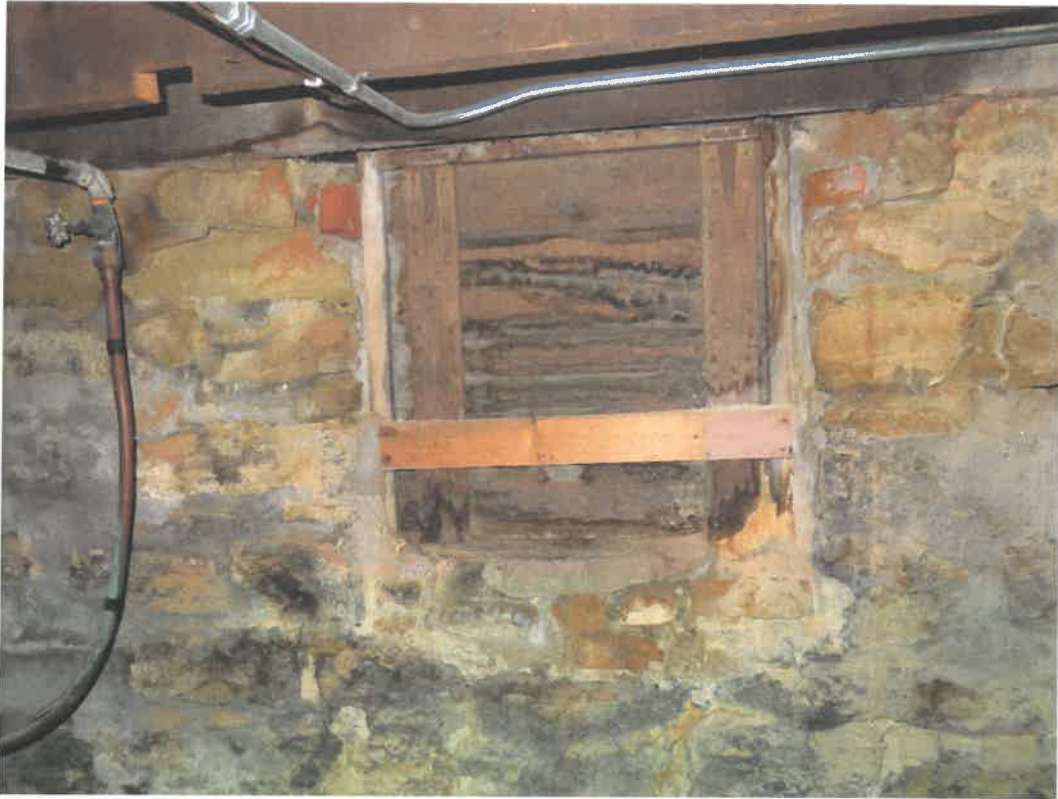
**Photo 91 Building No. 38 – Ramsey Family Fountain (155 S 3rd St)
Wood Plank Filled-In Coal Chute in Basement**

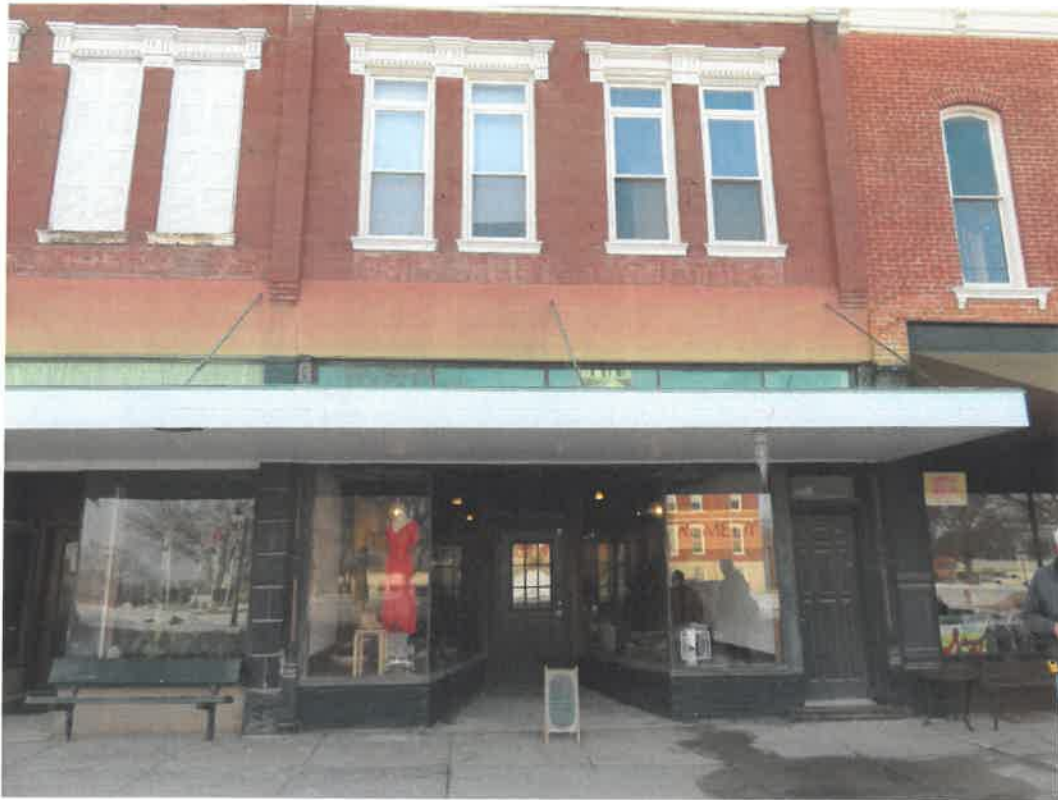
**Photo 92 Building No. 39 – Remedy (171 S 3rd St)
Frontage Looking West**

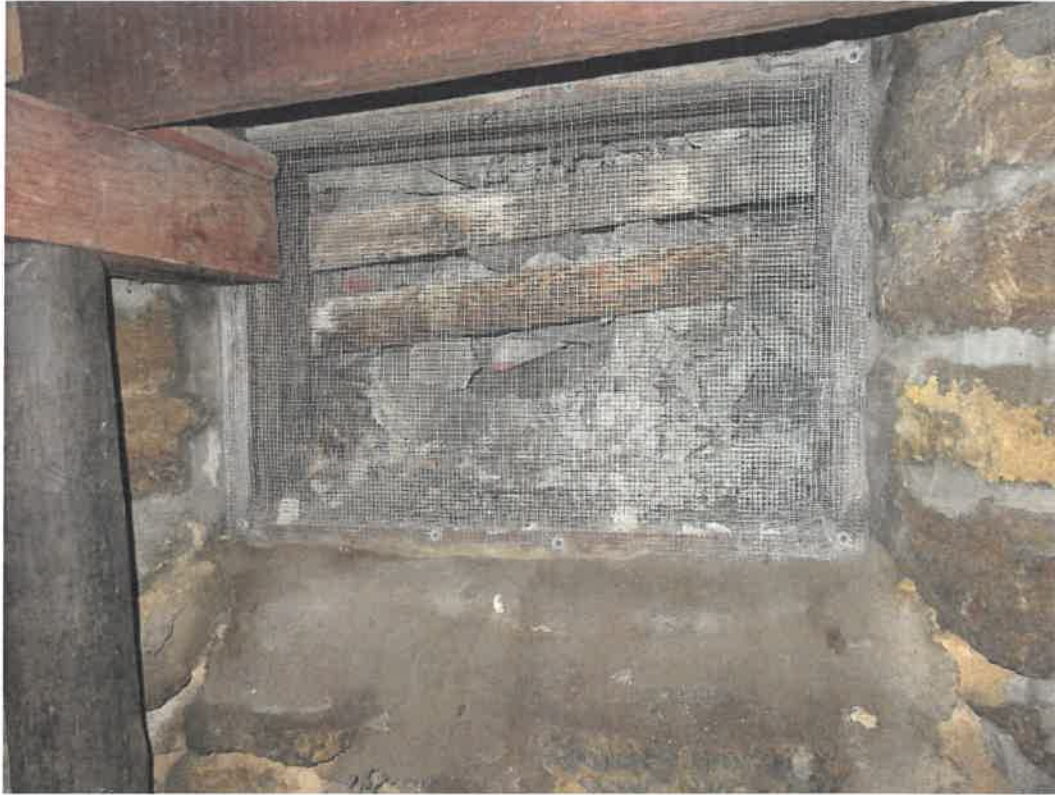
Photo 93 **Building No. 39 – Remedy (171 S 3rd St)**
Rubble Filled-In Coal Chute in Basement

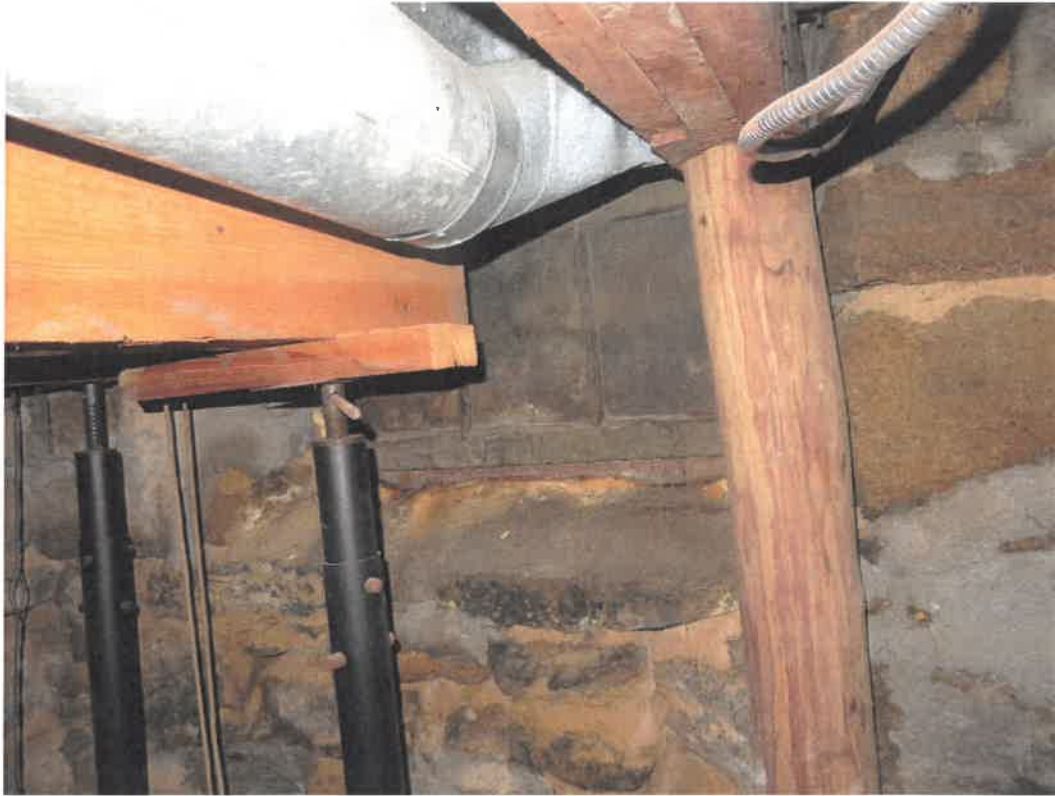
Photo 95 **Building No. 40 – Flanigan’s On the Square (173 S 3rd St)**
Rubble Filled-In Coal Chute in Basement

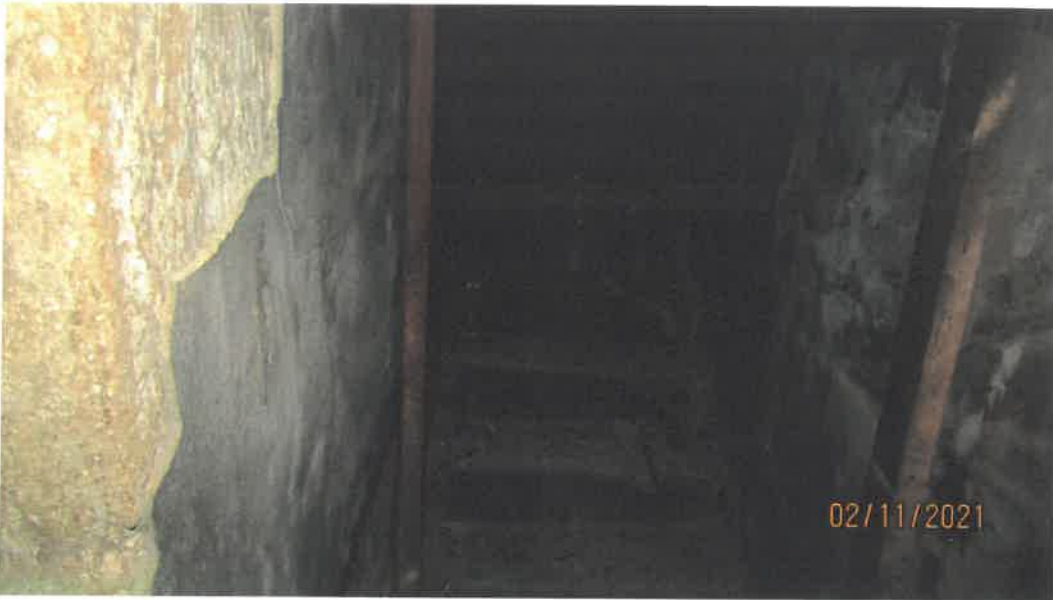
**Photo 97 Building No. 41 – Col. Barney Oldfield Education Center (175 S 3rd St)
Stair of Vault Under Sidewalk**

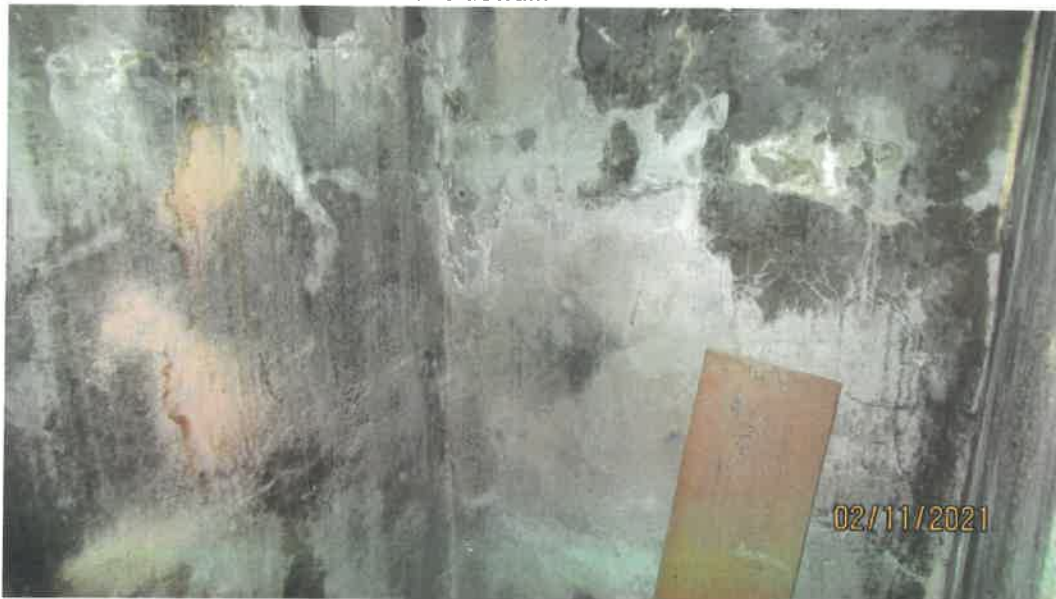
**Photo 98 Building No. 41 – Col. Barney Oldfield Education Center (175 S 3rd St)
Vault Under Sidewalk**

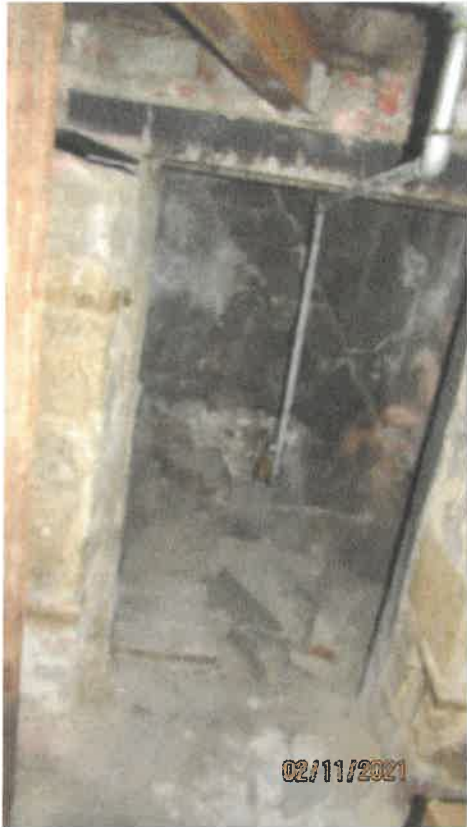
**Photo 99 Building No. 41 – Col. Barney Oldfield Education Center (175 S 3rd St)
Door Opening to Vault in Basement**

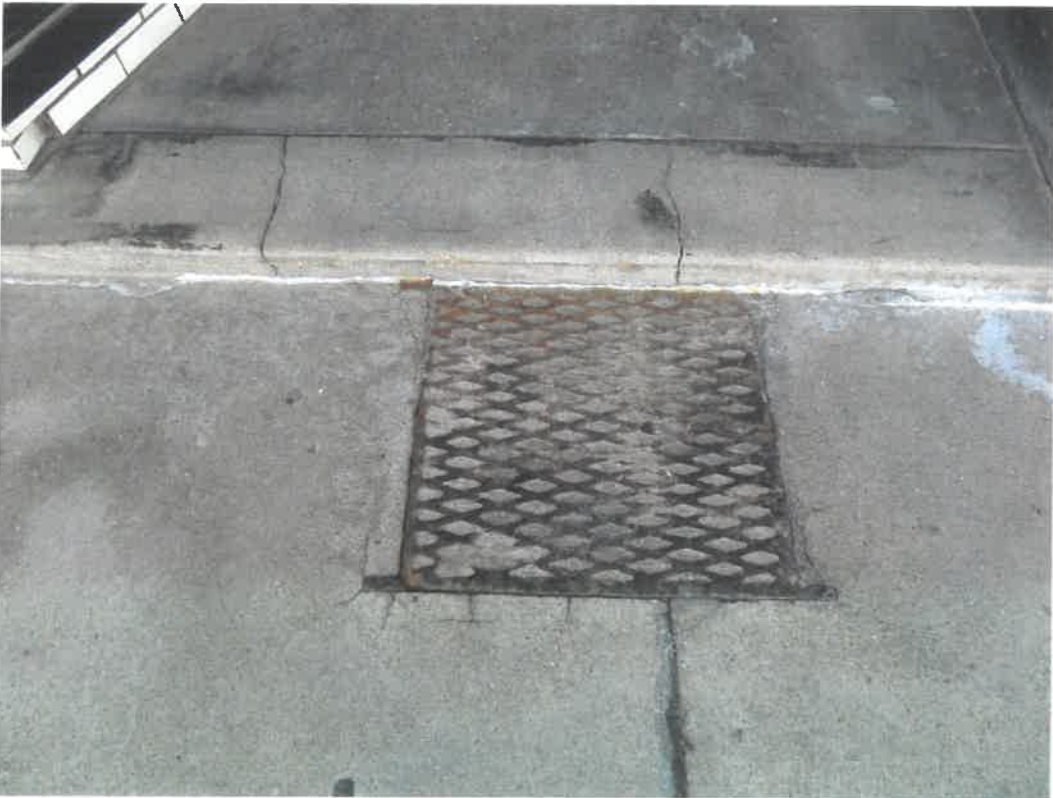
**Photo 101 Building No. 42 – Morrissey, Morrissey & Dalluge (177 S 3rd St)
Concrete Filled-In Coal Chute in Sidewalk**

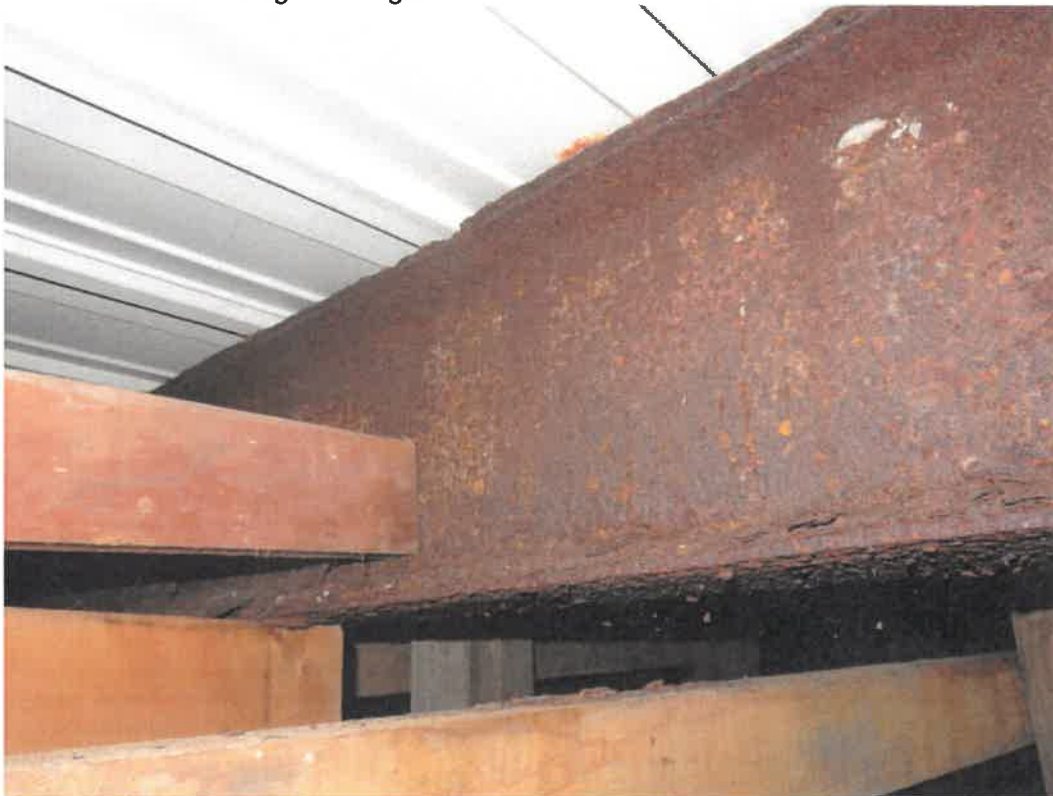
**Photo 104 Building No. 43 – Farm Bureau Financial Services (185 S 3rd St)
Steel Beam/Metal Form Deck/Wood Framing of Vault Under Sidewalk**

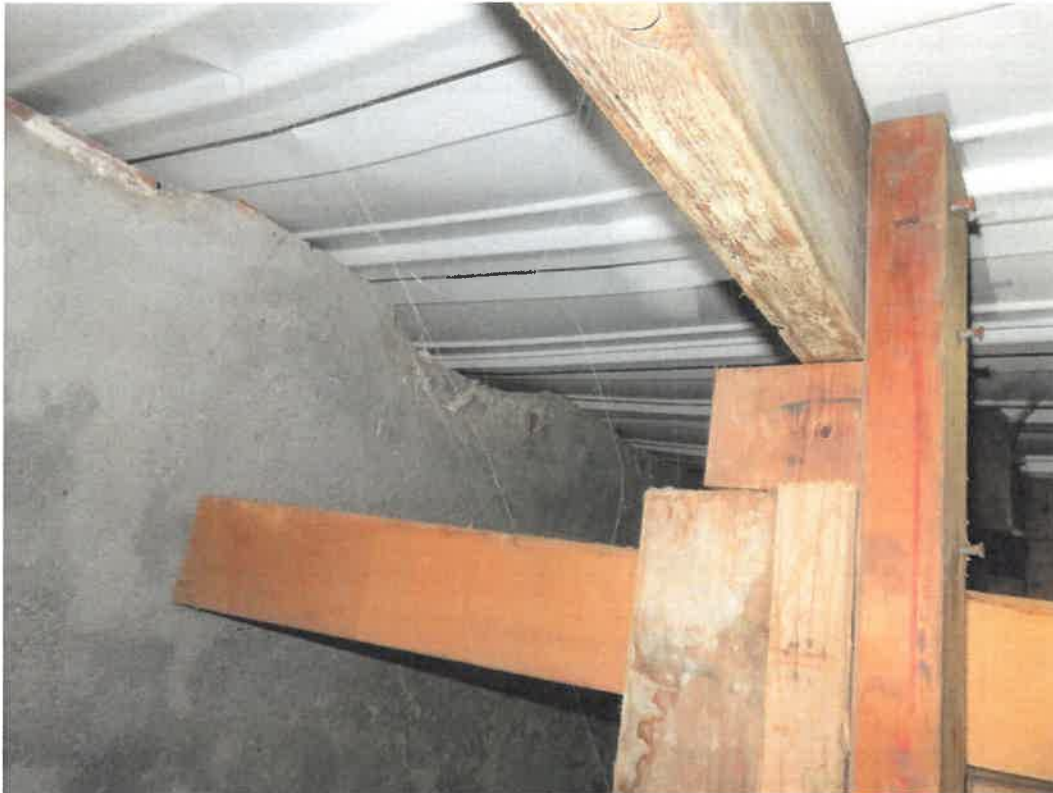
Photo 105 Building No. 43 – Farm Bureau Financial Services (185 S 3rd St)
Metal Form Deck/Wood Framing/Concrete Wall of Vault Under Sidewalk

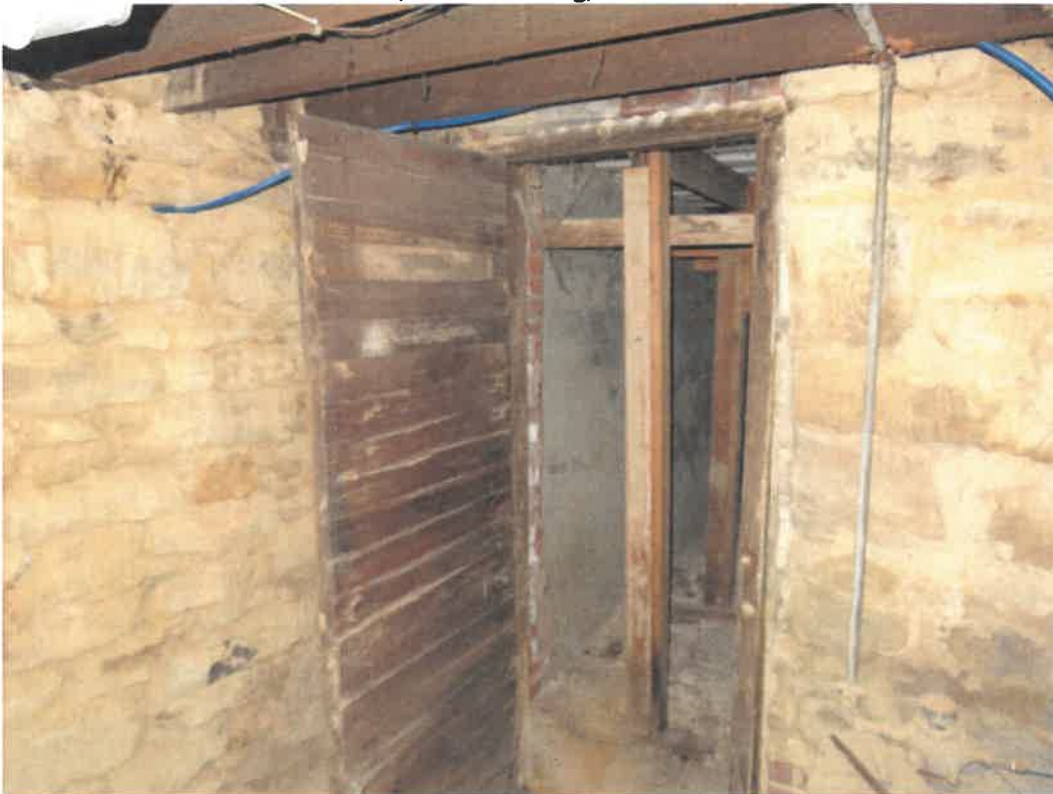
Photo 106 Building No. 43 – Farm Bureau Financial Services (185 S 3rd St)
Open Door to Vault in Basement of Building

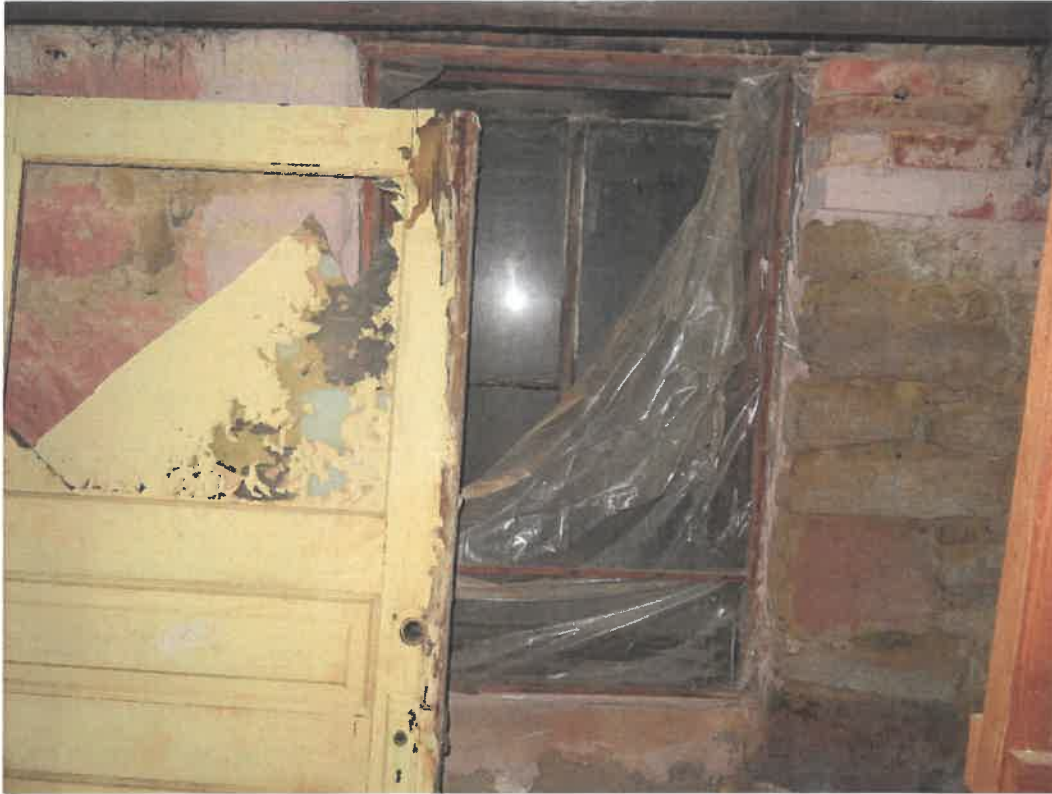
Photo 107 **Building No. 43 – Farm Bureau Financial Services (185 S 3rd St)**
Open Window to Vault in Basement of Building

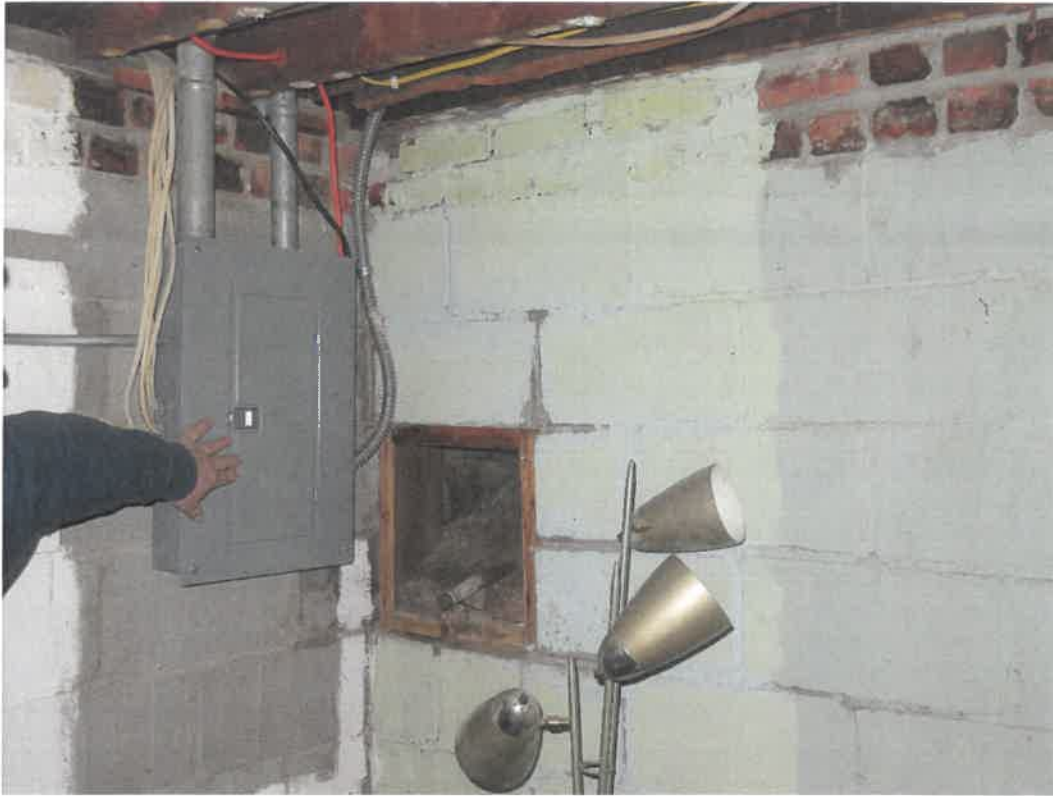
Photo 109 Building No. 44 – To Gather On the Square (193 S 3rd St)
Opening for Water Shut-off in Basement of Building

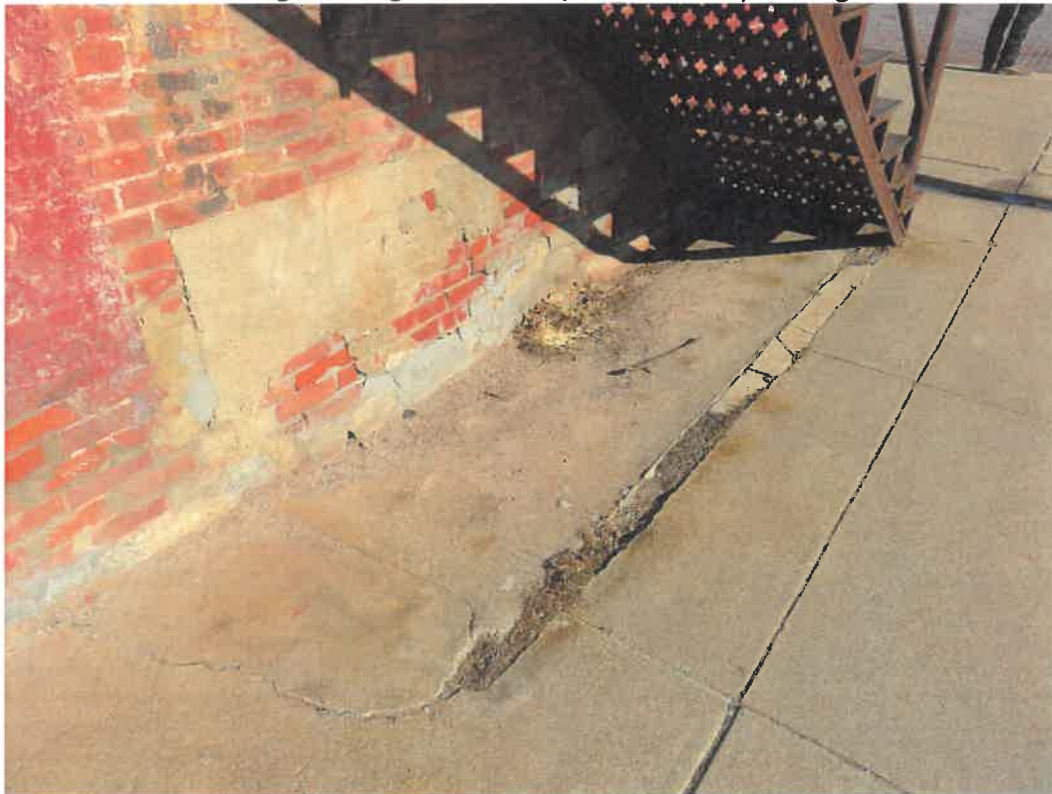
Photo 112 Building No. 45 – Hair by Luann (195 S 3rd St)
Concrete Filled-In Stairway in Sidewalk on South Face of Building

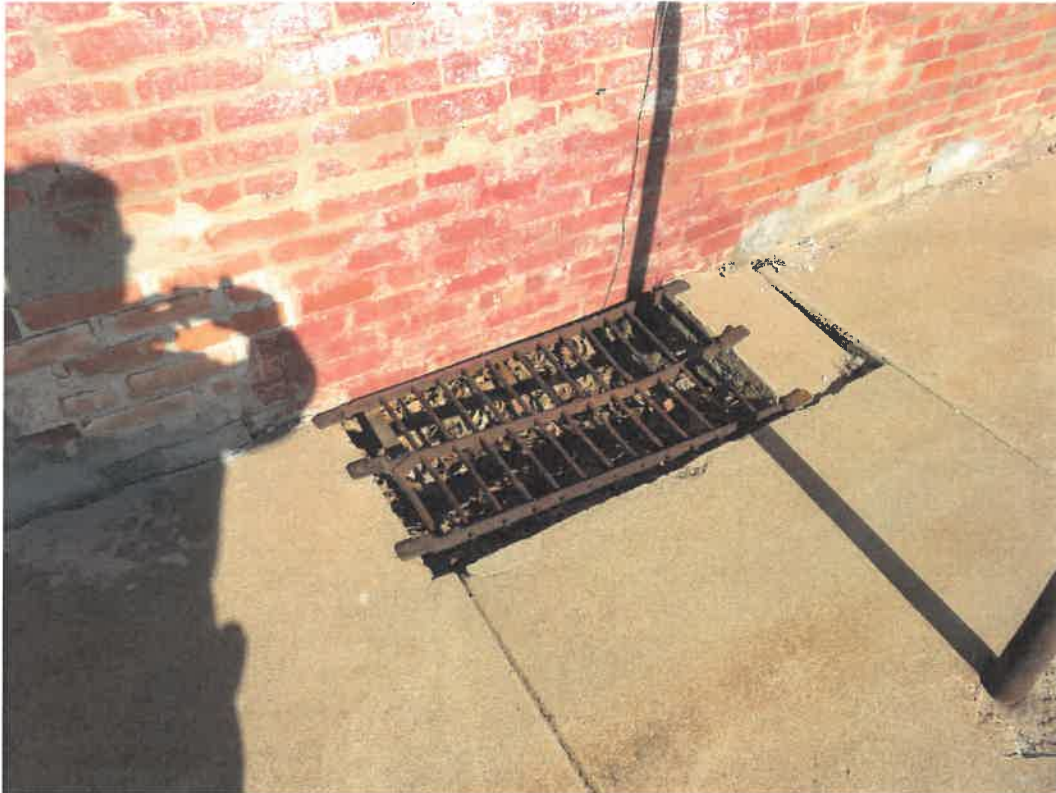
Photo 113 Building No. 45 – Hair by Luann (195 S 3rd St)
Open Vent in Sidewalk on South Face of Building

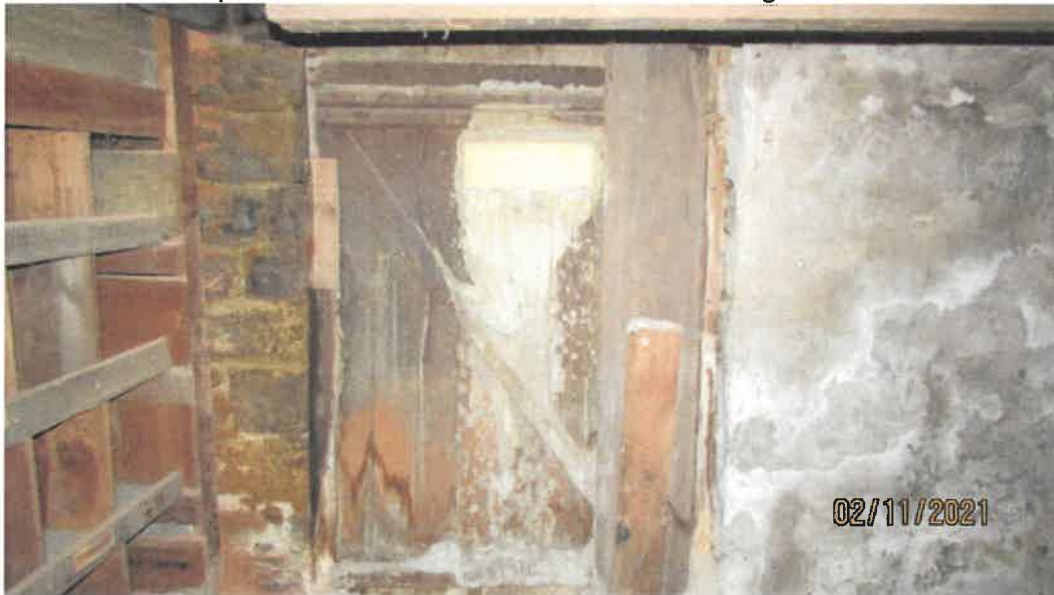
Photo 114 Building No. 45 – Hair by Luann (195 S 3rd St)
Concrete Filled-In Door to Previous Stairway on South Face of Building

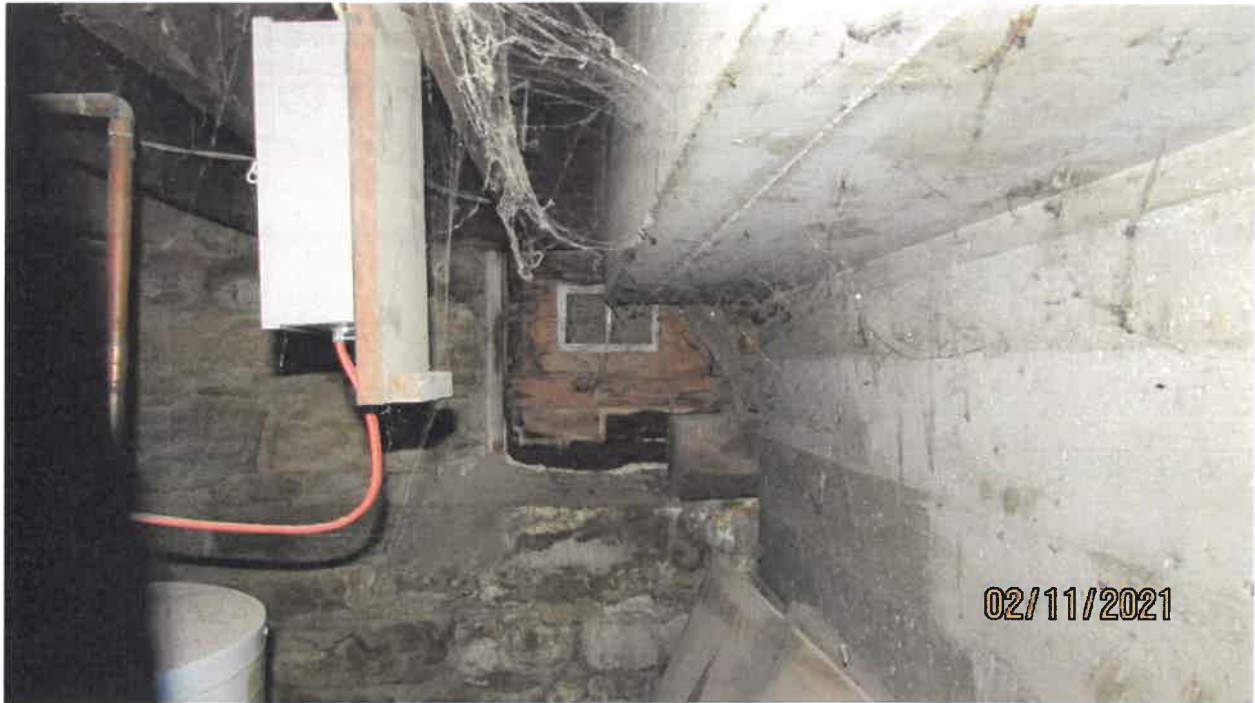
Photo 115 **Building No. 45 – Hair by Luann (195 S 3rd St)**
Open Vent on South Face of Building in Basement
