OBSERVATION REPORT

Tecumseh Historic Square Preservation – Structural Evaluation

Submitted by Olsson Inc.

February 18, 2022

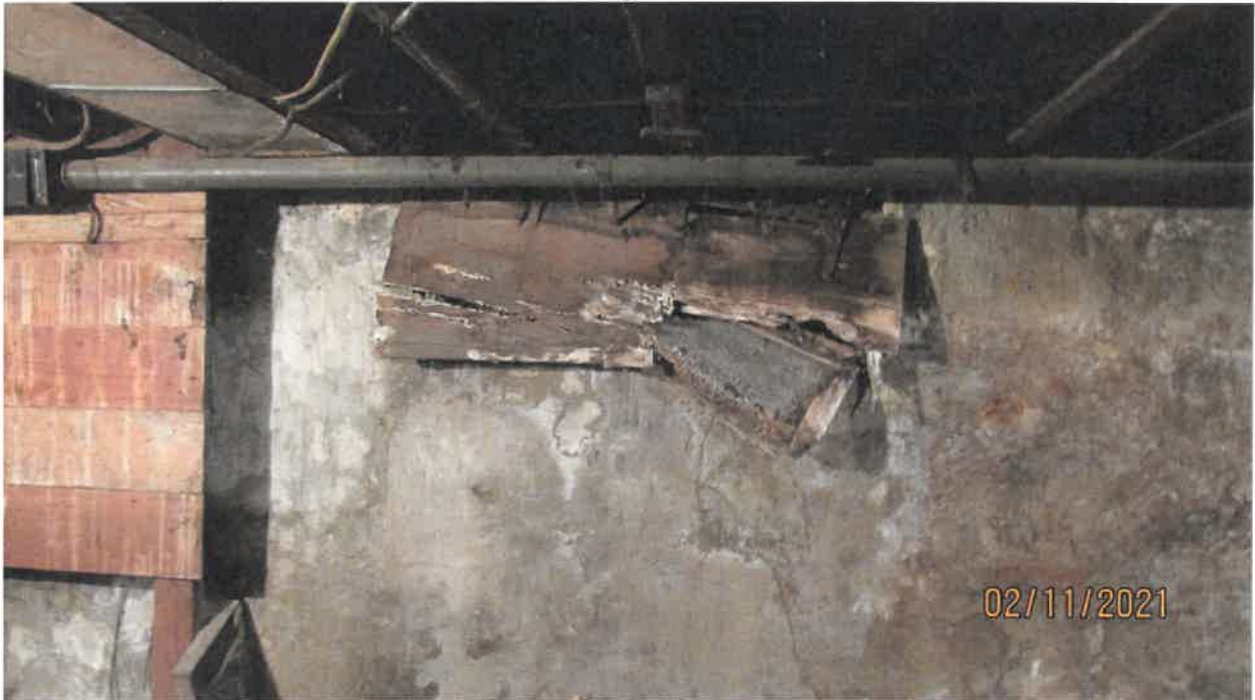
Photo 116 **Building No. 45 – Hair by Luann (195 S 3rd St)**
Wood Filled-In Coal Chute on South Face of Building in Basement

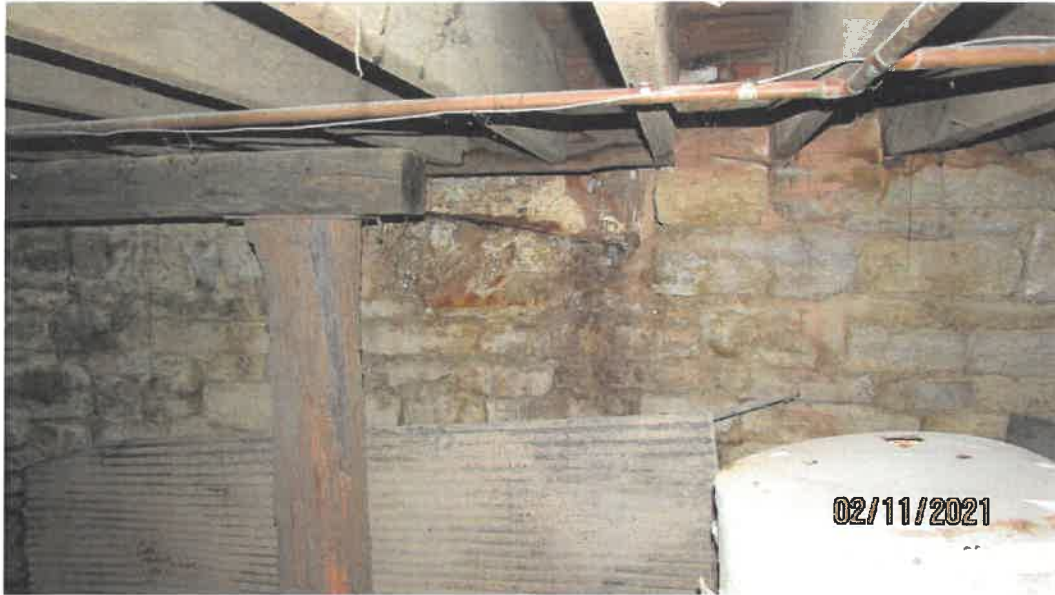
Photo 117 Building No. 45 – Hair by Luann (195 S 3rd St)
Rubble Limestone Filled-In Coal Chute on South Face of Building in Basement

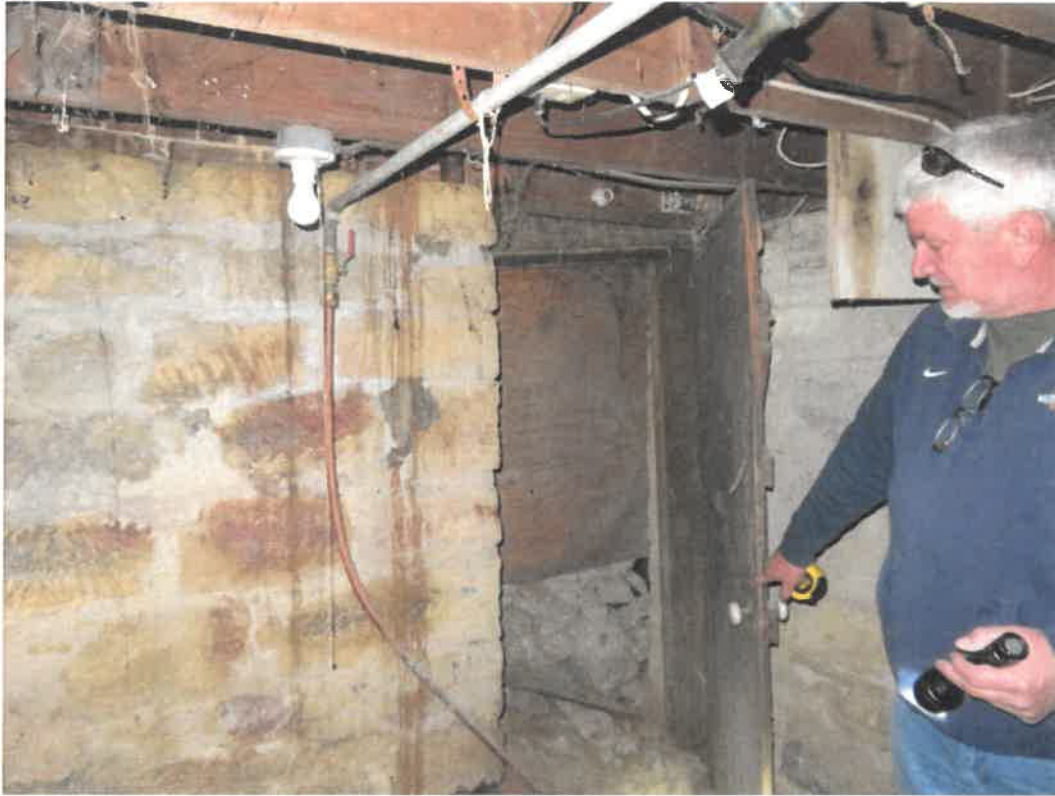
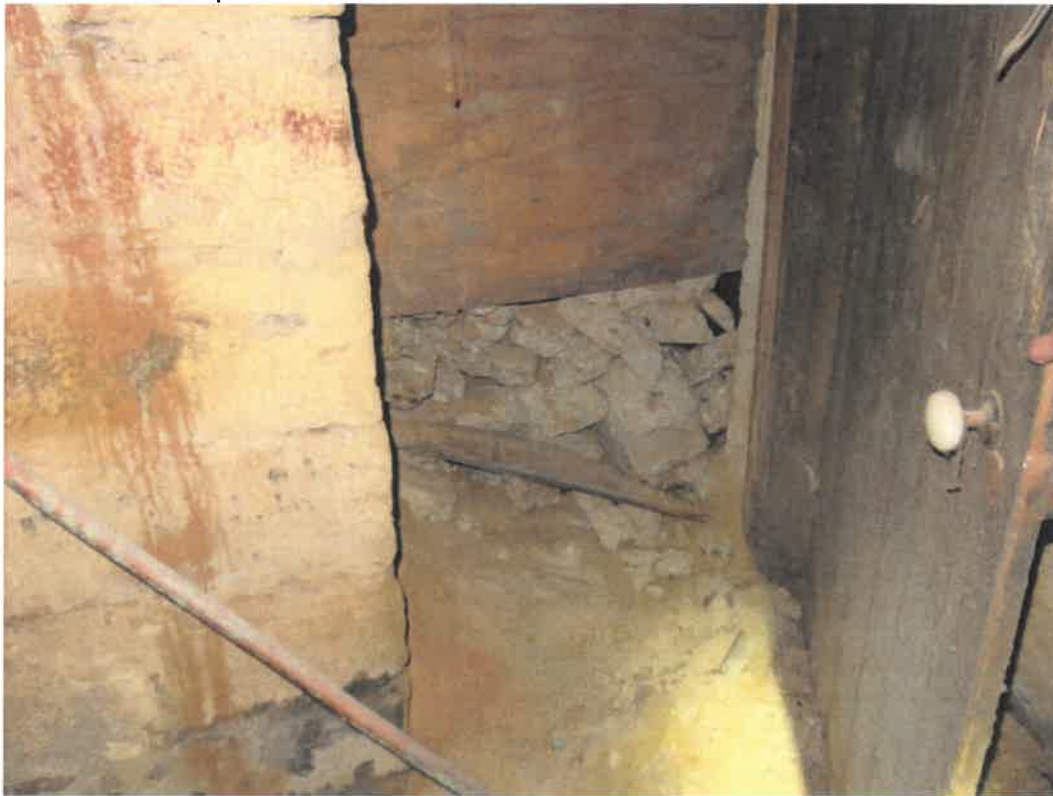
**Photo 119 Building No. 46 – Blessing Heating & Plumbing (276 Clay St)
Open Door in Basement to Vault Under Sidewalk**

**Photo 120 Building No. 46 – Blessing Heating & Plumbing (276 Clay St)
Open Door in Basement to Vault Under Sidewalk**

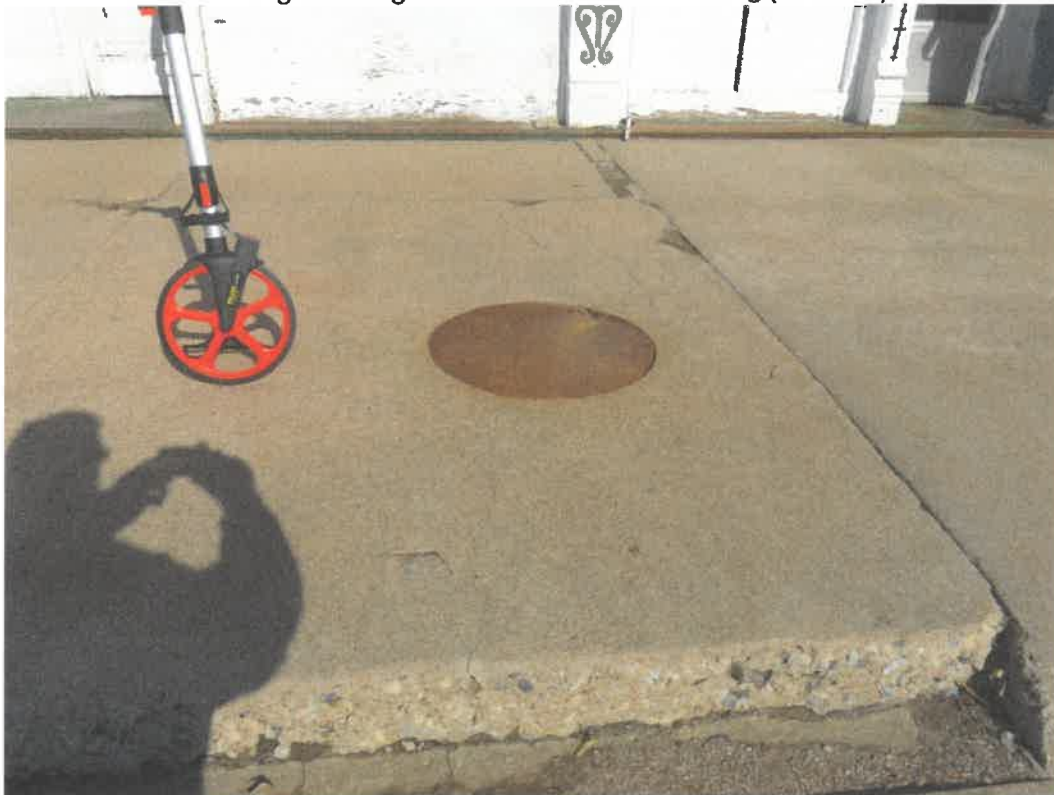
**Photo 122 Building No. 47 – Hupka Farm Toys (266 Clay St)
Manhole to Vault Under Sidewalk**

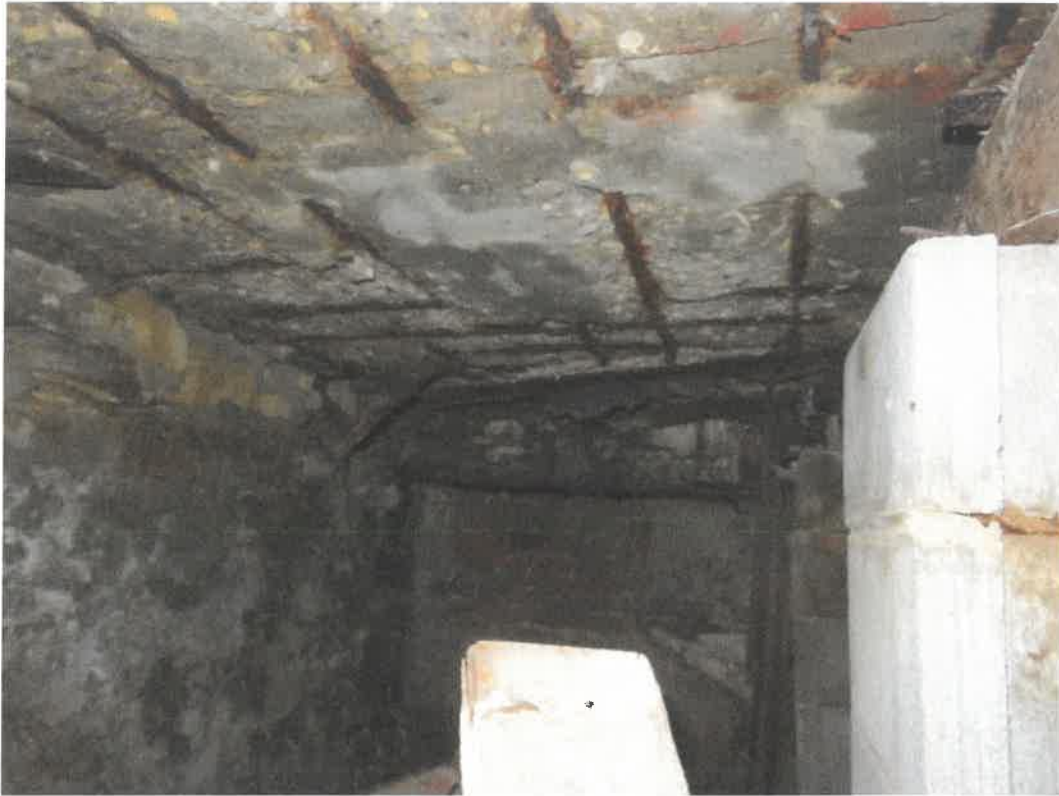
**Photo 123 Building No. 47 – Hupka Farm Toys (266 Clay St)
Vault Under Sidewalk Looking West**

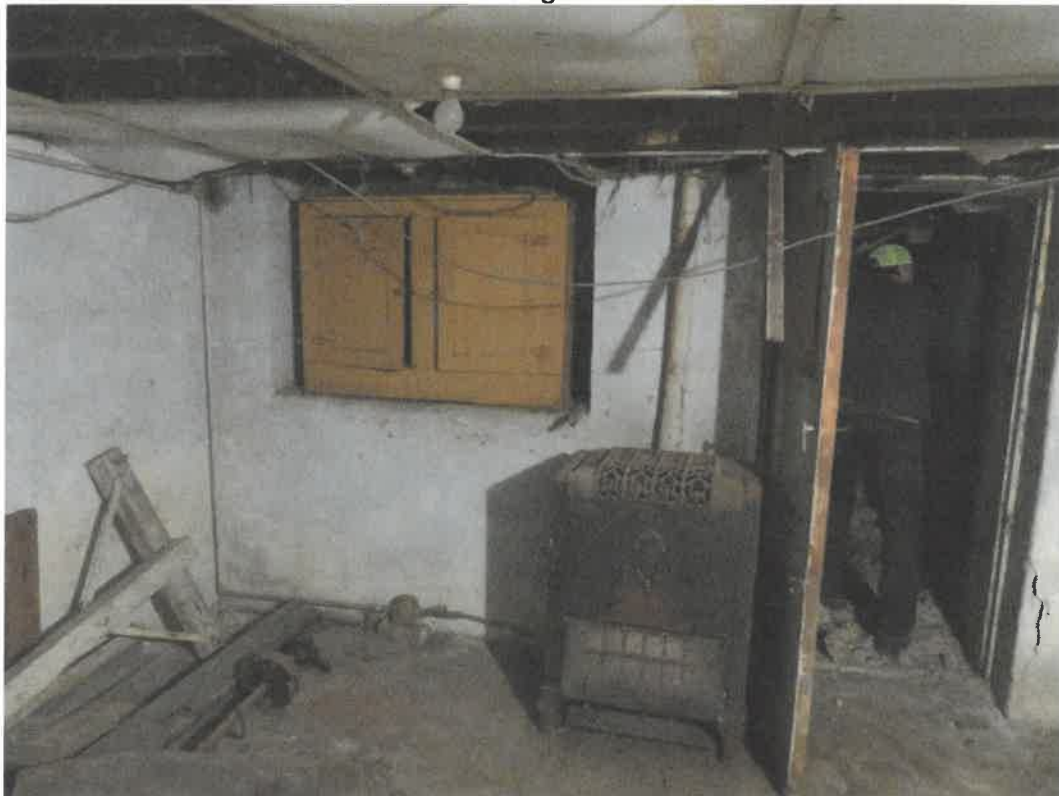
**Photo 124 Building No. 47 – Hupka Farm Toys (266 Clay St)
Open Door & Window in Basement to Vault Under Sidewalk**

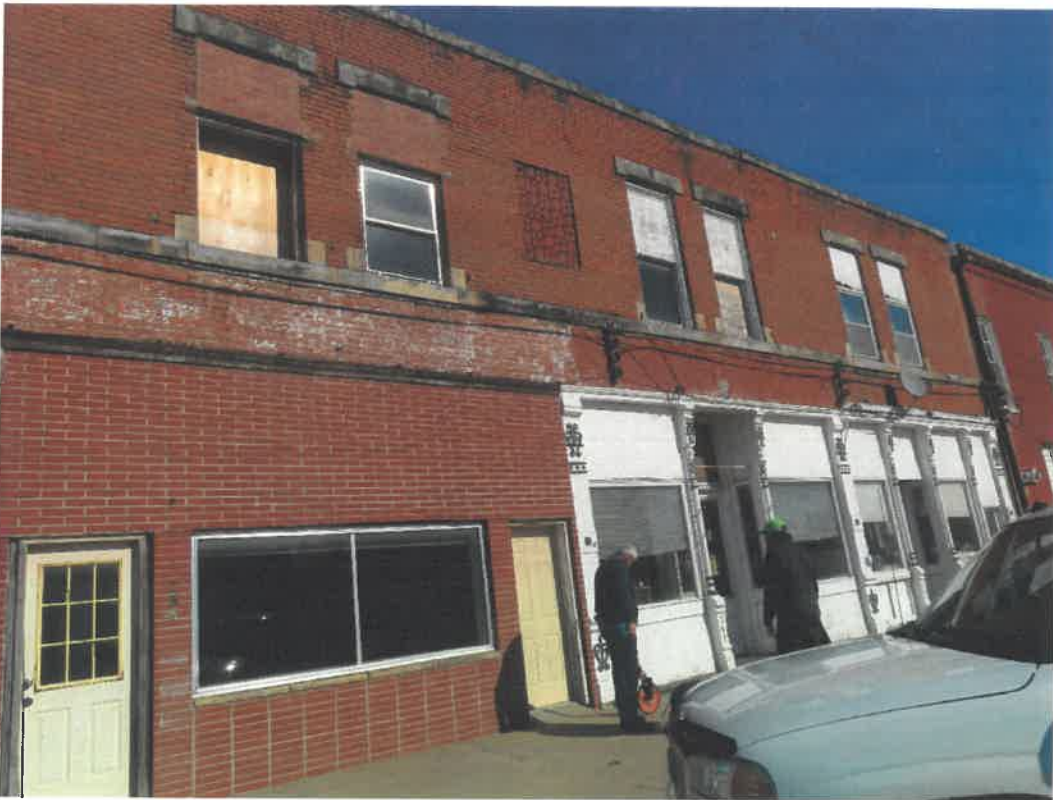
Photo 125 Building No. 48 – Tecumseh EDC Building (256 Clay St)
Frontage Looking Northeast (Note: Vault Discovered Under Sidewalk)

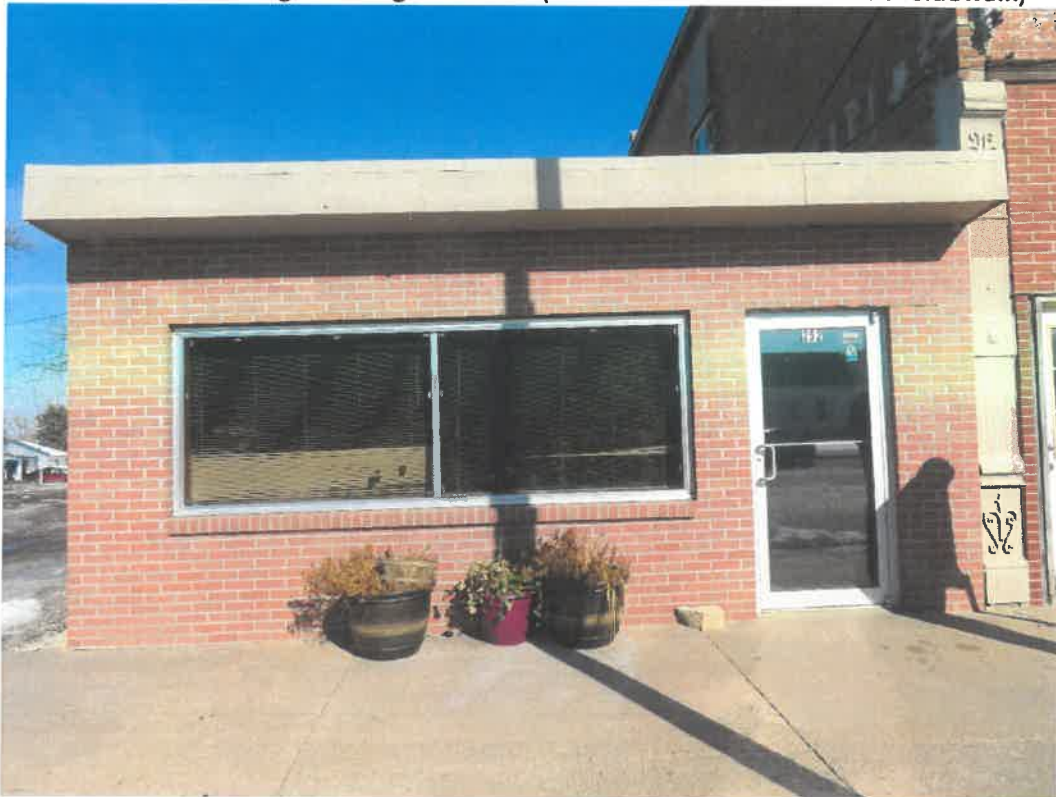
Photo 126 Building No. 49 – Gartner Transportation (252 Clay St)
Frontage Looking North (Note: Vault Discovered Under Sidewalk)

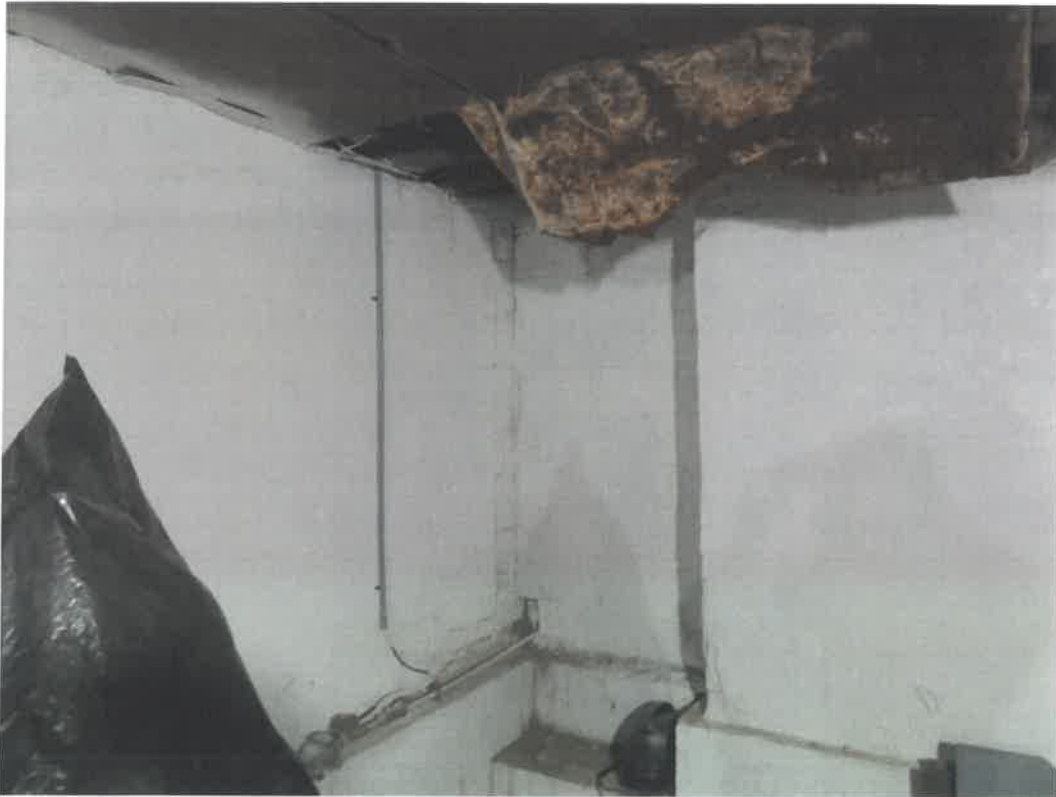
Photo 127 Building No. 49 – Gartner Transportation (252 Clay St)
CMU Filled-In Door in Basement to Vault Under Sidewalk

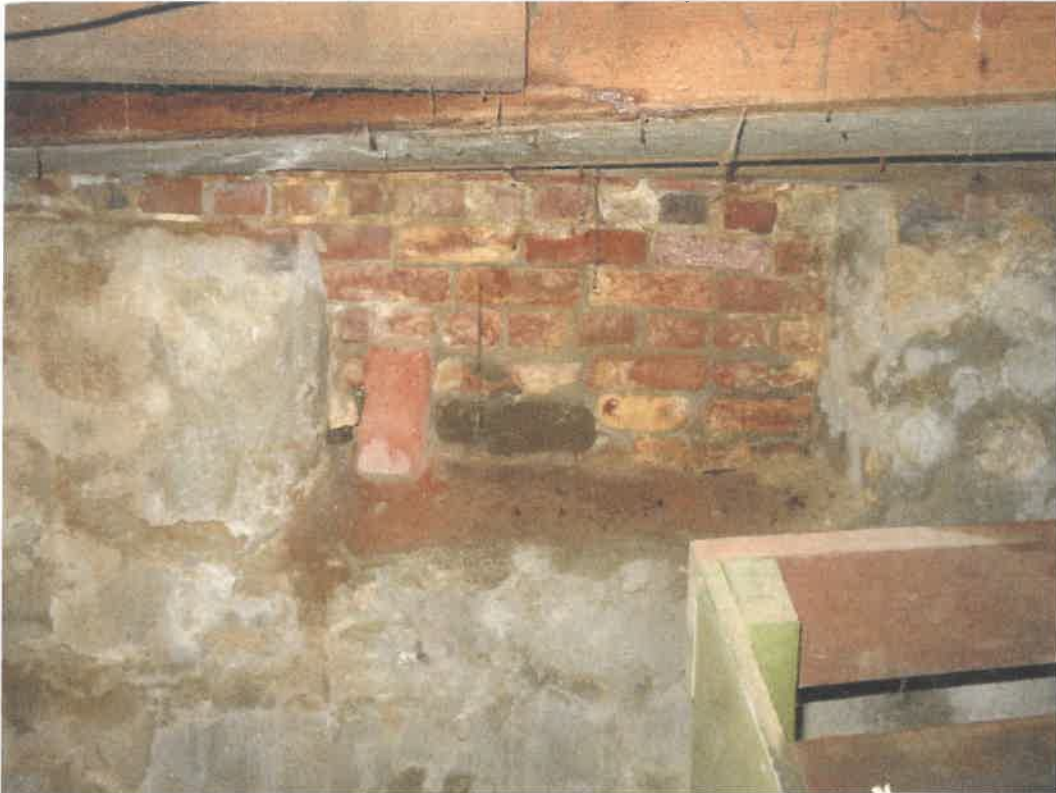
**Photo 131 Building No. 52 – Bob Gregory Building (241 Clay St)
Brick Filled-In Coal Chute in Basement**

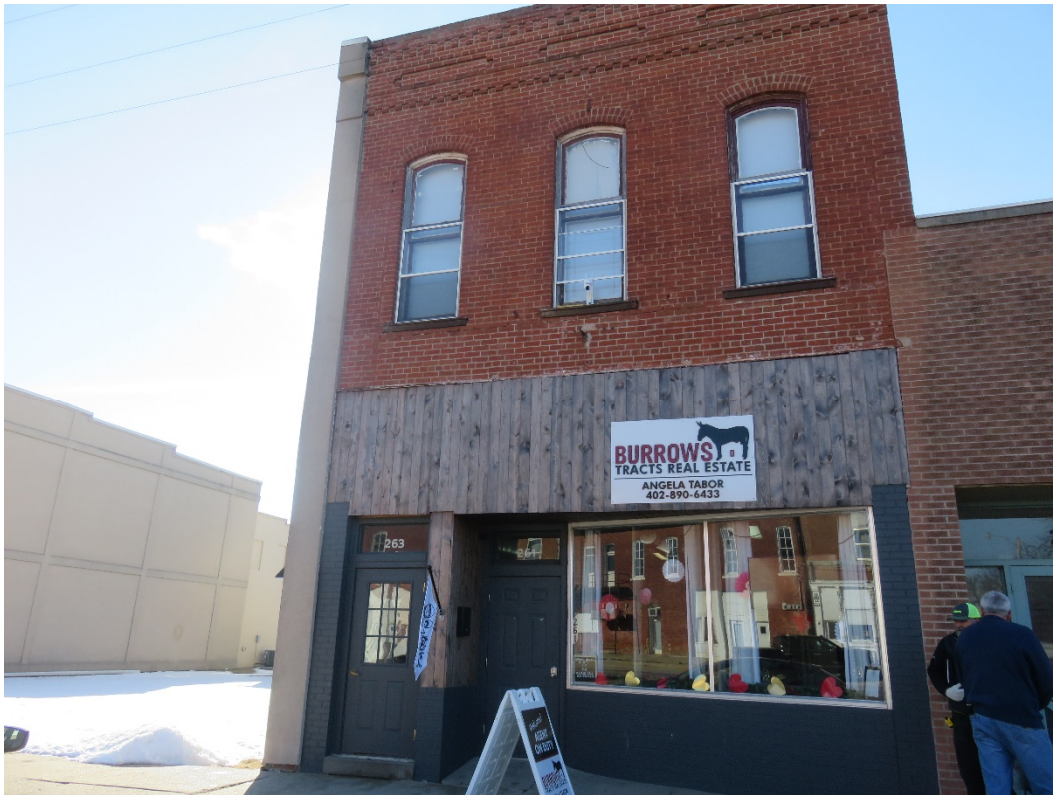
This two-story structure does not have a basement. The building appears to be in good condition. Olsson does not anticipate any problems with construction of sidewalk improvements.

**Photo 133 Building No. 54 – Burrows Tracts Real Estate (261 Clay St)
Frontage Looking South**

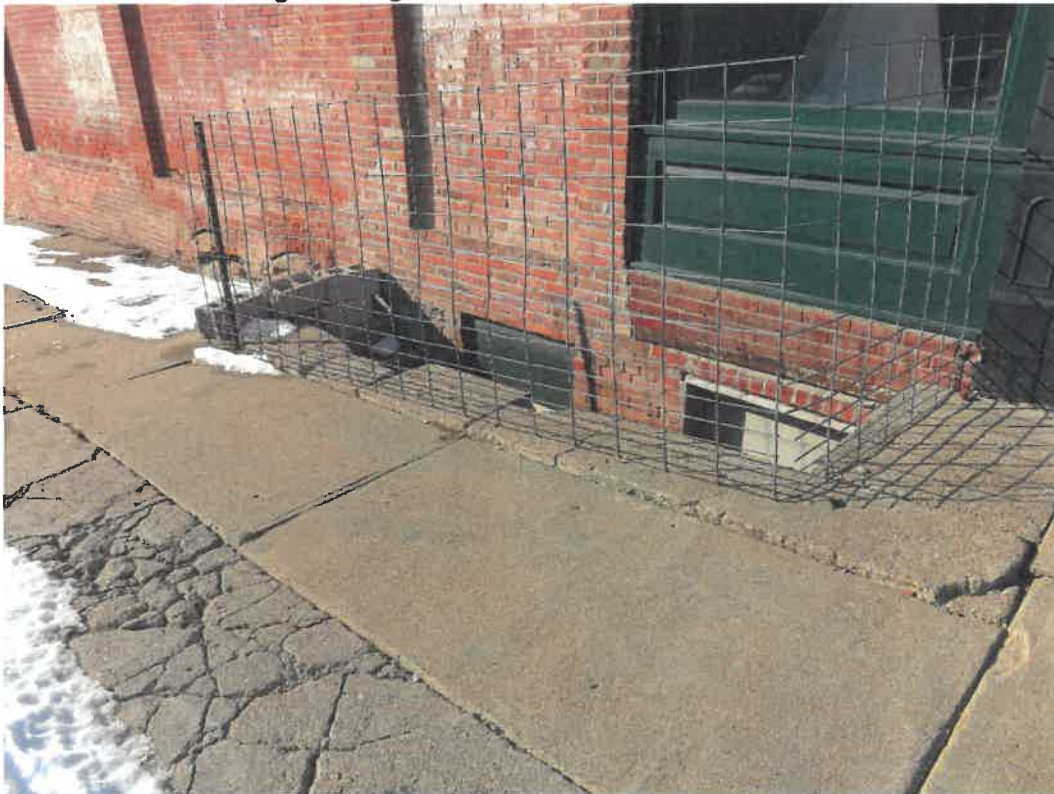
**Photo 136 Building No. 55 – Johnson County Museum (235 S 3rd St)
Open Stairway in Sidewalk on East Face of Building**

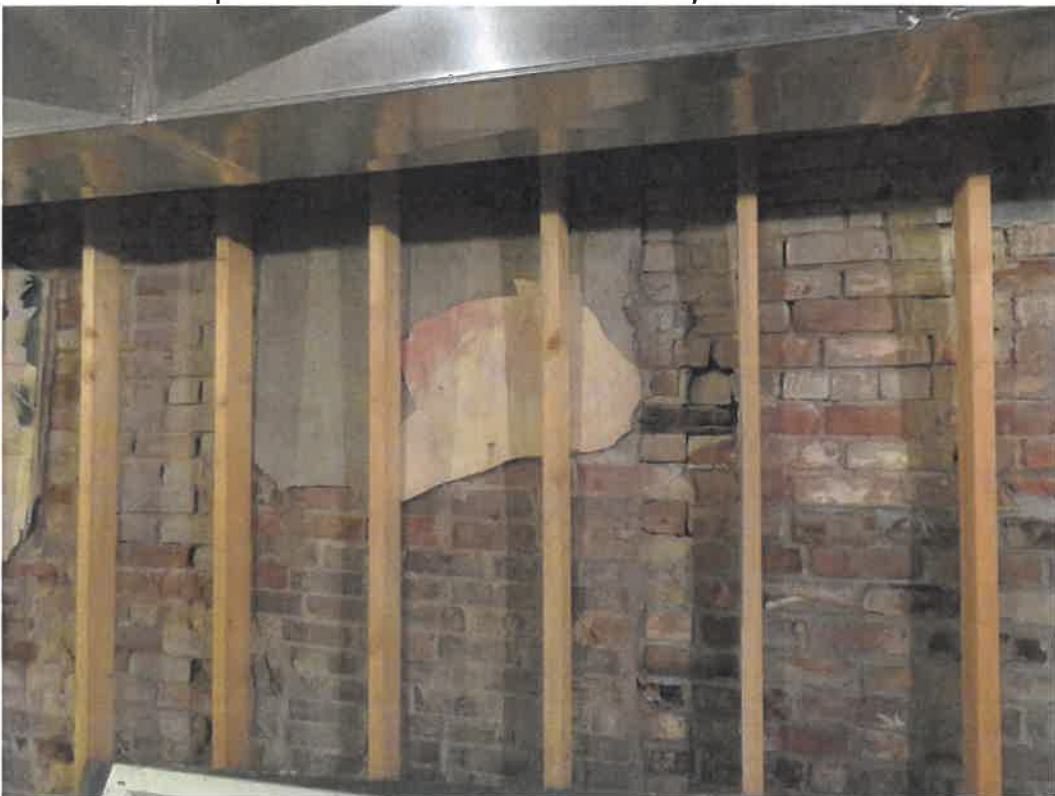
Photo 140 Building No. 55 – Johnson County Museum (235 S 3rd St)
Concrete Filled-In Coal Chute on North Wall of Basement

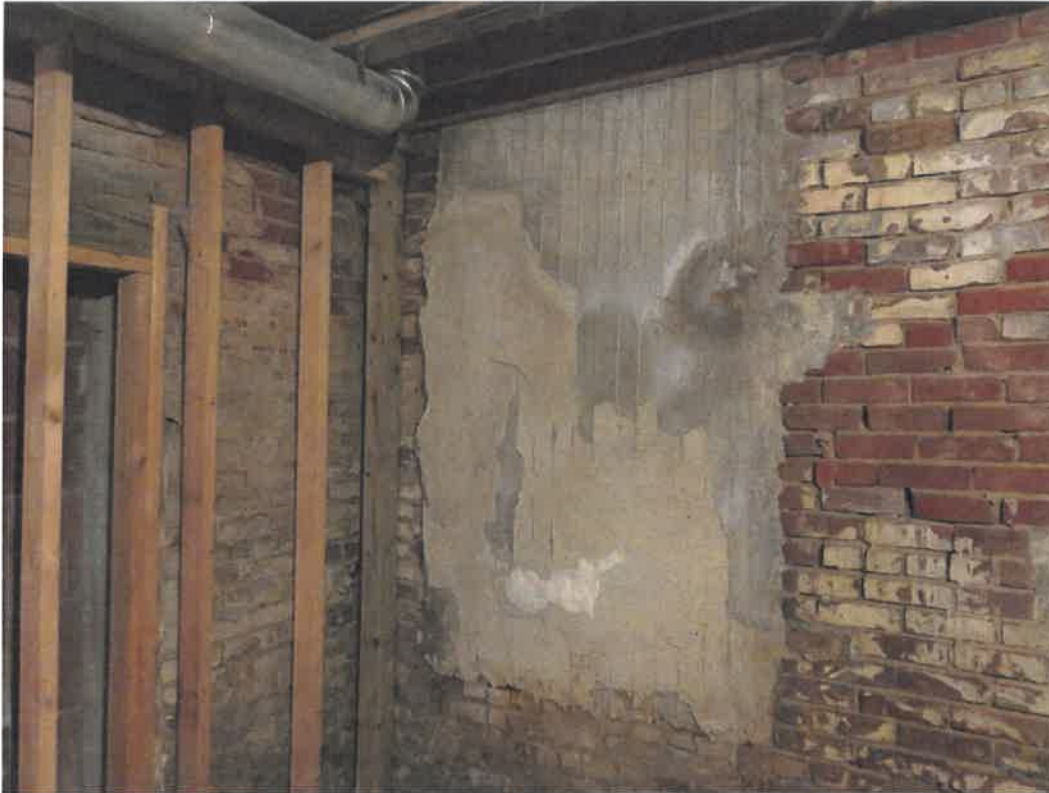
Photo 141 **Building No. 55 – Johnson County Museum (235 S 3rd St)**
Concrete Filled-In Coal Chute on North Wall of Basement

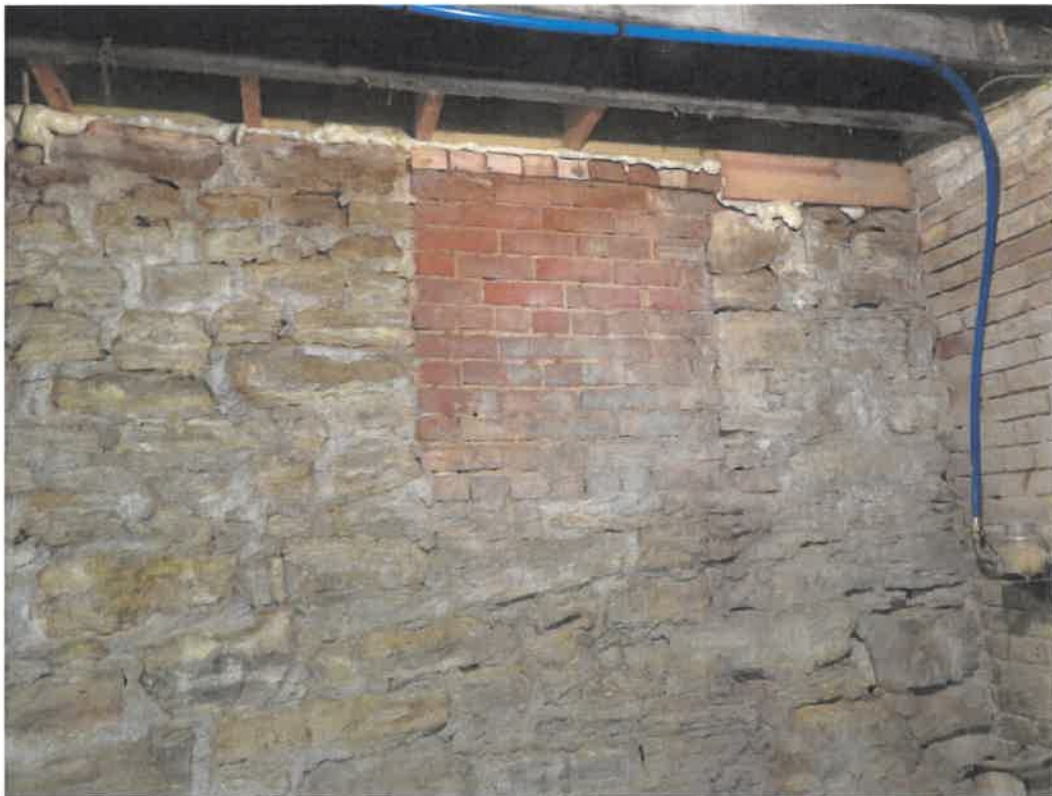
Photo 142 **Building No. 55 – Johnson County Museum (235 S 3rd St)**
Brick Filled-In Coal Chute on North Wall of West Annex in Basement

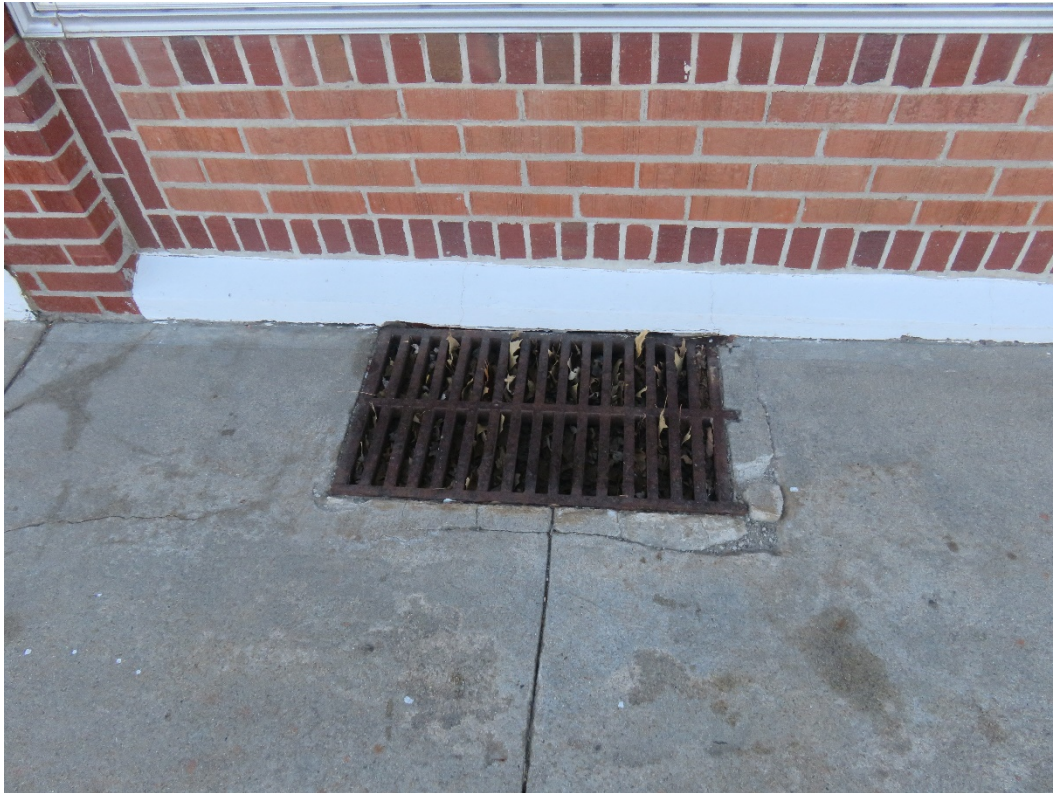
The other coal chute with wood framing and manhole wall opening in the limestone foundation wall are open and filled in with debris. Neither appears to be in stable condition.

Photo 145 **Building No. 56 – Brinkman’s Chevrolet & Buick (301/305/306 Clay St)**
Open Coal Chute in Sidewalk of East Annex

For sidewalk improvements at these two openings, Olsson recommends the manhole be removed, the debris be removed from the coal chute and manhole, the wood framing of the wall openings be removed, the walls of the openings beneath the sidewalk be removed down to the bottom of the basement openings, the wall openings be filled in with limestone and appropriate mortar, and the voids beneath the sidewalk be filled in with an aggregate/gravel material prior to the placement of a new sidewalk. Implementing these recommendations will require the contractor to access the basement during construction.

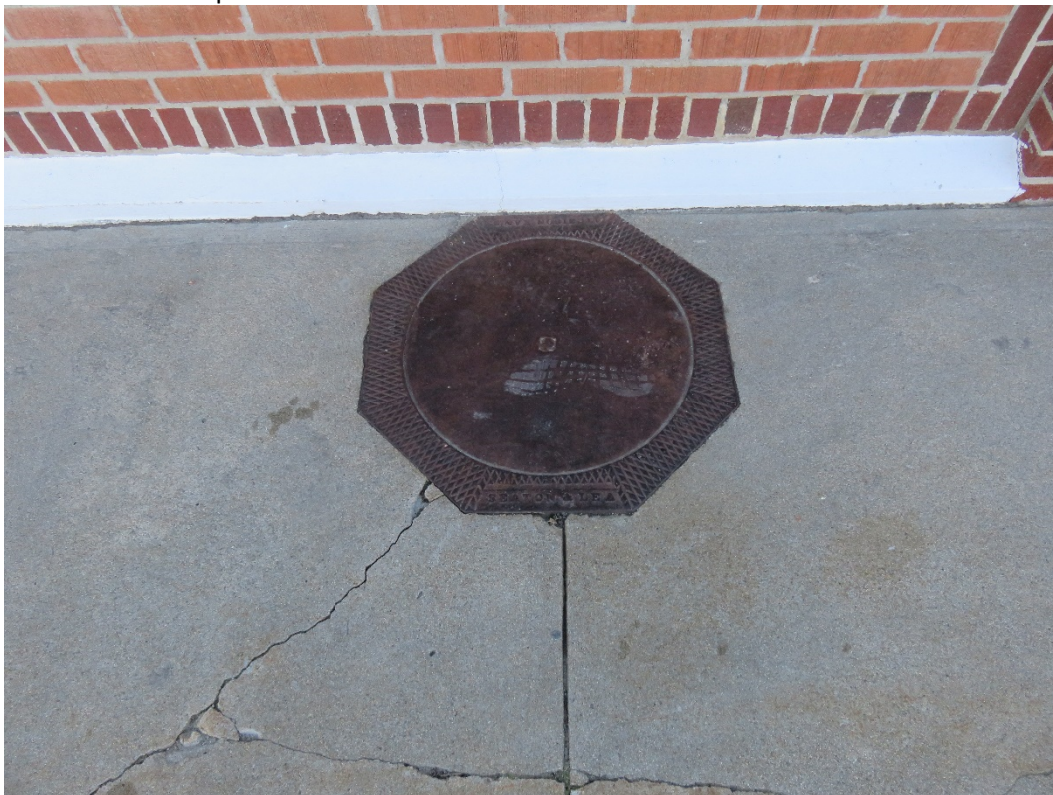
Photo 146 **Building No. 56 – Brinkman’s Chevrolet & Buick (301/305/306 Clay St)**
Open Manhole in Sidewalk of East Annex

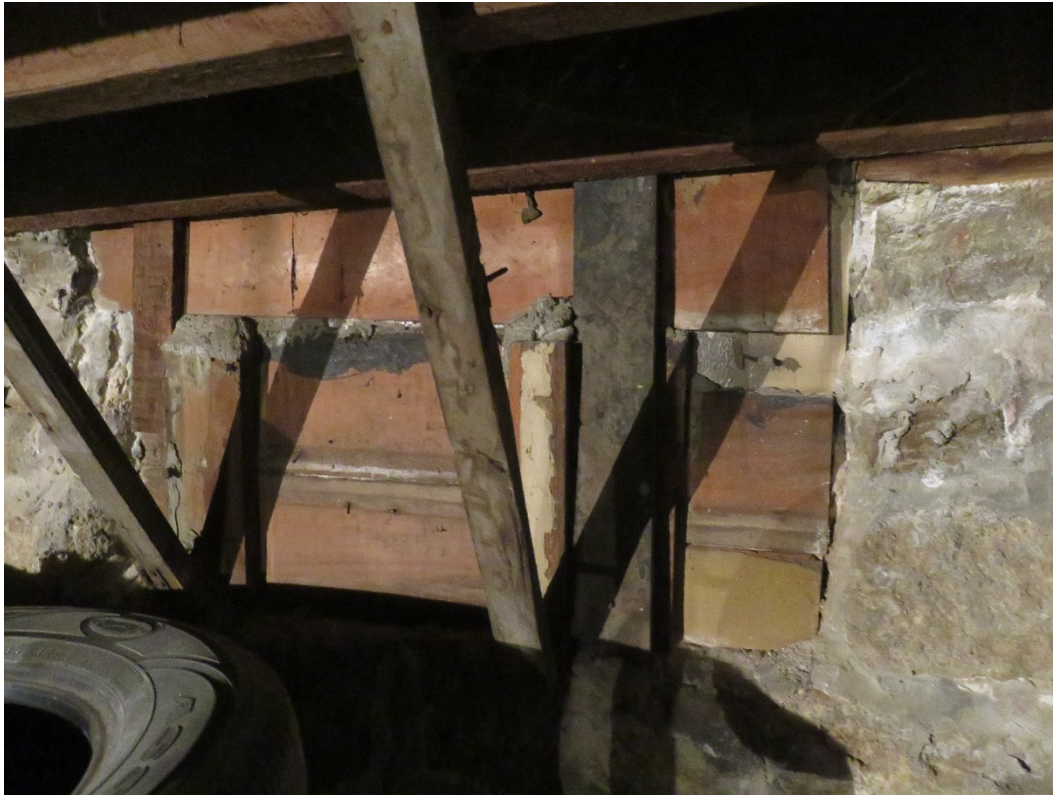
**Photo 147 Building No. 56 – Brinkman’s Chevrolet & Buick (301/305/306 Clay St)
Concrete Filled-In Coal Chute in Basement**

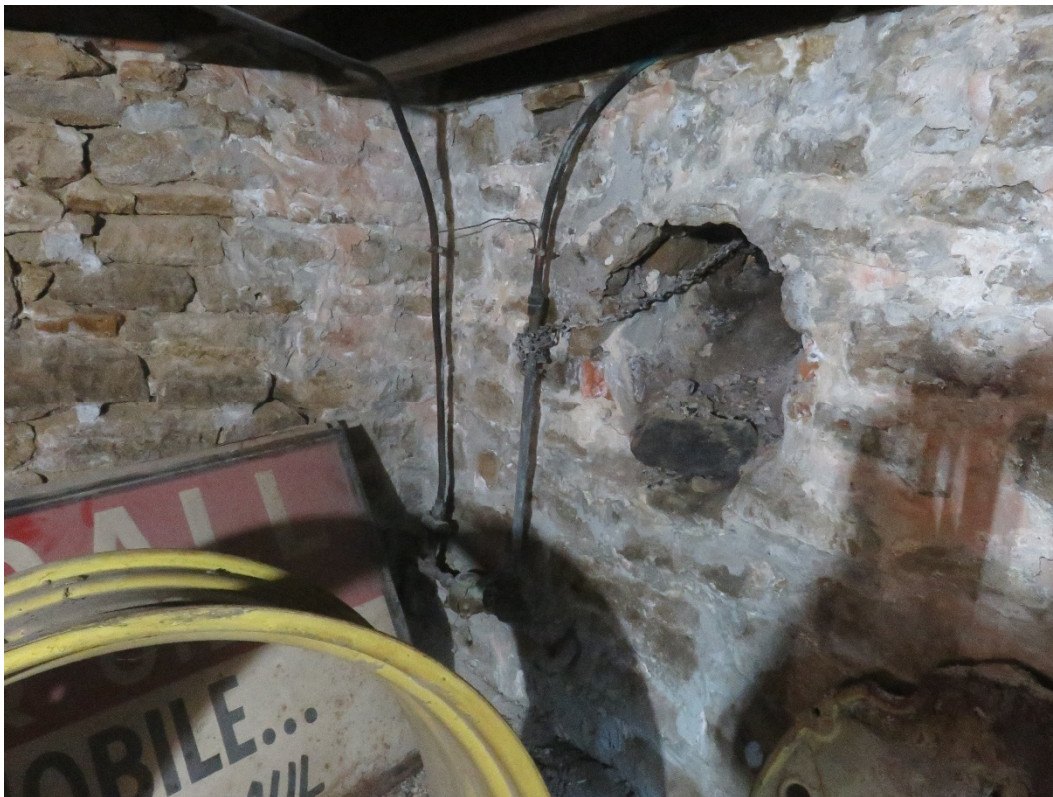
**Photo 148 Building No. 56 – Brinkman’s Chevrolet & Buick (301/305/306 Clay St)
Open Manhole Opening in Basement**

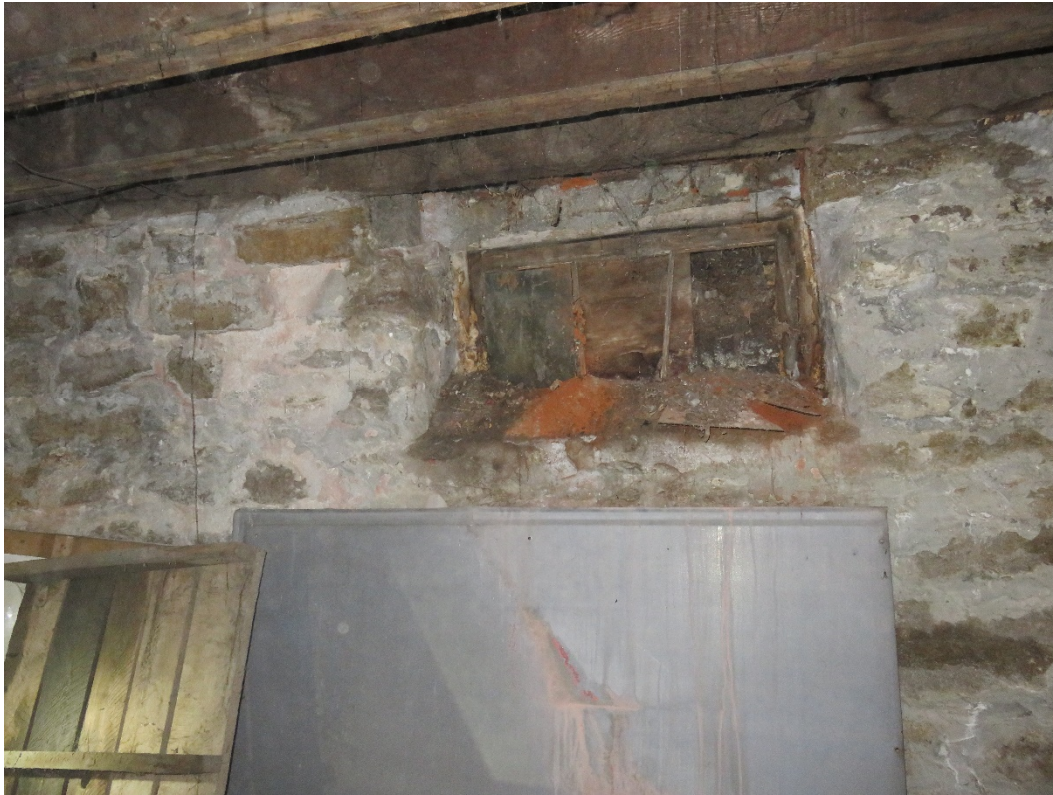
Photo 149 **Building No. 56 – Brinkman’s Chevrolet & Buick (301/305/306 Clay St)**
Rubble Filled-In Coal Chute in Basement

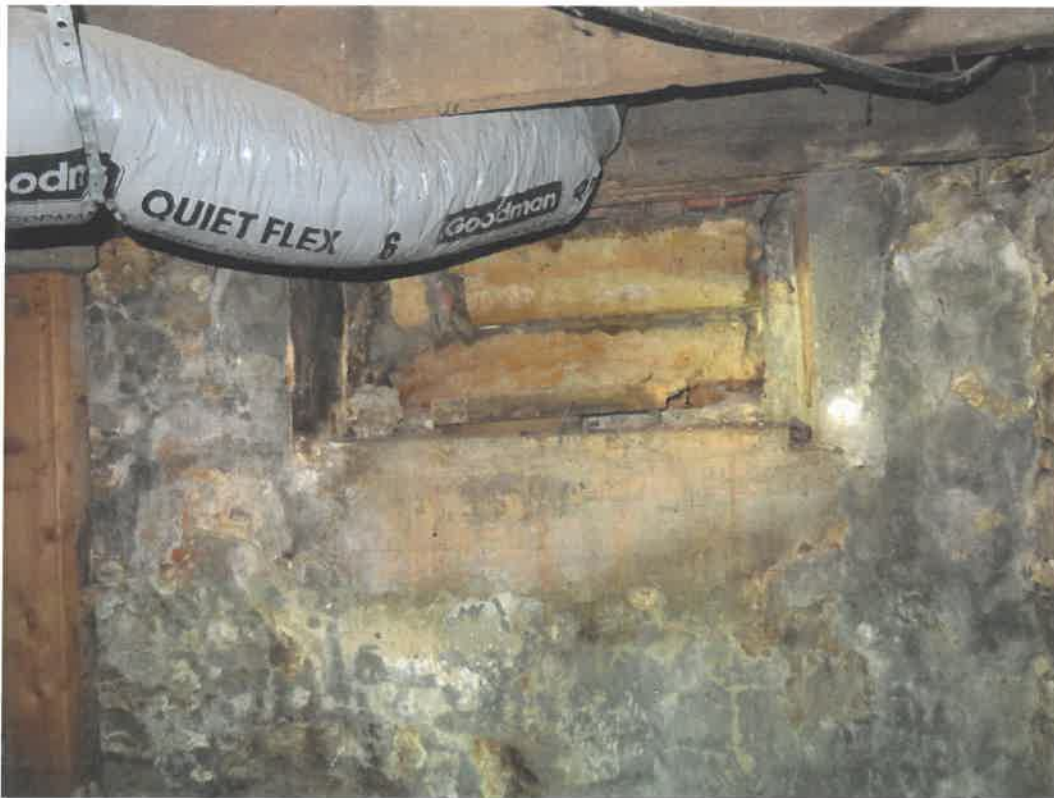
A coal chute opening with wood framing along the frontage of the building was identified in the limestone basement foundation wall. The opening has not been closed off. Rubble fills the coal chute below the sidewalk and does not present a stable condition. For sidewalk improvements, Olsson recommends the rubble be removed, the wood framing of the wall opening be removed, the walls of the opening beneath the sidewalk be removed down to the bottom of the basement opening, the wall opening be filled in with limestone and appropriate mortar, and the void beneath the sidewalk be filled in with an aggregate/gravel material prior to the placement of a new sidewalk. Implementing these recommendations will require the contractor to access the basement during construction.

**Photo 151 Building No. 57 – Darel Weber Real Estate (335 Clay St)
Rubble Filled-In Coal Chute in Basement**

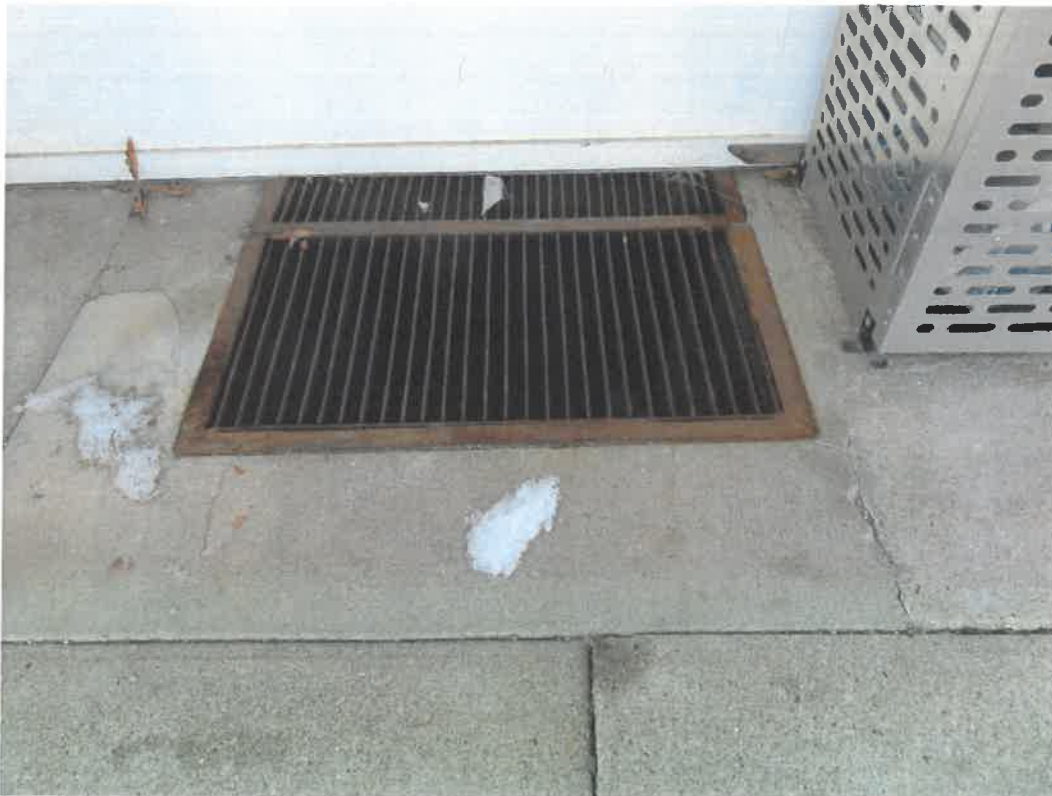
A vent opening along the north frontage of the west building was identified in the CMU basement foundation wall. The CMU wall opening of the vent and the cast-in-place concrete opening with grate under the sidewalk appear to be in very good and stable condition. The metal grate in the sidewalk should be removed and reset during the sidewalk improvements. Sidewalk improvements can be made with no effects to the building. It will not be necessary for the contractor to access the basement during construction for this vent opening.

Photo 155 Building No. 59 – Tecumseh Central Market (381 Clay St)
Open Vent in Sidewalk on North Side of Building

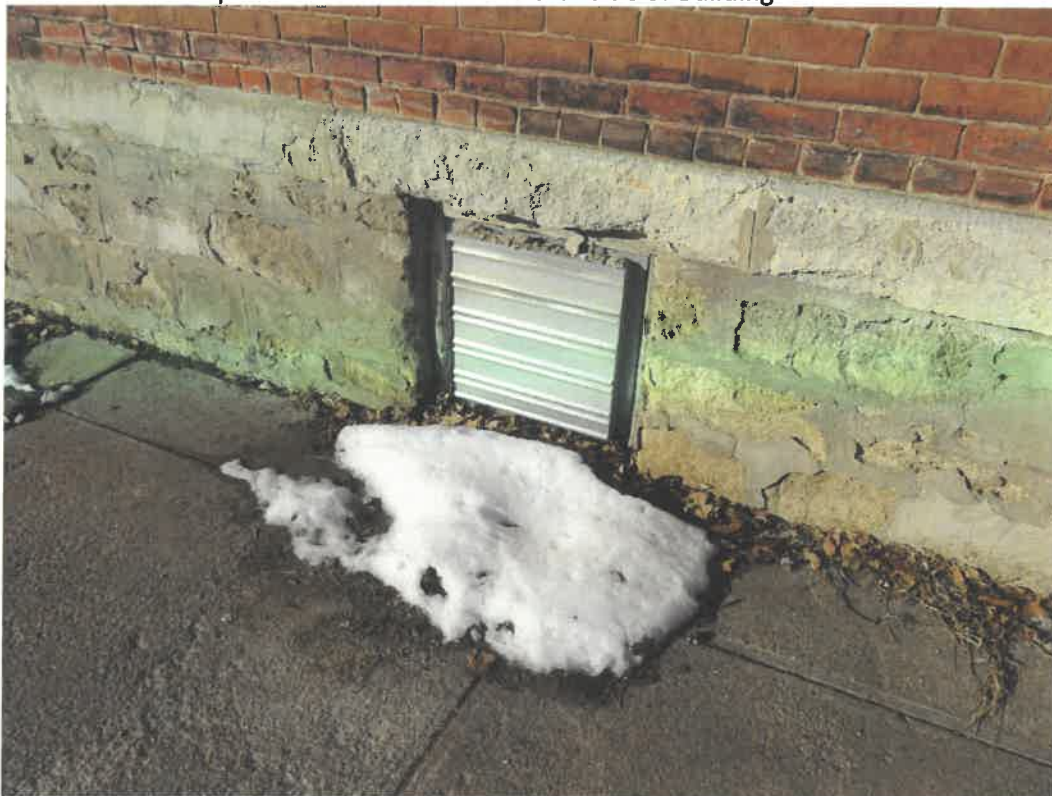
Photo 156 Building No. 59 – Tecumseh Central Market – East Annex (381 Clay St)
Vent Opening in Basement Wall on East Side of East Annex

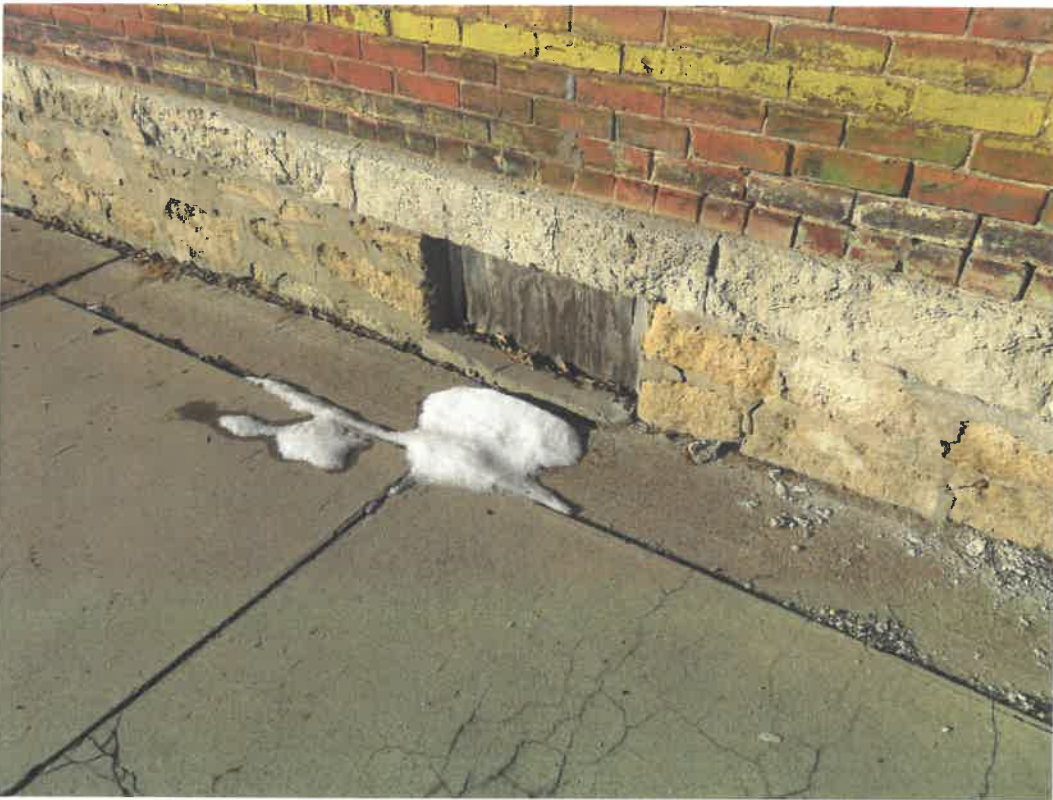
Two window openings with wood framing (one with a vent above the sidewalk) were identified in the limestone basement foundation wall along the east frontage of the east annex building. Both window openings are filled in with batt insulation below the sidewalk elevation. The openings are mostly below the sidewalk and present an unstable condition. For sidewalk improvements, Olsson recommends soil be removed down to the bottom of the two window openings, the wood framing of the two openings be removed, the wall openings be filled in with limestone and appropriate mortar, and the voids beneath the sidewalk be filled in with an aggregate/gravel material prior to the placement of a new sidewalk. The vent is to be placed back in the new wall construction. It will be necessary for the contractor to access the basement during foundation wall construction for these two window openings.

Photo 157 Building No. 59 – Tecumseh Central Market (381 Clay St)
Typical Window Opening in Basement Wall on East Side of East Annex
