OBSERVATION REPORT

Tecumseh Historic Square Preservation – Structural Evaluation

Submitted by Olsson Inc.

February 18, 2022

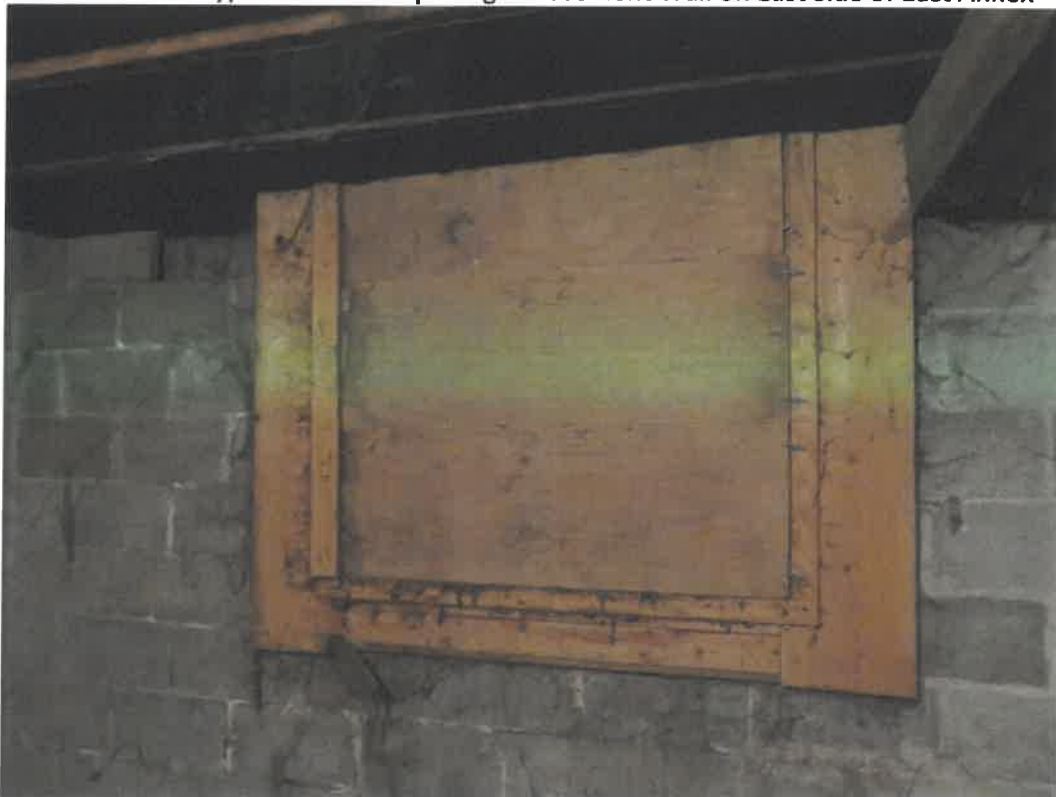
A vent opening along the north frontage of the west building was identified in the CMU basement foundation wall. The CMU wall opening of the vent and the cast-in-place concrete opening with grate under the sidewalk appear to be in very good and stable condition. The metal grate in the sidewalk should be removed and reset during the sidewalk improvements. Sidewalk improvements can be made with no effects to the building. It will not be necessary for the contractor to access the basement during construction for this vent opening.

Photo 158 Building No. 59 – Tecumseh Central Market – East Annex (381 Clay St)
Vent Opening in Basement Wall on North Side of Building

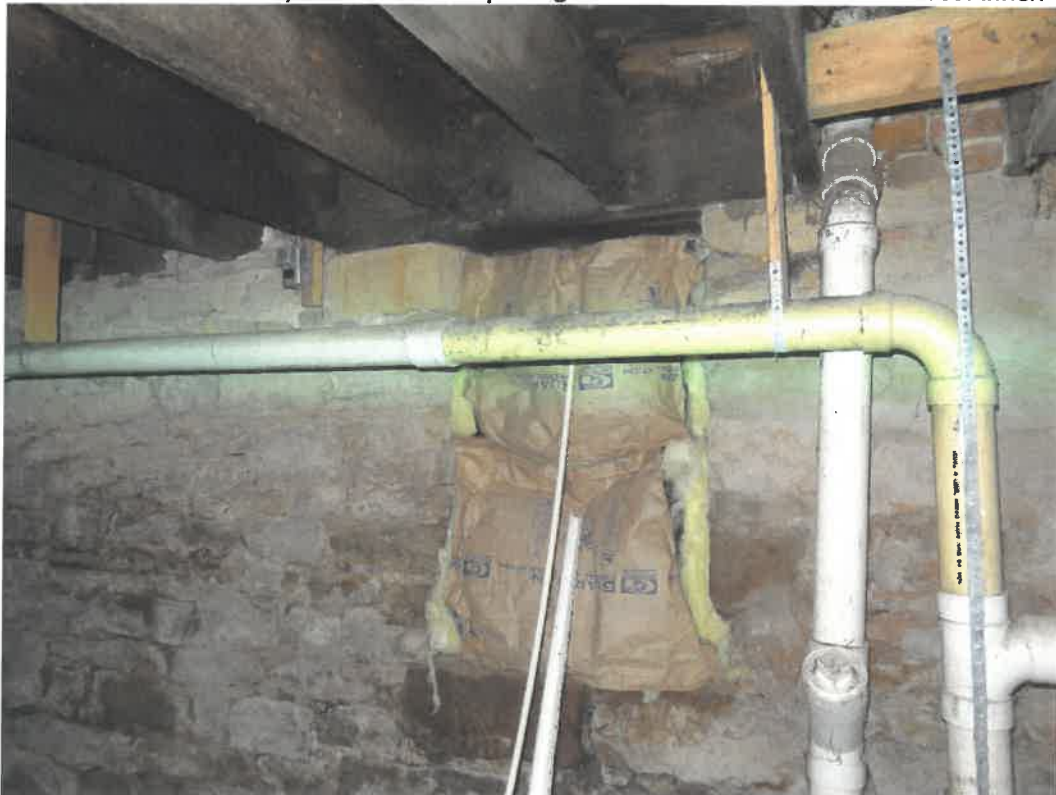
Two window openings with wood framing (one with a vent above the sidewalk) were identified in the limestone basement foundation wall along the east frontage of the east annex building. Both window openings are filled in with batt insulation below the sidewalk elevation. The openings are mostly below the sidewalk and present an unstable condition. For sidewalk improvements, Olsson recommends soil be removed down to the bottom of the two window openings, the wood framing of the two openings be removed, the wall openings be filled in with limestone and appropriate mortar, and the voids beneath the sidewalk be filled in with an aggregate/gravel material prior to the placement of a new sidewalk. The vent is to be placed back in the new wall construction. It will be necessary for the contractor to access the basement during foundation wall construction for these two window openings.

Photo 160 Building No. 59 – Tecumseh Central Market – East Annex (381 Clay St)
Typical Partially Filled-In Window Opening in Basement on East Side of East Annex
